Falcon Creek Erosion Control Study (CNR to Willowbrook Road)

City of Burlington
Regional Municipality of Halton

September 2024

File: **22118**

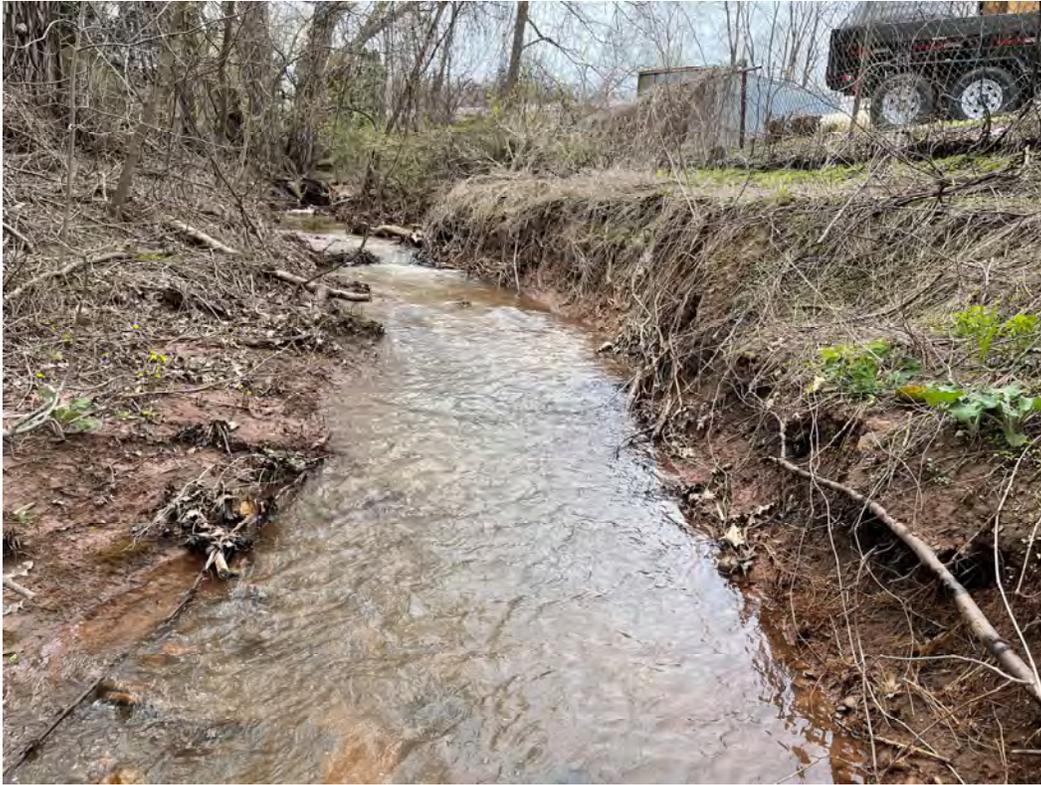
Erosion Site #1 is a steep left bank and is having bank failure of non-cohesive bank material. Though the bank has lots of gravel, the angle of the bank combined with the silty sand is at risk for erosion due to the flow resulting in stress greater than the critical shear stress of the bank material. There is also undercutting at the bank. This is the outside bank of a curve and would have the highest velocities in the channel. The right bank opposite ES#1 is a point bar, with deposition taking place. Across from point bars creating a vortex flow which can lead to the undercutting of the bank due to the geometry of the cross section. The banks are almost vertical at points which is at risk of continued degradation over time. The rate of erosion is not high.

Photo 2.1: Erosion Site #1 – Falcon Creek Upstream of Enfield Road

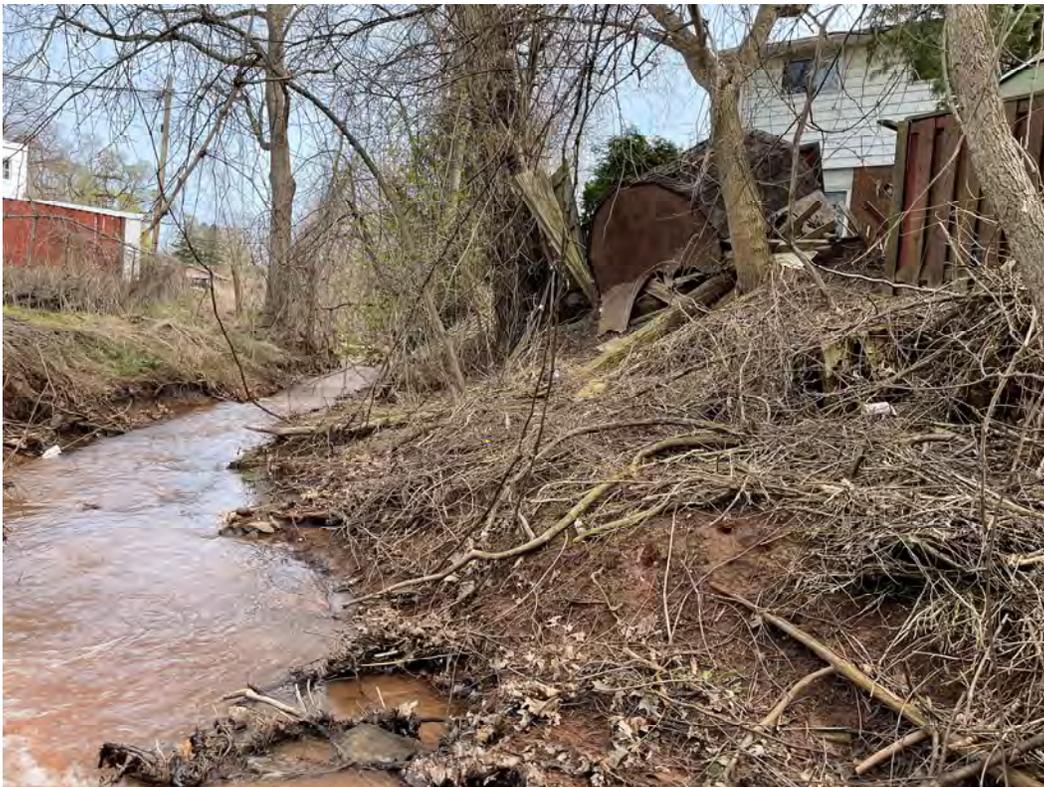
Erosion Site #2 is across from ES #1. The top of bank has been eroding causing fences and trees to lean into the river. Judging by the slope of the bank there has been slump/rotational failure in the bank and or possible frost heave associated with it. The bank appears to be less coarse material than the RB so it would react differently to the flows. The private infrastructure is not at current risk, but it is unsightly. Though there is deposition at this site, it is not enough to make up for the erosion. Compared to a 2015 photo, the site has not been altered significantly. As a result, annual erosion rates are seen to be low.

A shed in disrepair and fallen wooden fencing was observed within the lot associated with 417 Enfield Road near Erosion Site #2 and piles of leaves, branches, and other yard waste were found apparently dumped on the bank slopes within the city-owned creek block adjacent 420 Enfield Road. In addition, raised gardens have been planted within the city-owned creek block adjacent 420 Enfield Road. The bank slope at Erosion Site #1 is steep but not as high as at Erosion Sites #3 and #4. The bank slope at Erosion Site #2 is relatively mild. Several trees along the top of slope at Erosion Site #3 and Erosion Site #4 also have roots that are exposed, as the soil supporting the trees has partially eroded away. Photos of the creek at Erosion Sites #1, #2, #3, and #4 are provided in **Photos 2.1, 2.2, 2.3** and **2.4**, respectively.

Photo 2.2: Erosion Site #2 – Falcon Creek Upstream of Enfield Road

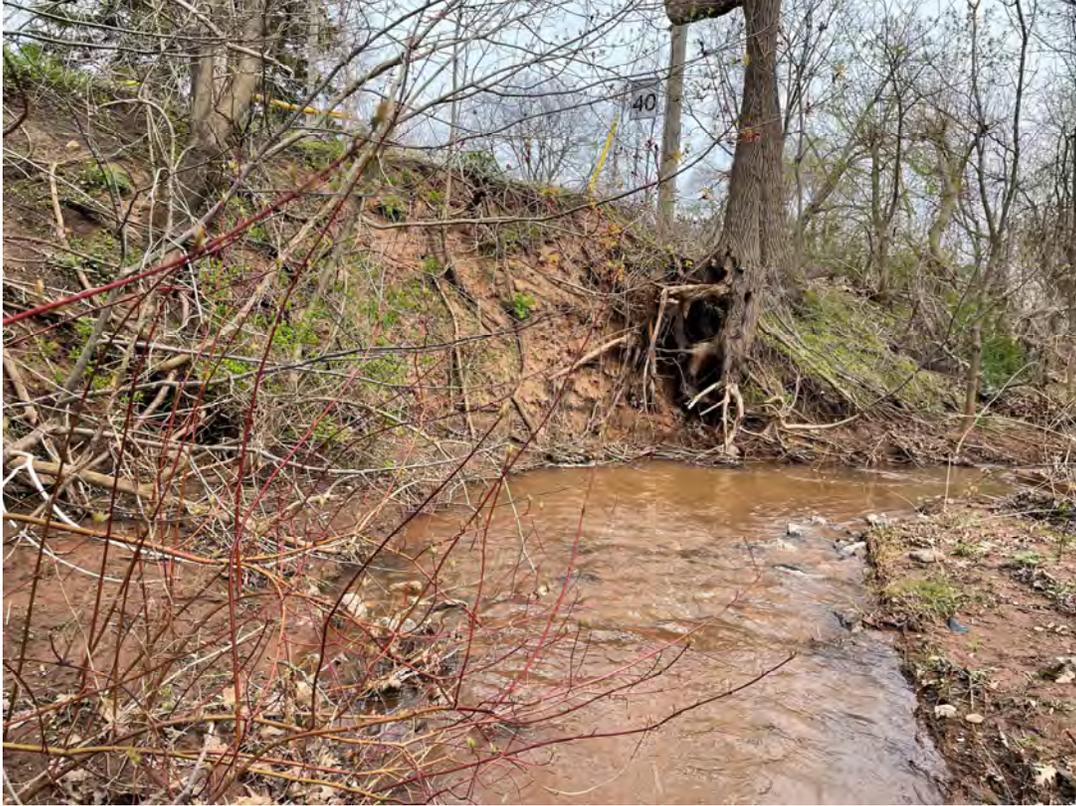
Photo 2.3: Erosion Site #3 – Falcon Creek Adjacent Willowbrook Road

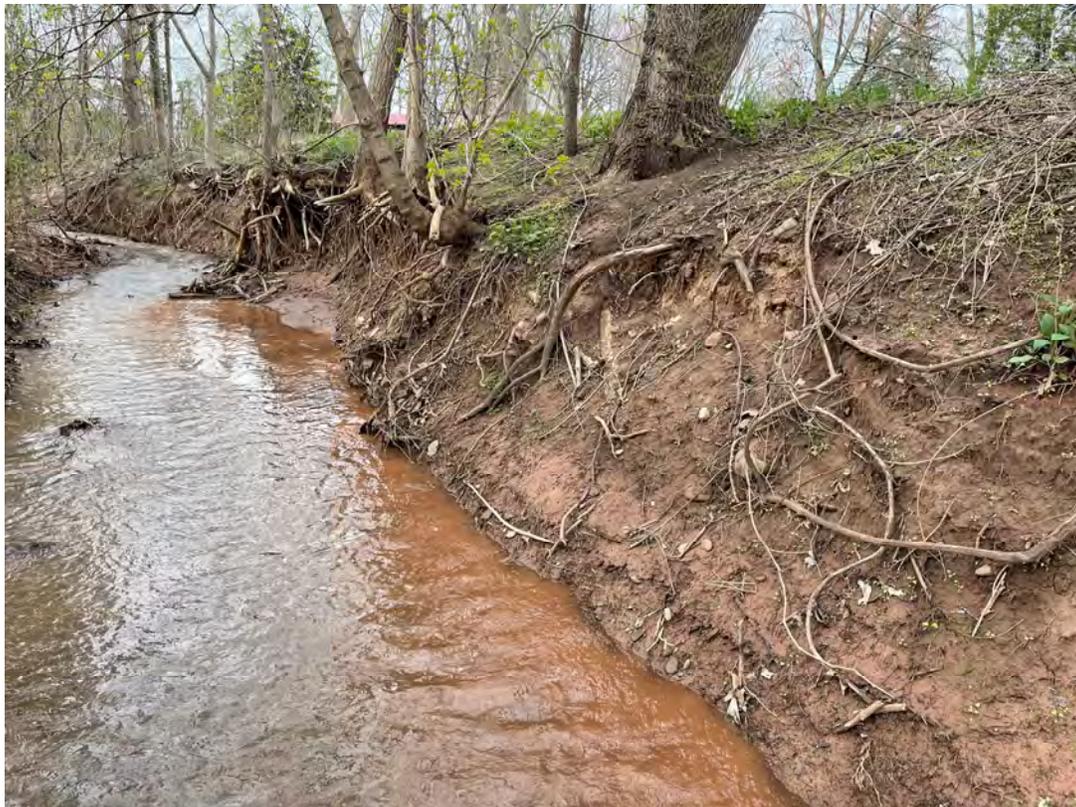
Photo 2.4: Erosion Site #4 – Falcon Creek Adjacent Willowbrook Road

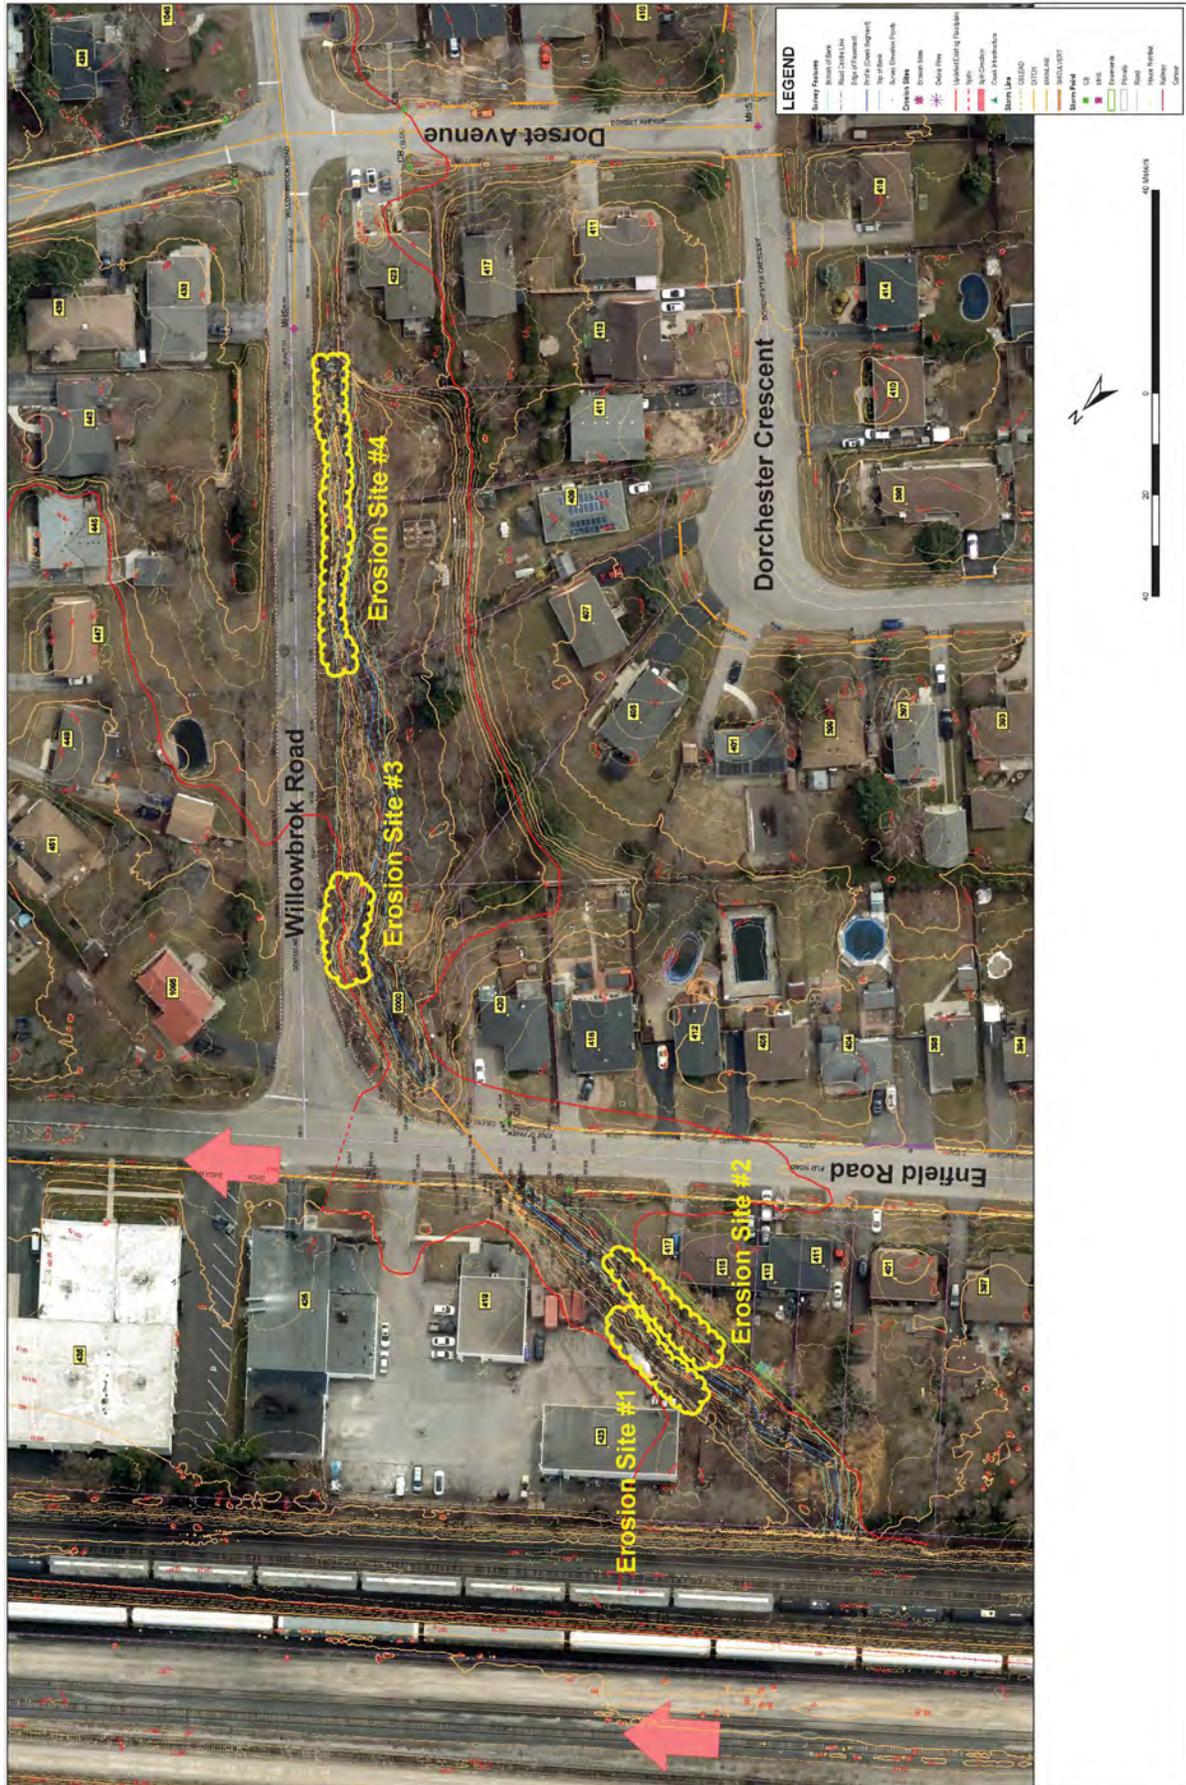
DWG 3.1: Location of Identified Erosion Sites

Based on observations during field surveys and creek walks, four key erosion sites were identified within the subject reach where existing banks are in poor condition. There were some additional areas where minor erosion is occurring but not presenting any immediate issues. Some minor debris piles were also noted within the subject reach consisting of fallen trees, branches, leaves, and other debris that has accumulated over time. The four erosion sites identified were named Erosion Sites #1, #2, #3 and #4, and the approximate location of each is shown on Drawing **DWG 3.1** in **Section 3**.
