PROJECT NO.: **SM 135134-G**

January 14, 2014

**SLOPE STUDY
FALCON CREEK, INDIAN CREEK AND GRINDSTONE CREEK
1200 KING ROAD
BURLINGTON, ONTARIO**

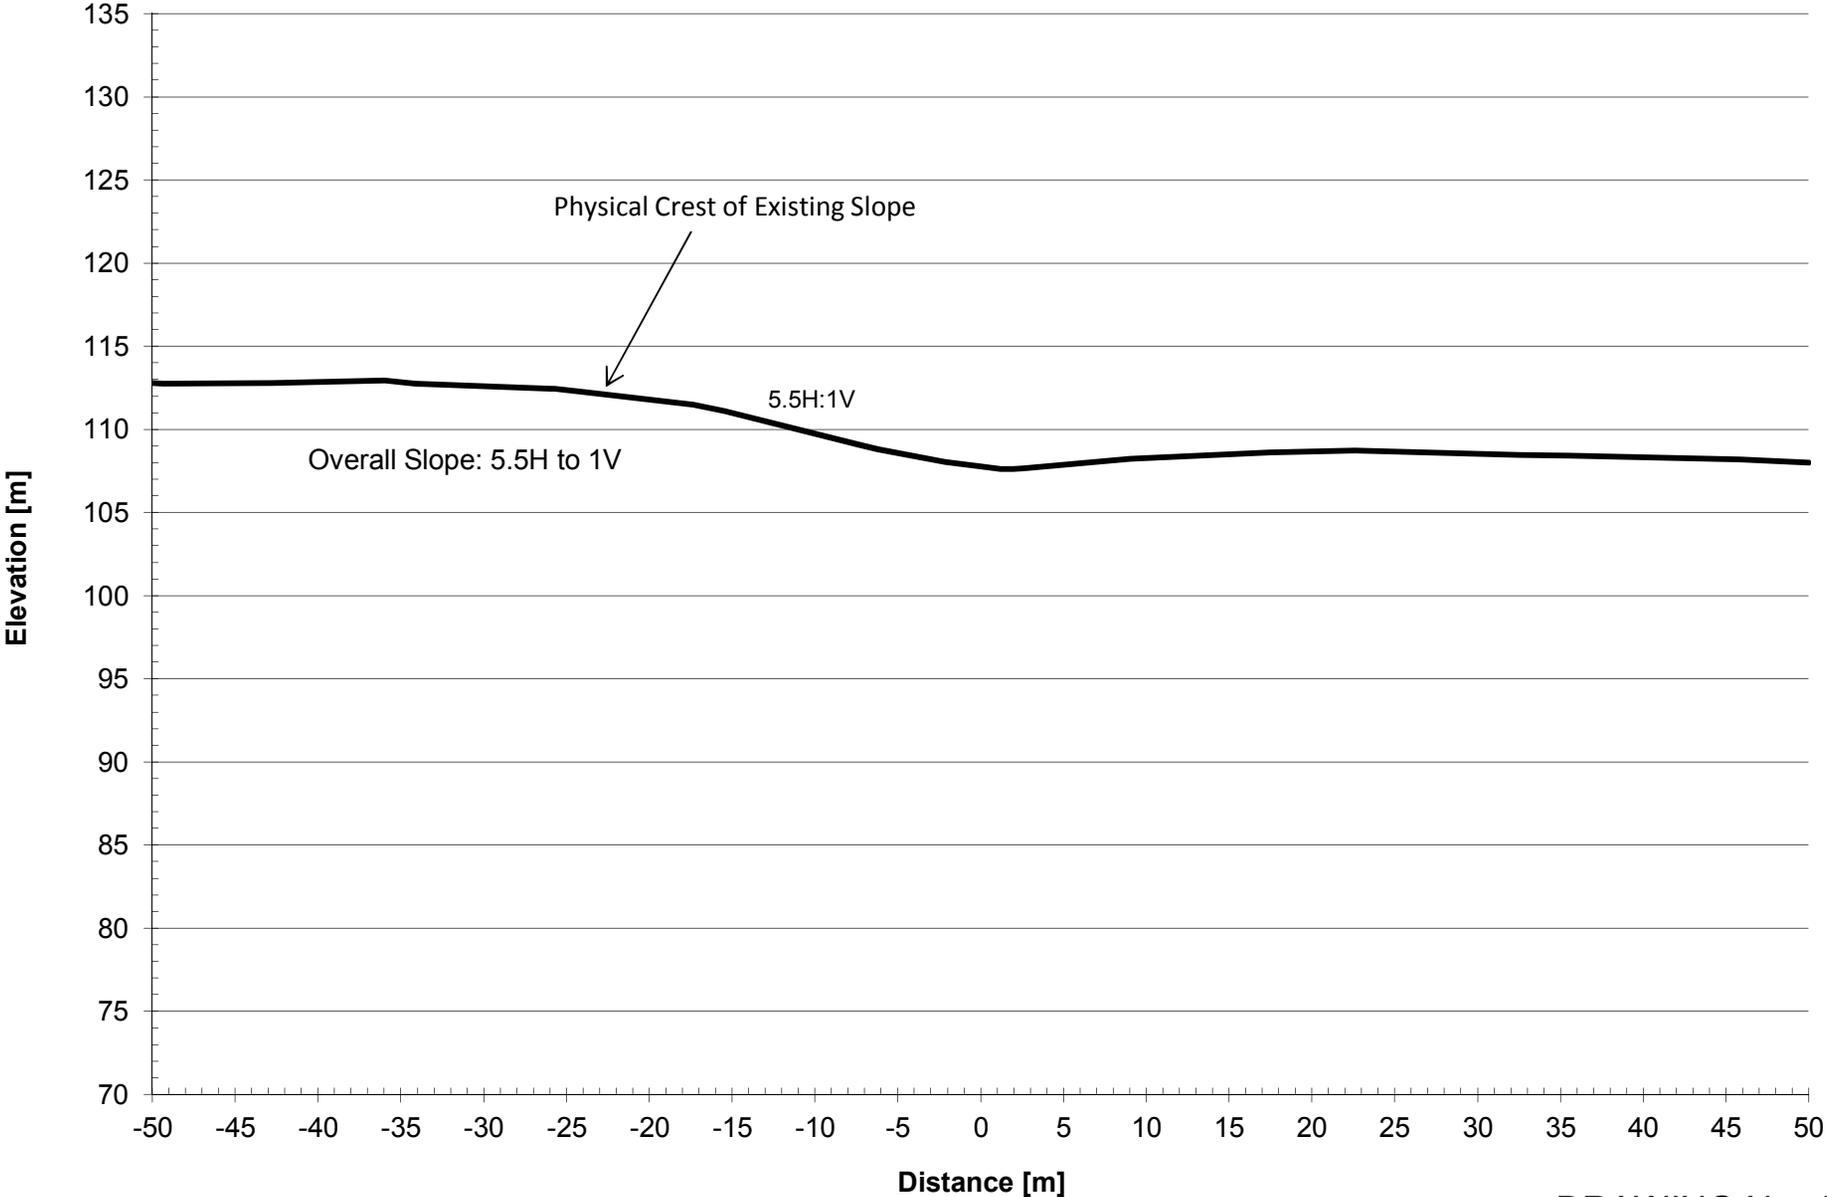
**Slope Study
1200 King Road
Indian Creek
Station 0+080**

The results of this study confirm that the banks of both Indian and Grindstone Creeks are inherently stable across the subject site, at inclinations of 3 horizontal to 1 vertical or flatter. As such the Top of Stable slope would coincide with physical crest of slope. The stability analyses of Falcon Creek confirm the Top of Stable Slope, as summarized above and illustrated on the attached slope profiles, to have factors of safety in excess of 1.5. Any development 'uphill' of the physical crest/Top of Stable Slope would have no impact on the subject slopes, from a geotechnical point of view.

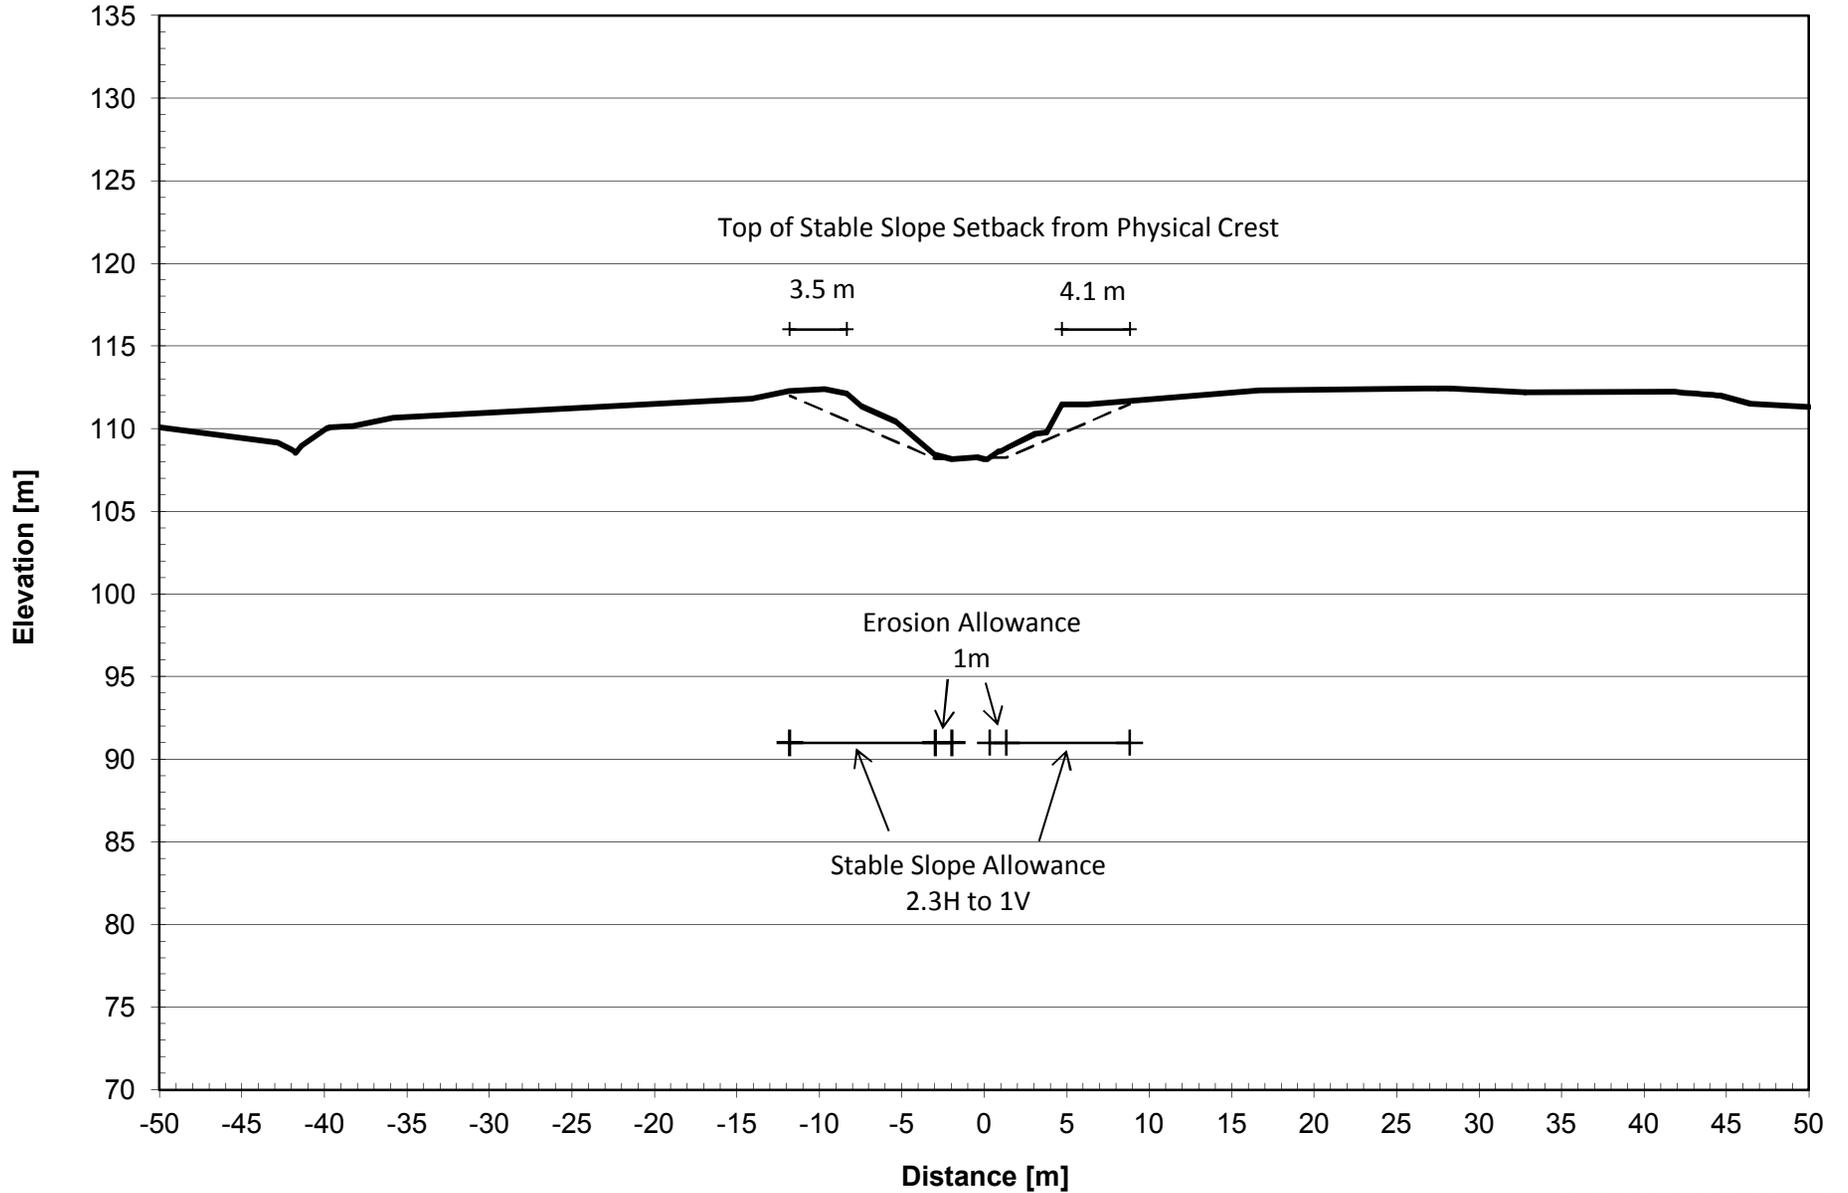
**Slope Study
1200 King Road
Falcon Creek
Station 0+080**

Falcon Creek Station	Left Bank		Right Bank	
	Minimum Factor of Safety	Top of Stable Slope Setback from Crest (m)	Minimum Factor of Safety	Top of Stable Slope Setback from Crest (m)
0+080.00	1.408	3.5	1.459	4.1
0+160.00	1.993	3.8	1.996	3.0
0+260.00	2.085	3.6	1.514	-
0+340.00	1.552	1.9	1.873	0
0+380.00	1.518	3.5	2.094	-
0+420.00	1.884	1.8	2.293	3.9
