# ARBORIST REPORT

3110 South Service Road, Burlington, ON

Date: February 10, 2026

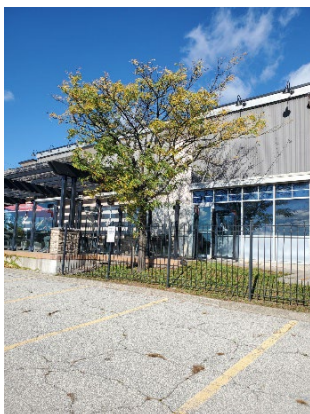
Tree 1 (Neighbouring – 3120 South Service Road)

| Tree # | Species (Common Name) | Species (Botanical Name) | DBH (cm) | Crown Width (m) | Crown Class* | Structural Condition (%) | Health Condition (%) | Overall Condition (%) | Overall Condition Rating | mTPZ (m) | mTPZ (m²) | mTPZ encroachment (m²) | mTPZ encroachment (%) | CRZ (m) | CRZ (m²) | CRZ encroachment (m²) | CRZ encroachment (%) | Comments | Potential Impacts from Construction | Ownership | Recommendation |
|---|---|---|---|---|---|---|---|---|---|---|---|---|---|---|---|---|---|---|---|---|---|
| 1 | Thornless Honeylocust | <i>Gleditsia triacanthos var. inermis</i> | 21 | 5 | D | 80% | 80% | 80% | GOOD | 2.4 | 19.71 | 5.87 | 30% | 4.0 | 52.94 | 19.77 | 37% | Asymmetrical crown (minor) | moderate mTPZ and significant CRZ encroachment due to proposed parking lot replacement | Neighbouring (3120 S Service Rd) | Save |

Portions of the mTPZ and CRZ of Trees #1 and #2 are situated within the existing parking lot of the Subject Site. The proposed work in the vicinity of Trees 1&2 entails removal of existing asphalt paving and replacing with a new asphalt parking surface. This work will extend only to the existing curb line.

Trees #1 and 2 are situated within a neighbouring landscaped island (3120 South Service Road) surrounded by existing curbs and asphalt parking. This suggests that the root systems of these two trees are unlikely to extend beneath the curbs and asphalt parking (i.e., into the Subject Site); rather, it is much more likely that the root systems extend laterally to the northwest and southeast within the existing landscaped island. For this reason, Trees #1 and #2 are not expected to incur any significant injuries during the proposed work.

The existing conditions surrounding Trees 1& 2 afford insufficient space to provide full mTPZ protection as stipulated in *City of Burlington Specifications Index for Tree Protection and Preservation (SPEC NO. SS12A)*. It is recommended that the existing wrought-iron fence between the Subject Site and 3120 South Service Road serve as a Tree Protection Barrier with 1.2m height orange plastic web snow fencing attached along with any and all required signage. Refer to Tree Protection Plan (prepared by adesso design inc.) for layout and location of proposed Tree Protection Barriers.

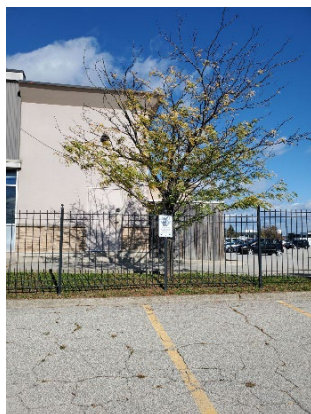
Tree 2 (Neighbouring – 3120 South Service Road)

| Tree # | Species (Common Name) | Species (Botanical Name) | DBH (cm) | Crown Width (m) | Crown Class* | Structural Condition (%) | Health Condition (%) | Overall Condition (%) | Overall Condition Rating | mTPZ (m) | mTPZ (m²) | mTPZ encroachment (m²) | mTPZ encroachment (%) | CRZ (m) | CRZ (m²) | CRZ encroachment (m²) | CRZ encroachment (%) | Comments | Potential Impacts from Construction | Ownership | Recommendation |
|---|---|---|---|---|---|---|---|---|---|---|---|---|---|---|---|---|---|---|---|---|---|
| 2 | Thornless Honeylocust | <i>Gleditsia triacanthos var. inermis</i> | 21 | 4 | D | 80% | 80% | 80% | GOOD | 2.4 | 19.71 | 7.01 | 36% | 4.0 | 52.94 | 21.84 | 41% | | significant mTPZ and CRZencroachment due to proposed parking lot replacement | Neighbouring (3120 S Service Rd) | Save |

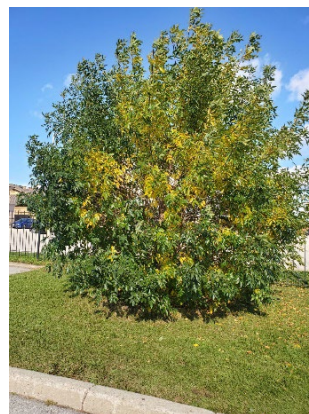
Tree 3 (Subject Site – 3110 South Service Road)

Two Subject Site trees (Trees #3, #4) are aggressively suckering Green/Red Ash stumps; the removal of these two trees occurred prior to the time of inventory. Similarly, Tree #9 is an aggressively suckering Manitoba Maple and appears to have been cut prior to the first inventory in 2021.

In addition, the condition of Tree #3 (Very Poor) and Trees #14, #15, #17 (Dead/Dying) mean that these trees are unlikely to withstand and recover from any construction-related activities.

| Tree # | Species (Common Name) | Species (Botanical Name) | DBH (cm) | Crown Width (m) | Crown Class* | Structural Condition (%) | Health Condition (%) | Overall Condition (%) | Overall Condition Rating | mTPZ (m) | mTPZ (m²) | mTPZ encroachment (m²) | mTPZ encroachment (%) | CRZ (m) | CRZ (m²) | CRZ encroachment (m²) | CRZ encroachment (%) | Comments | Potential Impacts from Construction | Ownership | Recommendation |
|---|---|---|---|---|---|---|---|---|---|---|---|---|---|---|---|---|---|---|---|---|---|
| 3 | Green/Red Ash | <i>Fraxinus pennsylvanica</i> | 22.36 (10x5cm) | 6 | D | 30% | 10% | 20% | VERY POOR | 2.4 | 19.82 | 19.82 | 100% | 4.0 | 53.11 | 43.29 | 82% | Visible EAB damage, bark peeling | direct conflict with proposed parking area and grading | Subject Site | Remove |

All twelve (12) Subject Site Trees are recommended for removal due to either direct conflict with the proposed building footprint (Trees #4, #6, #7, #8), and/or significant to severe mTPZ encroachment as a result of proposed grading and excavation (Trees #3, #9, #12, #13, #14, #15, #16, #17).

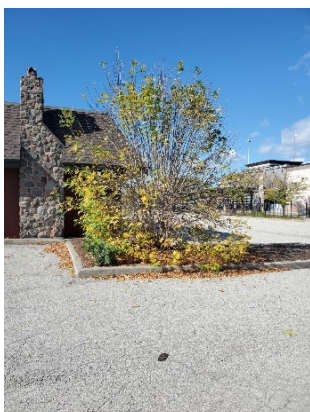
Tree 4 (Subject Site)

| Tree # | Species (Common Name) | Species (Botanical Name) | DBH (cm) | Crown Width (m) | Crown Class* | Structural Condition (%) | Health Condition (%) | Overall Condition (%) | Overall Condition Rating | mTPZ (m) | mTPZ (m²) | mTPZ encroachment (m²) | mTPZ encroachment (%) | CRZ (m) | CRZ (m²) | CRZ encroachment (m²) | CRZ encroachment (%) | Comments | Potential Impacts from Construction | Ownership | Recommendation |
|---|---|---|---|---|---|---|---|---|---|---|---|---|---|---|---|---|---|---|---|---|---|
| 4 | Green/Red Ash | <i>Fraxinus pennsylvanica</i> | 26.73 (10x8cm, 3x5cm) | 8 | D | 30% | 50% | 40% | POOR | 2.4 | 20.23 | 20.23 | 100% | 4.0 | 53.68 | 53.68 | 100% | Epicormic branching, coppice growth, included bark | direct conflict with proposed building footprint | Subject Site | Remove |

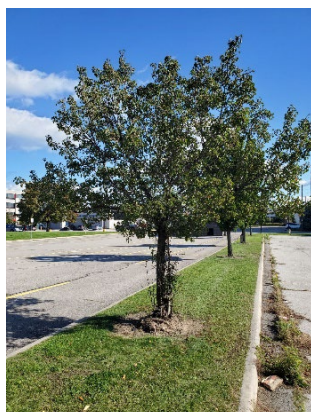
Tree 5 (Neighbouring – 3115 Harvester Road))

| Tree # | Species (Common Name) | Species (Botanical Name) | DBH (cm) | Crown Width (m) | Crown Class* | Structural Condition (%) | Health Condition (%) | Overall Condition (%) | Overall Condition Rating | mTPZ (m) | mTPZ (m²) | mTPZ encroachment (m²) | mTPZ encroachment (%) | CRZ (m) | CRZ (m²) | CRZ encroachment (m²) | CRZ encroachment (%) | Comments | Potential Impacts from Construction | Ownership | Recommendation |
|---|---|---|---|---|---|---|---|---|---|---|---|---|---|---|---|---|---|---|---|---|---|
| 5 | Ornamental Pear species | <i>Pyrus calleryana 'Capital'</i> | 17 | 5 | D | 70% | 70% | 70% | GOOD | 2.4 | 20.17 | 0.00 | 0% | 4.0 | 53.68 | 0.00 | 0% | Watersprouts (severe), epicormic branching | none | Neighbouring (3115 Harvester Rd) | Save |

Tree #5 is recommended for preservation and no impacts to the tree's mTPZ or CRZ are expected as the tree is well beyond the limit of proposed work. Refer to Tree Protection Plan by adesso design inc. for location and extent of proposed Tree Protection Measures.

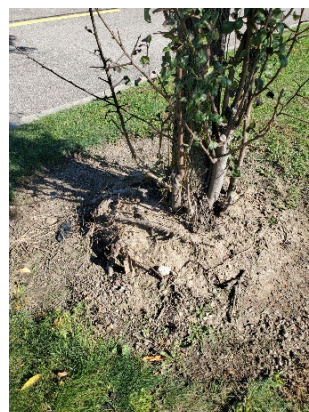
Tree 5 (Neighbouring – 3115 Harvester Road) – Exposed root plate with suspected girdling root

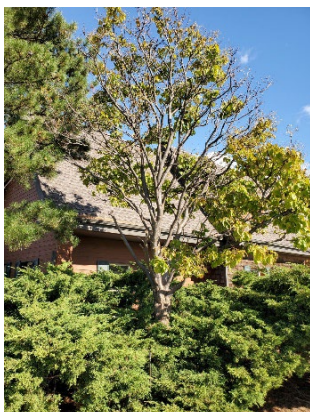
Tree 6 (Subject Site)

| Tree # | Species (Common Name) | Species (Botanical Name) | DBH (cm) | Crown Width (m) | Crown Class* | Structural Condition (%) | Health Condition (%) | Overall Condition (%) | Overall Condition Rating | mTPZ (m) | mTPZ (m²) | mTPZ encroachment (m²) | mTPZ encroachment (%) | CRZ (m) | CRZ (m²) | CRZ encroachment (m²) | CRZ encroachment (%) | Comments | Potential Impacts from Construction | Ownership | Recommendation |
|---|---|---|---|---|---|---|---|---|---|---|---|---|---|---|---|---|---|---|---|---|---|
| 6 | Japanese Tree Lilac | <i>Syringa reticulata</i> | 28 | 4 | D | 30% | 50% | 40% | POOR | 2.4 | 20.27 | 20.27 | 100% | 4.0 | 53.85 | 53.85 | 100% | Dead/broken branches in canopy (severe) | direct conflict with proposed building footprint | Subject Site | Remove |

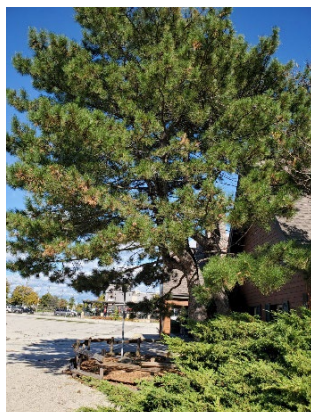
Tree 7 (Subject Site)

| Tree # | Species (Common Name) | Species (Botanical Name) | DBH (cm) | Crown Width (m) | Crown Class* | Structural Condition (%) | Health Condition (%) | Overall Condition (%) | Overall Condition Rating | mTPZ (m) | mTPZ (m²) | mTPZ encroachment (m²) | mTPZ encroachment (%) | CRZ (m) | CRZ (m²) | CRZ encroachment (m²) | CRZ encroachment (%) | Comments | Potential Impacts from Construction | Ownership | Recommendation |
|---|---|---|---|---|---|---|---|---|---|---|---|---|---|---|---|---|---|---|---|---|---|
| 7 | Austrian Pine | <i>Pinus nigra</i> | 63.98 (37,31,42) | 12 | C | 60% | 70% | 65% | GOOD | 4.2 | 64.18 | 64.18 | 100% | 7.0 | 168.33 | 168.33 | 100% | Insect damage, asymmetrical crown, possible diplodia tip blight | direct conflict with proposed building footprint | Subject Site | Remove |

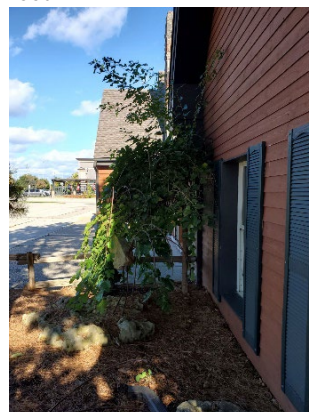
Tree 8 (Subject Site)

| Tree # | Species (Common Name) | Species (Botanical Name) | DBH (cm) | Crown Width (m) | Crown Class* | Structural Condition (%) | Health Condition (%) | Overall Condition (%) | Overall Condition Rating | mTPZ (m) | mTPZ (m²) | mTPZ encroachment (m²) | mTPZ encroachment (%) | CRZ (m) | CRZ (m²) | CRZ encroachment (m²) | CRZ encroachment (%) | Comments | Potential Impacts from Construction | Ownership | Recommendation |
|---|---|---|---|---|---|---|---|---|---|---|---|---|---|---|---|---|---|---|---|---|---|
| 8 | Weeping White Mulberry | <i>Morus alba 'Pendula'</i> | 9 | 1 | C | 60% | 50% | 55% | FAIR | 1.8 | 10.69 | 10.69 | 100% | 1.8 | 10.69 | 10.69 | 100% | Dead/broken branches in canopy, asymmetrical crown | direct conflict with proposed building footprint | Subject Site | Remove |

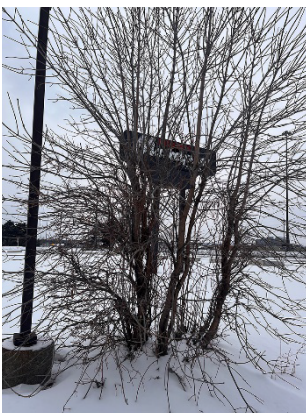
Tree 9 (Subject Site)

| Tree # | Species (Common Name) | Species (Botanical Name) | DBH (cm) | Crown Width (m) | Crown Class* | Structural Condition (%) | Health Condition (%) | Overall Condition (%) | Overall Condition Rating | mTPZ (m) | mTPZ (m²) | mTPZ encroachment (m²) | mTPZ encroachment (%) | CRZ (m) | CRZ (m²) | CRZ encroachment (m²) | CRZ encroachment (%) | Comments | Potential Impacts from Construction | Ownership | Recommendation |
|---|---|---|---|---|---|---|---|---|---|---|---|---|---|---|---|---|---|---|---|---|---|
| 9 | Manitoba Maple | <i>Acer negundo</i> | 12.73 (4x4cm,2x7cm) | 3 | D | 40% | 70% | 55% | FAIR | 2.4 | 19.07 | 19.07 | 100% | 4.0 | 51.88 | 51.88 | 100% | coppice growth | direct conflict with proposed parking area and grading | Subject Site | Remove |

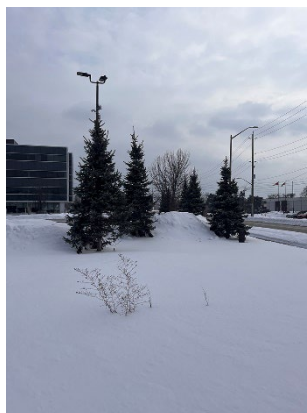
Trees 10-11 (Neighbouring – 3106 South Service Road)  
Tree 12 (Subject Site)

| Tree # | Species (Common Name) | Species (Botanical Name) | DBH (cm) | Crown Width (m) | Crown Class* | Structural Condition (%) | Health Condition (%) | Overall Condition (%) | Overall Condition Rating | mTPZ (m) | mTPZ (m²) | mTPZ encroachment (m²) | mTPZ encroachment (%) | CRZ (m) | CRZ (m²) | CRZ encroachment (m²) | CRZ encroachment (%) | Comments | Potential Impacts from Construction | Ownership | Recommendation |
|---|---|---|---|---|---|---|---|---|---|---|---|---|---|---|---|---|---|---|---|---|---|
| 10 | Colorado Blue Spruce | <i>Picea pungens var. Glauca</i> | 13 | 3 | D | 70% | 80% | 75% | GOOD | 2.4 | 19.09 | 0.00 | 0% | 4.0 | 51.91 | 0.00 | 0% | Tree not surveyed | none | Neighbouring (3106 S Service Rd) | Save |

| Tree # | Species (Common Name) | Species (Botanical Name) | DBH (cm) | Crown Width (m) | Crown Class* | Structural Condition (%) | Health Condition (%) | Overall Condition (%) | Overall Condition Rating | mTPZ (m) | mTPZ (m²) | mTPZ encroachment (m²) | mTPZ encroachment (%) | CRZ (m) | CRZ (m²) | CRZ encroachment (m²) | CRZ encroachment (%) | Comments | Potential Impacts from Construction | Ownership | Recommendation |
|---|---|---|---|---|---|---|---|---|---|---|---|---|---|---|---|---|---|---|---|---|---|
| 11 | Colorado Blue Spruce | <i>Picea pungens</i> var. <i>Glauca</i> | 13 | 3 | D | 60% | 80% | 70% | GOOD | 2.4 | 19.09 | 0.00 | 0% | 4.0 | 51.91 | 0.00 | 0% | Tree not surveyed | none | Neighbouring (3106 S Service Rd) | Save |
| 12 | Colorado Blue Spruce | <i>Picea pungens</i> var. <i>Glauca</i> | 12 | 3 | D | 60% | 70% | 65% | GOOD | 2.4 | 19.01 | 13.59 | 71% | 4.0 | 51.78 | 32.89 | 64% | Tree not surveyed | severe mTPZ and CRZ injury due to proposed underground parking structure and grading | Subject Site | Remove |

Trees #10 and #11 are recommended for preservation and no mTPZ or CRZ injuries expected in the context of the proposed work. There is sufficient space around these two trees to provide full mTPZ and CRZ protection. Refer to Tree Protection Plan by adesso design inc. for location and extent of proposed Tree Protection Measures.

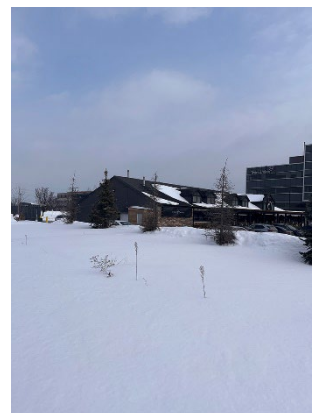
Trees 14-17 (Subject Site)

| Tree # | Species (Common Name) | Species (Botanical Name) | DBH (cm) | Crown Width (m) | Crown Class* | Structural Condition (%) | Health Condition (%) | Overall Condition (%) | Overall Condition Rating | mTPZ (m) | mTPZ (m²) | mTPZ encroachment (m²) | mTPZ encroachment (%) | CRZ (m) | CRZ (m²) | CRZ encroachment (m²) | CRZ encroachment (%) | Comments | Potential Impacts from Construction | Ownership | Recommendation |
|---|---|---|---|---|---|---|---|---|---|---|---|---|---|---|---|---|---|---|---|---|---|
| 14 | Colorado Blue Spruce | <i>Picea pungens</i> var. <i>Glauca</i> | 5 | 1 | D | 0% | 0% | 0% | DEAD/DYI NG | 1.8 | 10.46 | 8.40 | 80% | 1.8 | 10.46 | 8.40 | 80% | Tree not surveyed, dead standing | severe mTPZ and CRZ injury due to proposed underground parking structure and grading | Subject Site | Remove |
