January 03, 2018

ARBORIST REPORT
5353 Lakeshore Road, Burlington, Ontario

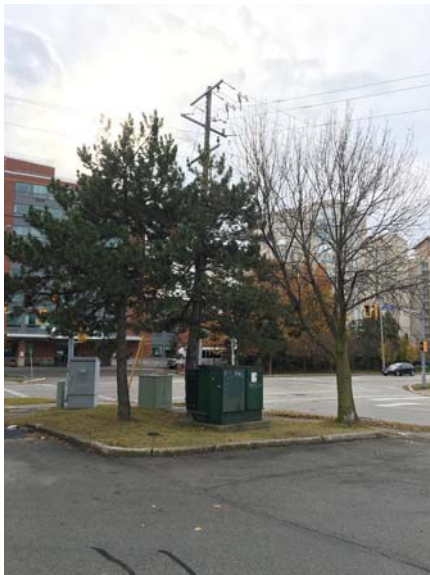
Trees #4 through #6, looking South

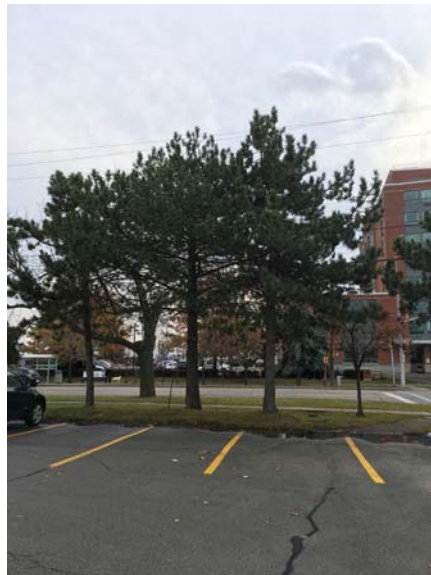
Trees #7 through #10, looking South

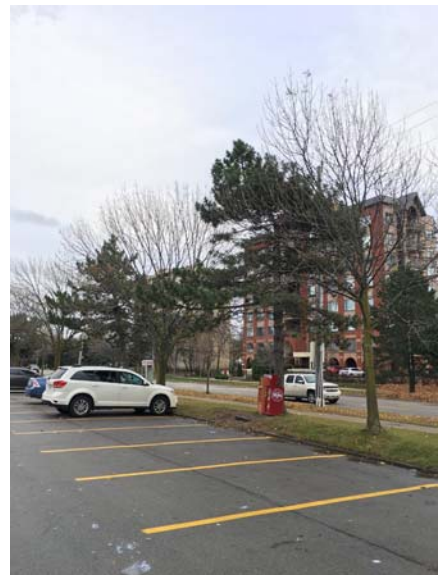
Trees #11 through #16, looking South-east

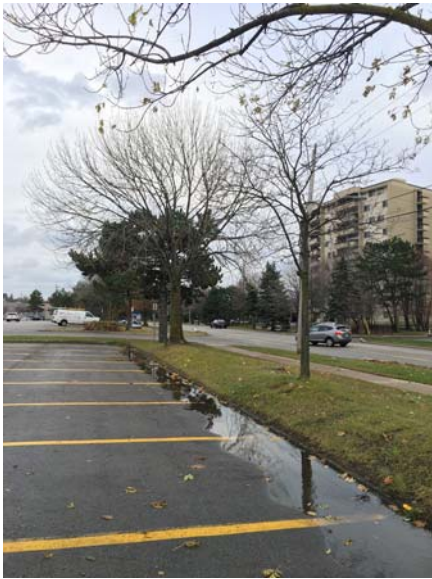
Trees #17 through #20, looking South-east

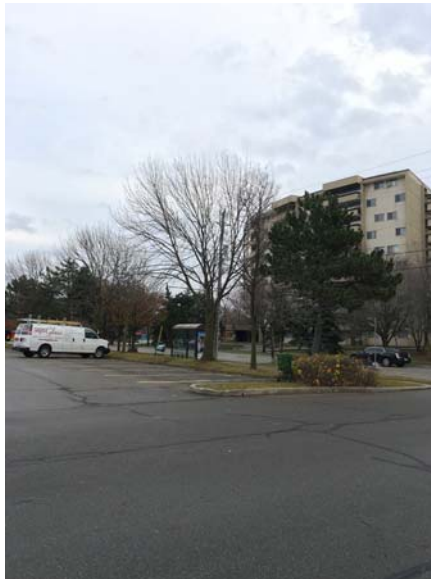
Trees #21 through #26 and #30, looking South-east

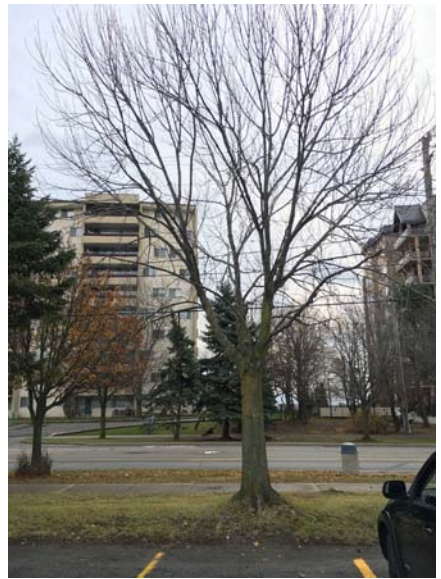
Trees #23, looking South

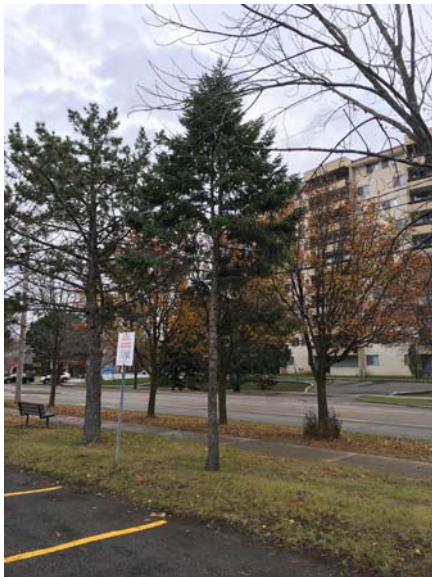
Trees, #24, #26, #27, and #31 through #33 looking South-east

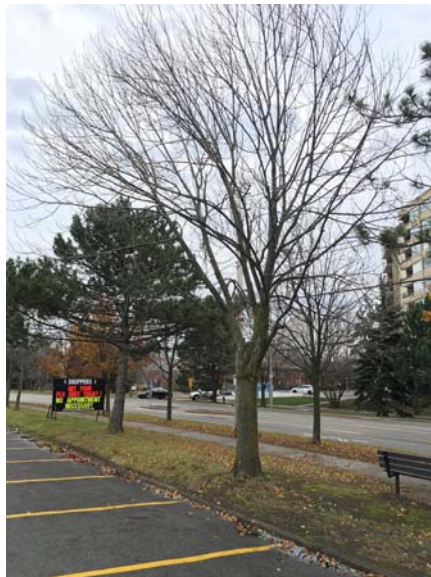
Trees #28 through #29 and #34, looking South-east

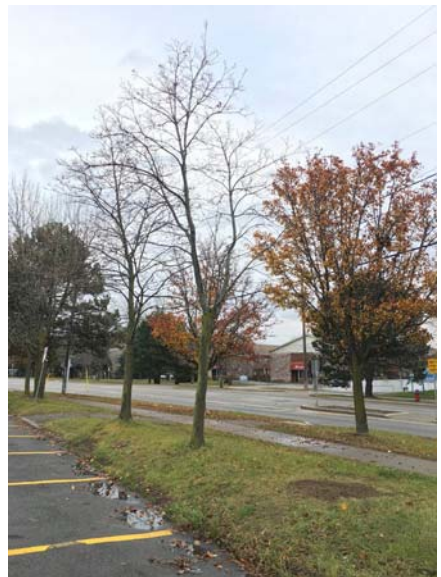
Trees #35 through #41, looking South-east

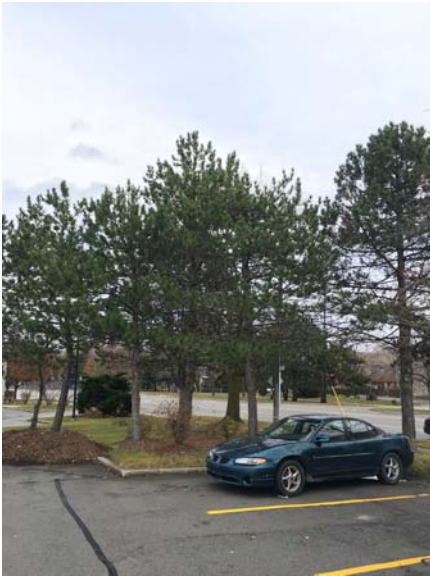
Trees #42 through #48, looking East

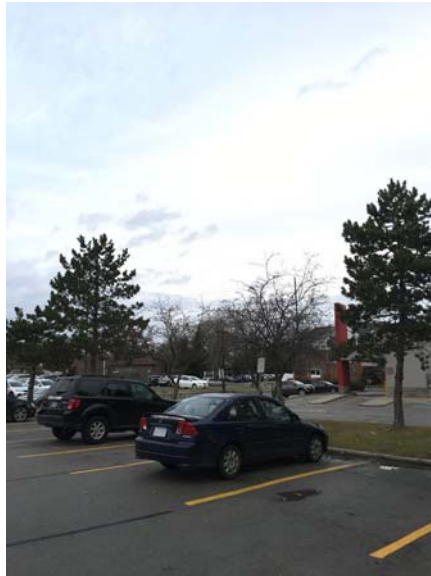
Trees #49 through #52, looking North-East

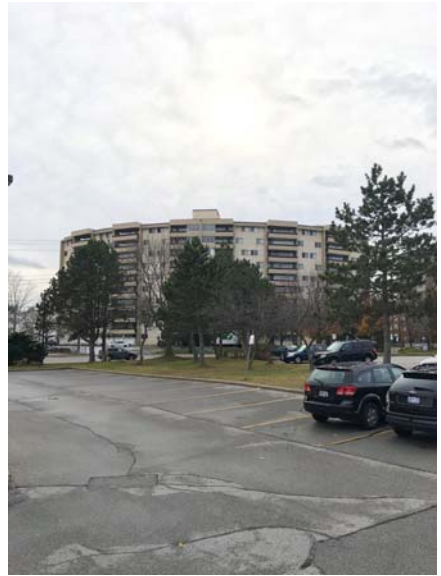
Trees #49 through #55, looking South

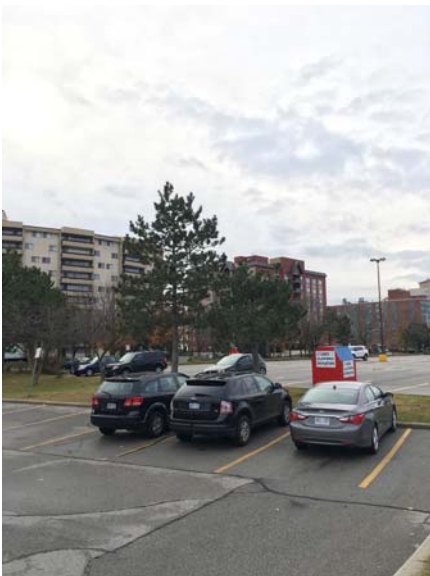
Trees #47 through #57, looking South

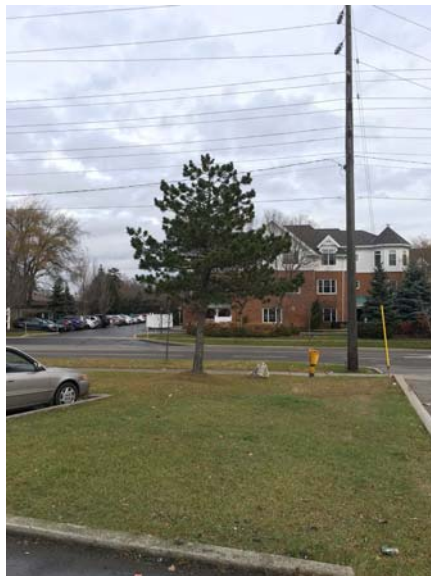
Trees #56, looking East

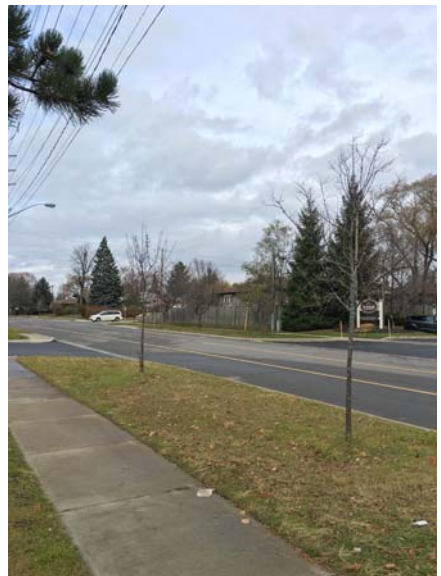
Trees #57 through #58, looking North

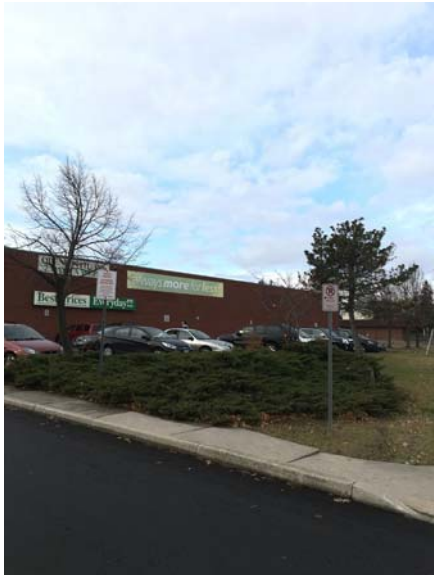
Trees #59 through #61, looking West

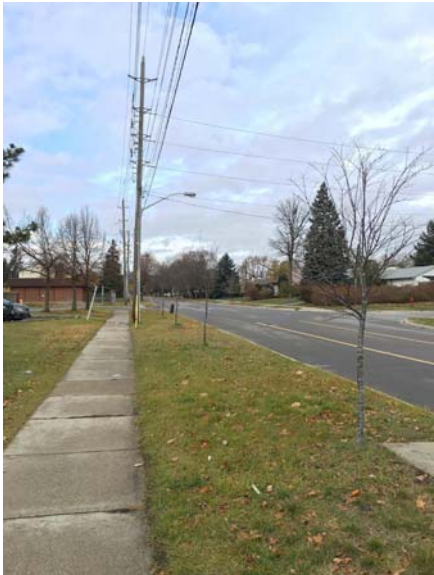
Trees #62 through #65, looking North

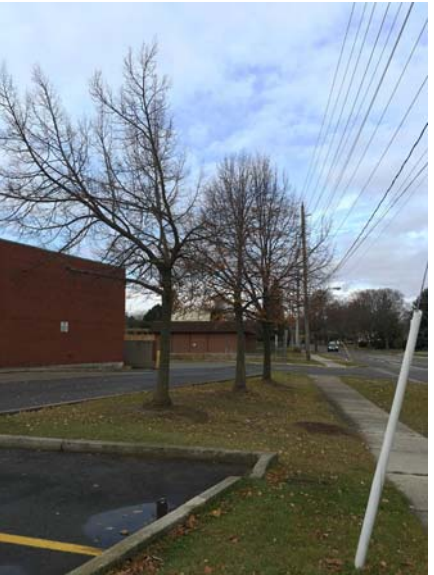
65	Ivory Silk Lilac	Syringa reticulata 'Ivory Silk'	5	F	1.8		Retain
66	Linden sp.	Tilia sp.	22	F	2.4	Exposed roots	Remove due to construction
67	Linden sp.	Tilia sp.	23	F	2.4	Exposed roots	Remove due to construction
68	Linden sp.	Tilia sp.	25	F	2.4	Exposed roots	Remove due to construction
69	Ash sp.	Fraxinus sp.	10-15	F	2.4	8 stem Ash clump; Grown into fence	Retain
70	Maple sp.	Acer sp.	45	P	2.4	Main leader cut; Grown into fence; Signs of insect infestation and rot	Retain
71	Apple sp.	Malus sp.	31	F	2.4		Retain

Trees #66 through #68, looking North-West

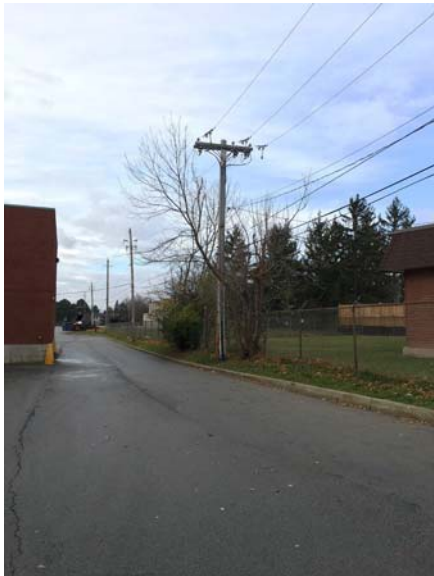
Trees #69, looking West

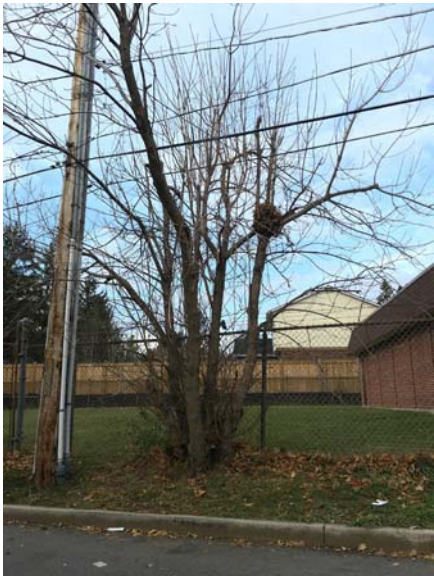
Trees #69, looking North-West

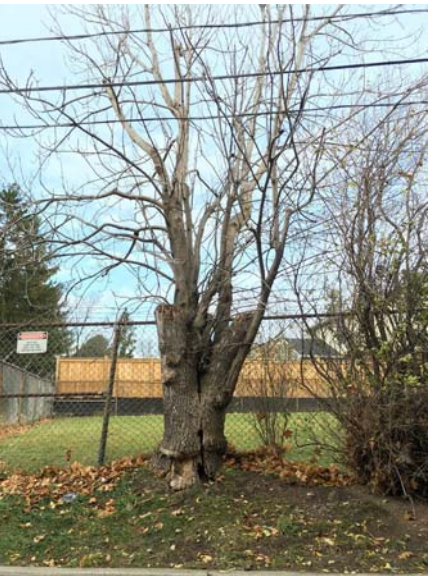
Trees #70, looking North-West

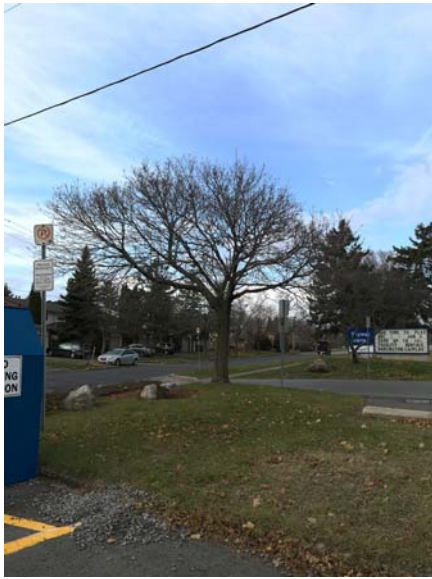
Trees #71, looking North-West

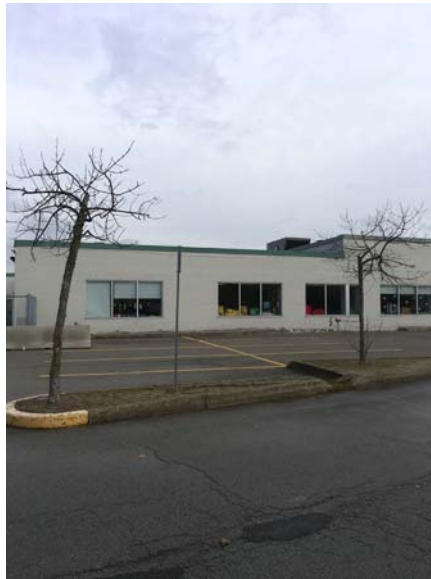
Trees #1 through #2, looking East

It is our opinion that fifty-seven (58) trees of the identified seventy-one (71) identified can be successfully retained if the recommendations contained herein are followed. Of the remaining thirteen (13) trees, trees #1 and #2 are recommended for removal due to their poor health condition and the remaining eleven (11) trees will need to be removed to accommodate the proposed development. Special care shall be taken when working within or near the tree protection zones of trees that are to be retained.

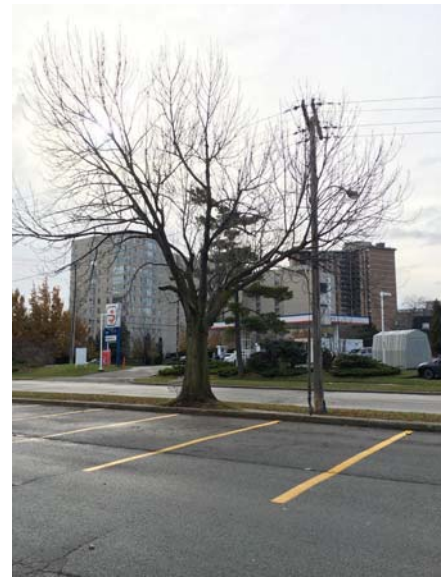
Trees #3, looking West
