ALAN ZEEGEN ASSOCIATES LTD.

December 2, 2009
Our Ref. #09048

Re: Freeman Train Station Burlington, Ontario

Here is my initial structural report for the Freeman Train Station. We carried out an inspection of the building and the temporary steel beam and wood crib foundation support on November 27th, 2009. The attached photographs and drawings show graphically the general defective areas referred to in the report.

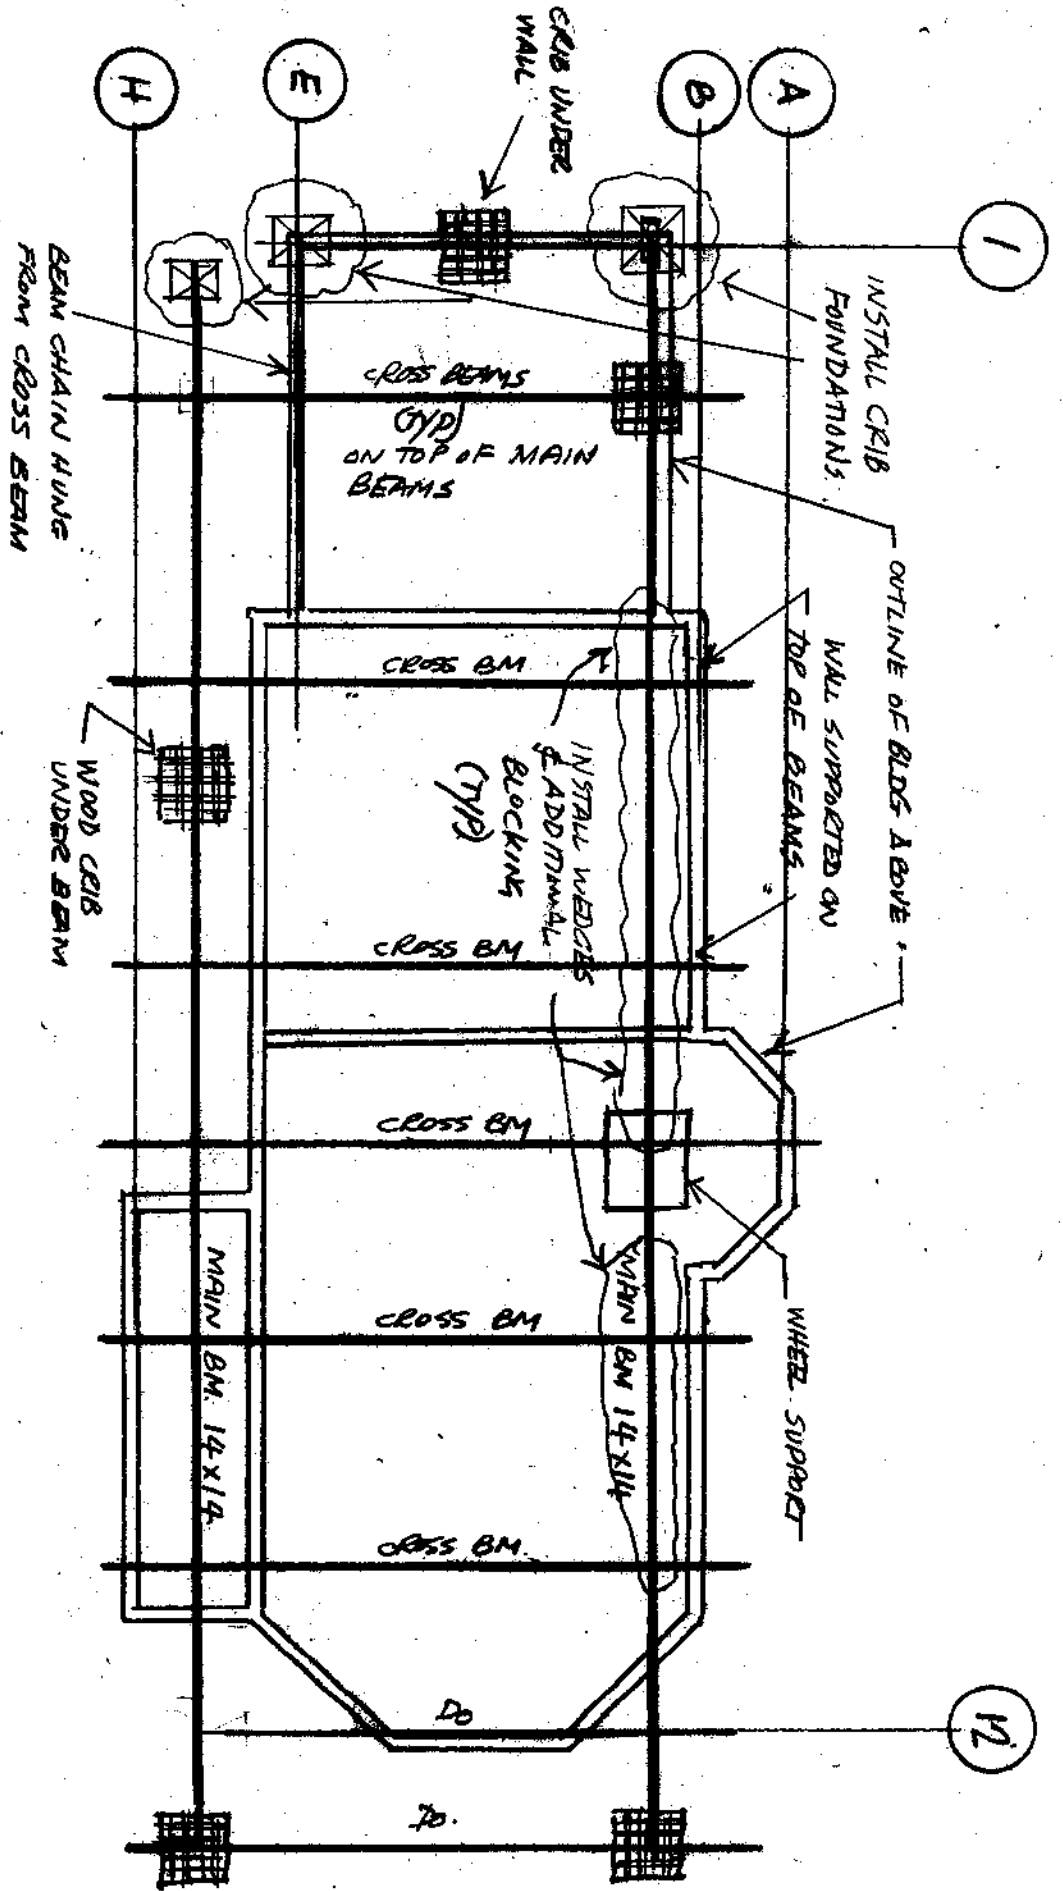
PREEMAN STATION, BURLINGTON
 DEC 2 2009 DRG. SK-2

The attached drawings and photographs show typical support points, both the main beams supported on the ground and the cross beams supporting the building. In fact, the west end of the building requires crib foundations to the ground to hold the end of the building up. This recommendation is shown on the drawings.

BUILDING FLOOR PLAN
SHOWING TEMP BEAM SUPPORT STRUCTURE
IMMEDIATE REPAIRS

Regarding the temporary support of the building in it's present location, I recommend the immediate installation of wood cribs in locations shown on the drawings.

- Install wood crib foundations under the unsupported ends of the west wall.
- Install wood crib foundations under ends of cantilevered steel beams at west end.
- Ensure all wood blocking from the steel beams to the building walls and joists are wedged tight. Add new blocking, as required, for secure bearings to the beam grid.

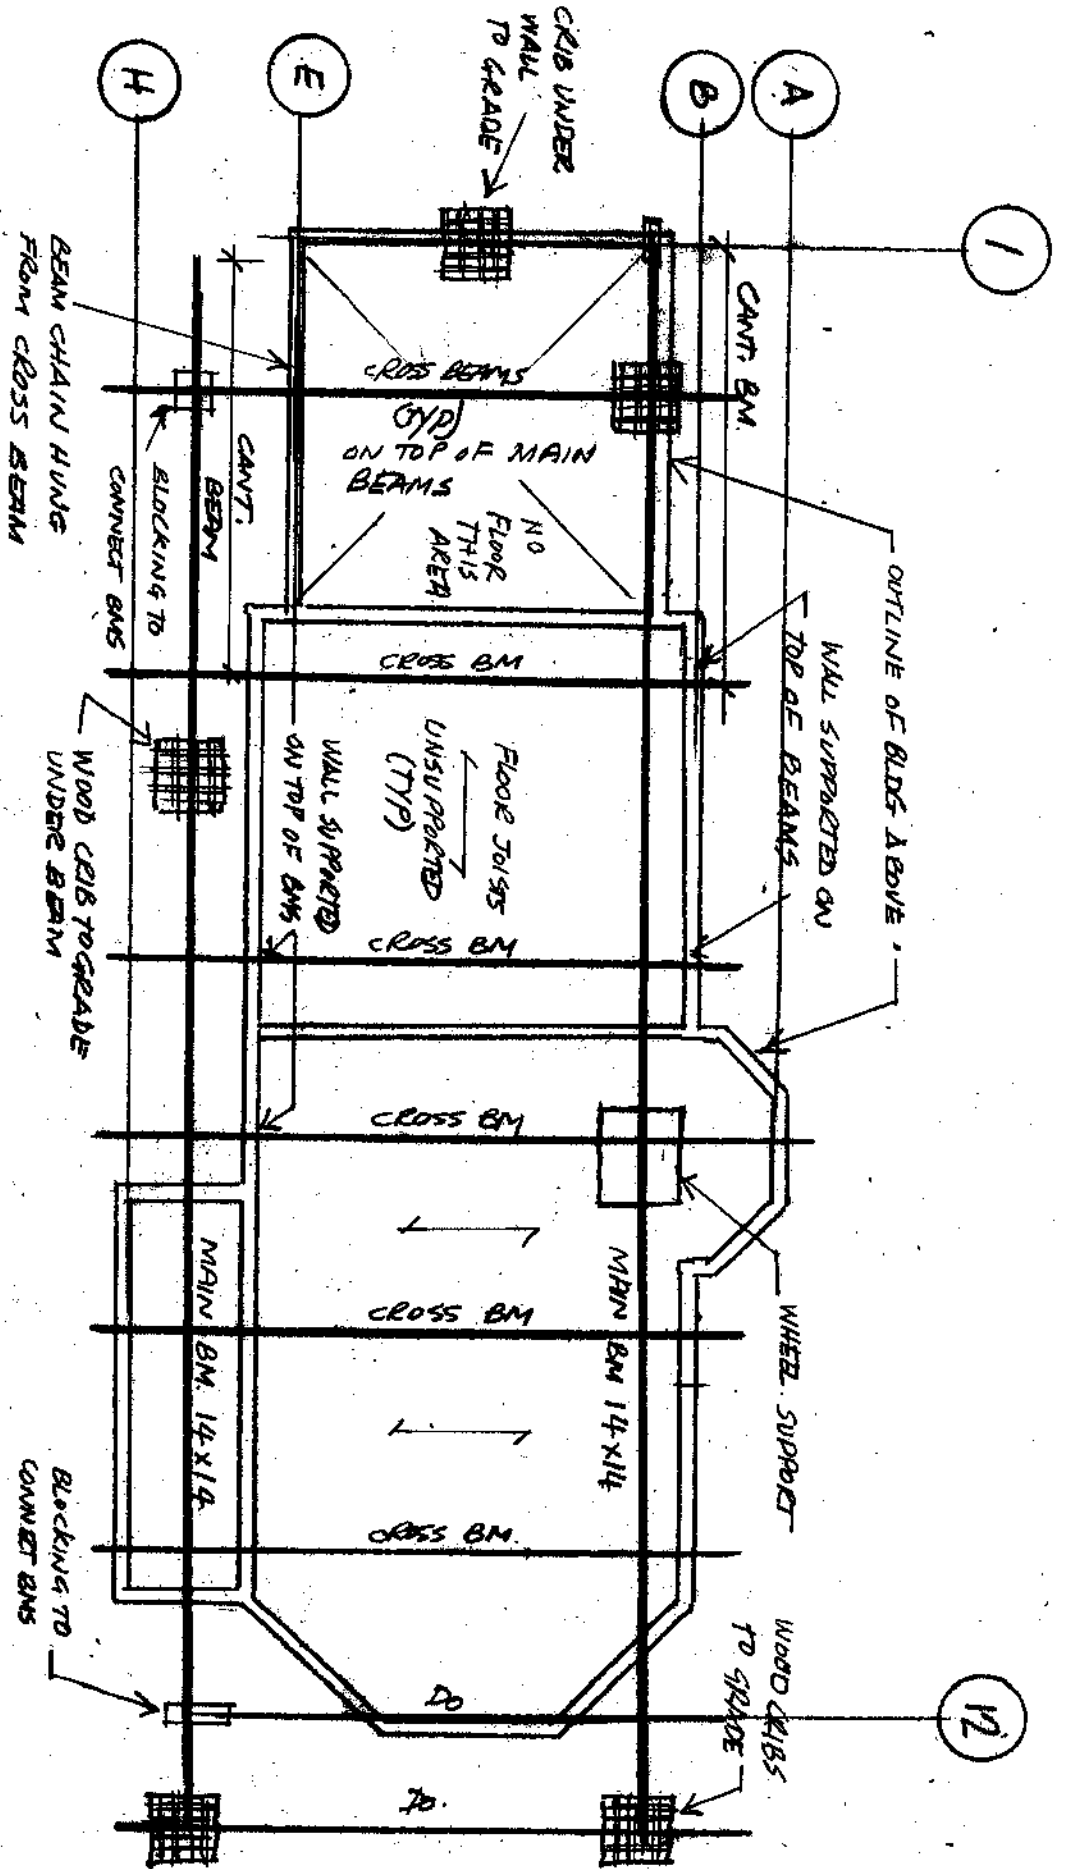
DRG. SK-1

While the steel support grid structure proved adequate for the move some three years ago, it is certainly inadequate for a future move or to remain as a stable temporary support for the building.

Generally, the cross beams under the walls do not provide safe support to the building as the pressure points at the beams are not distributed because of the missing sill plates. In addition, wood blockings under the main beams are loose and inadequate.

BUILDING FLOOR PLAN
 SHOWING TEMP. BEAM SUPPORT STRUCTURE
 N.T.S.
 EXISTING CONDITIONS
