## ARBORIST REPORT

**PROPOSED MIXED USE DEVELOPMENT  
484 PLAINS ROAD EAST  
CITY OF BURLINGTON**

**ISA CERTIFIED ARBORIST  
JOSHUA BEITZ ON-1463A  
OUR PROJECT NO:  
17-5038**

**February 15, 2019**

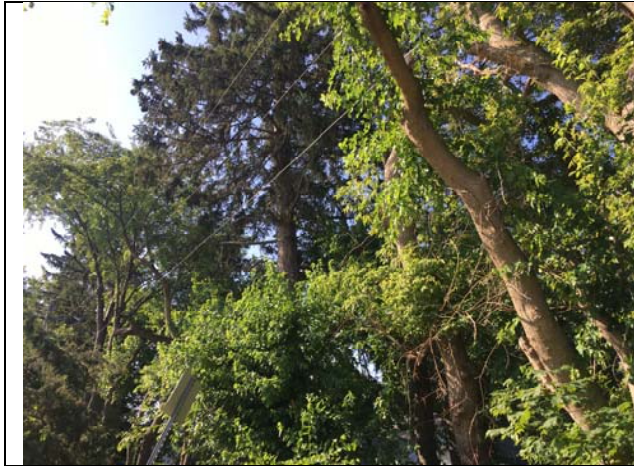
Hydro pruning/topping along West property limit

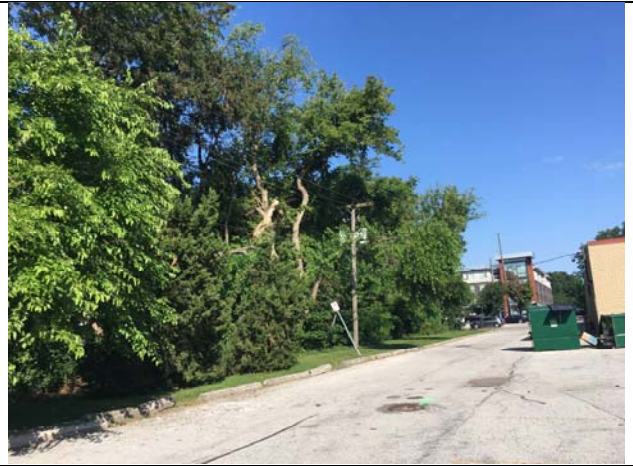
The west limit is dominated by a mature grouping of trees, most of which occur within the subject site. Several trees are located along the property limit and are growing within the existing mix of fence types along the lot line. Some of these trees are located within the adjacent rear lots. The species composition in this area is mostly Norway Maple, Manitoba Maple, White Mulberry and Norway Spruce. Other species noted include White Elm Eastern Red Cedar and Black Cherry. The health of these trees varies; however, their condition is considered poor. One sided, asymmetrical and leaning forms are caused by the crowded nature of the trees. Significant crown reduction pruning or topping, due to overhead wires, is also prevalent along this portion of the site. Overall, the majority of the edge trees along the west limit of the subject property are in poor condition.

View Northwest along partially naturalized West property limit

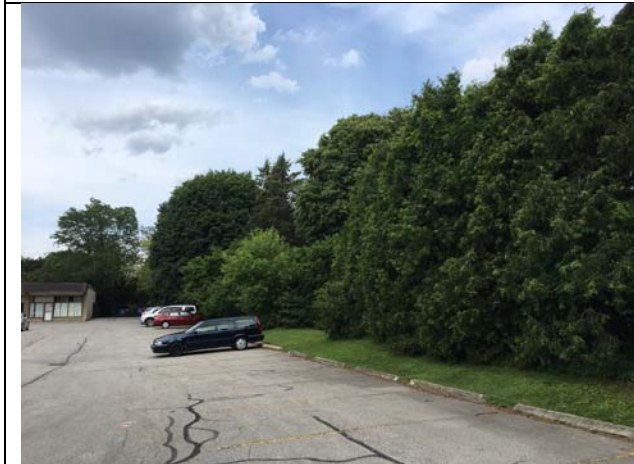
View East along South property limit (Inventory #48 White Cedar hedge)

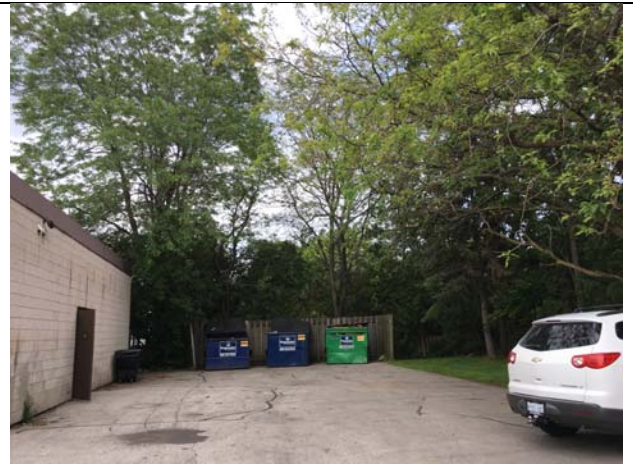
View East into southeast corner of site (Tree #'s 75-77 semi-mature to mature Honeylocusts)

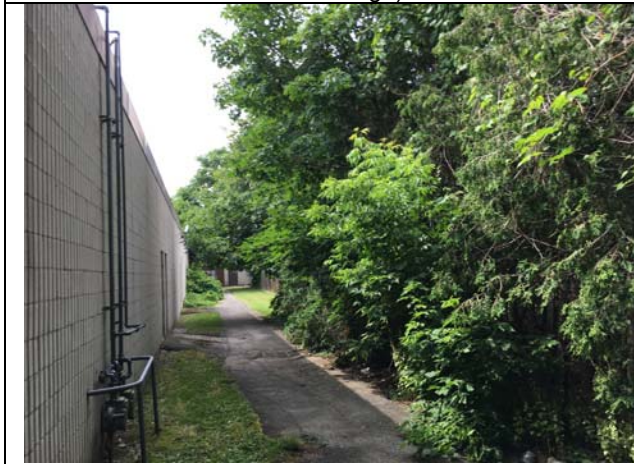
View North along East property line (Inventory # 74 White Cedar Hedge)

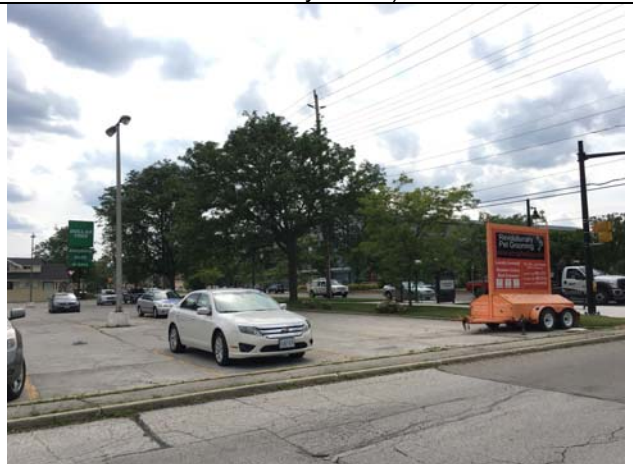
Additionally, the site grading limitations along the north property line are such that a significant grade change is required within the TPZ's of the mature boulevard trees. The trees are not anticipated to survive the impacts and are recommended for removal. In total, an aggregate caliper of 376 cm is proposed for removal within the City right of way. Similar to the replacement procedure noted above, it is anticipated that the City will apply an adjusted aggregate caliper ratio to the proposed City trees removals in order to determine compensation requirements.

View West towards Plains Road Streetscape - Midground Centre: Tree #102 Mature Honeylocust
