**SUBJECT: Arborist Report and Tree Protection Plan
1350 Waterdown Road, Burlington – Fellowship Church**

Arborist Report and Tree Protection Plan

1350 Waterdown Road, Burlington

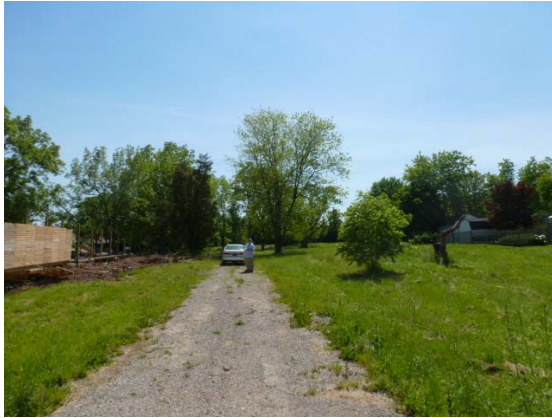
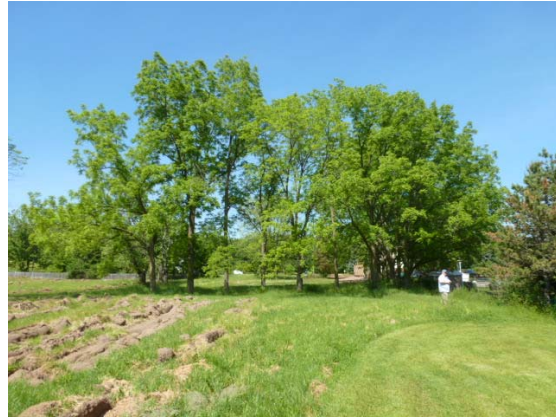
Figure #1: These 2 photos show the front and back yard of the property at 1350 Waterdown Road as they appeared during the tree inventory conducted on July 14, 2014.
