PROJECT No.: SM 166905-G

March 24, 2017

**SUPPLEMENTAL GEOTECHNICAL INVESTIGATION
SLOPE STABILITY ASSESSMENT
PROPOSED MULTI-STOREY BUILDING
401 TO 417 MARTHA STREET
BURLINGTON, ONTARIO**

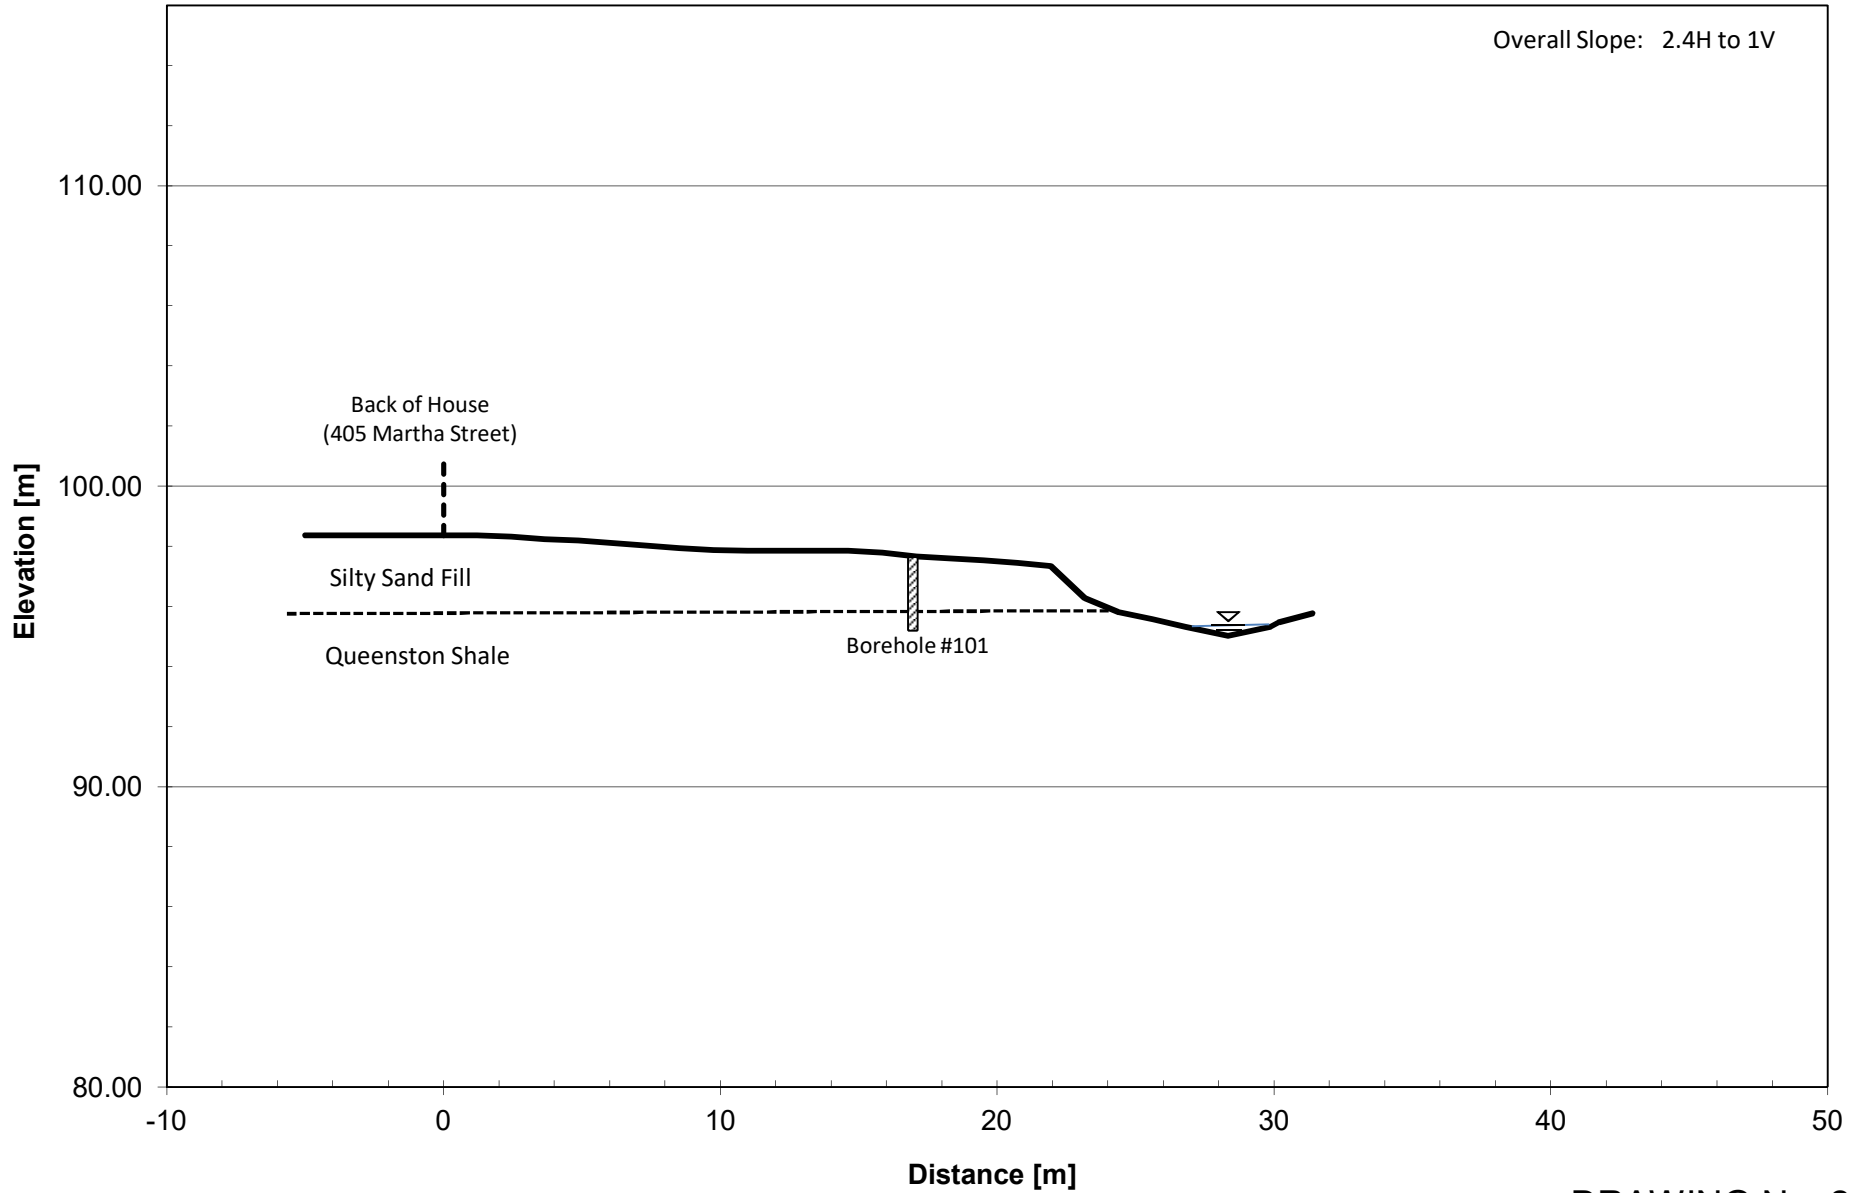
**Slope Stability Analysis
Proposed Condominium Building
401 - 417 Martha Street, Burlington
Slope Profile A-A**

Slope Profile A-A was noted to have an overall inclination of approximately 2.4 horizontal to 1 vertical, but to be as steep as 1.1 horizontal to 1 vertical. Slope Profile B-B was noted to have an overall inclination of approximately 6.5 horizontal to 1.0 vertical, with a very gradual drop in elevation to the level of Rambo Creek. It is noted that slopes in native soils at inclinations flatter than 3 horizontal to 1 vertical are generally regarded as being inherently stable.

Stability analyses were completed considering both a typical and elevated groundwater conditions. These analyses yielded minimum factors of safety on the order of approximately 1.14 and 1.03 for Slope Profile A-A under normal conditions, and considering an elevated groundwater condition. Results for Profile B-B yielded factor of safety of well over 3, consistent with the relatively flat inclination of the slope at that section. It is noted that theoretical surficial failure planes would exist with lower calculated factors of safety, however, these insignificant failure planes do not account for the stabilising effect of vegetation and would not impact the global stability of the slope. Sample results of these analyses are appended to this report.
