**Appleby Creek Flood Mitigation
Schedule B Class EA
Addendum Report**

Prepared For:
City of Burlington

**July 2024
300057084.0000**

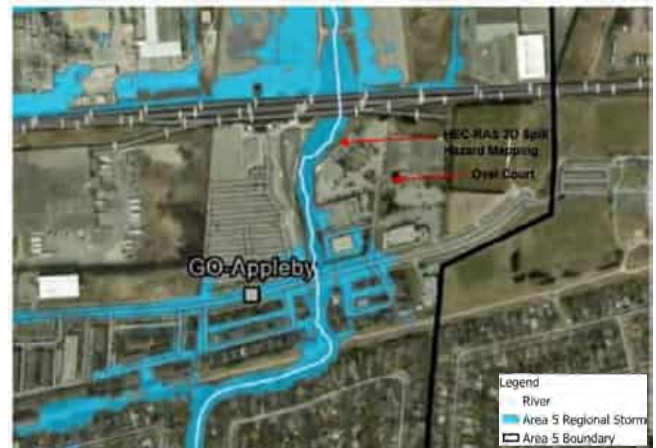
Source: EBC Study 2023 - Figure 5.5

Based upon the results of the updated flood hazard modelling and mapping in the EBC report, an evaluation of structures (buildings) at risk was completed for the 1D modelling results, representing the 100-year and Regional Storm flood hazard limits, and the 2D modelling results which represents the Spill Inundation Limits. Based upon land use category, the regulatory floodplain limits (riverine flooding) and the building footprint mapping provided by Conservation Halton, the findings of the study identified a variety of flood vulnerable roadways and buildings. This analysis resulted in the identification of 86 flood vulnerable buildings in Appleby Creek, with the majority of the identified structures designated as low density residential.

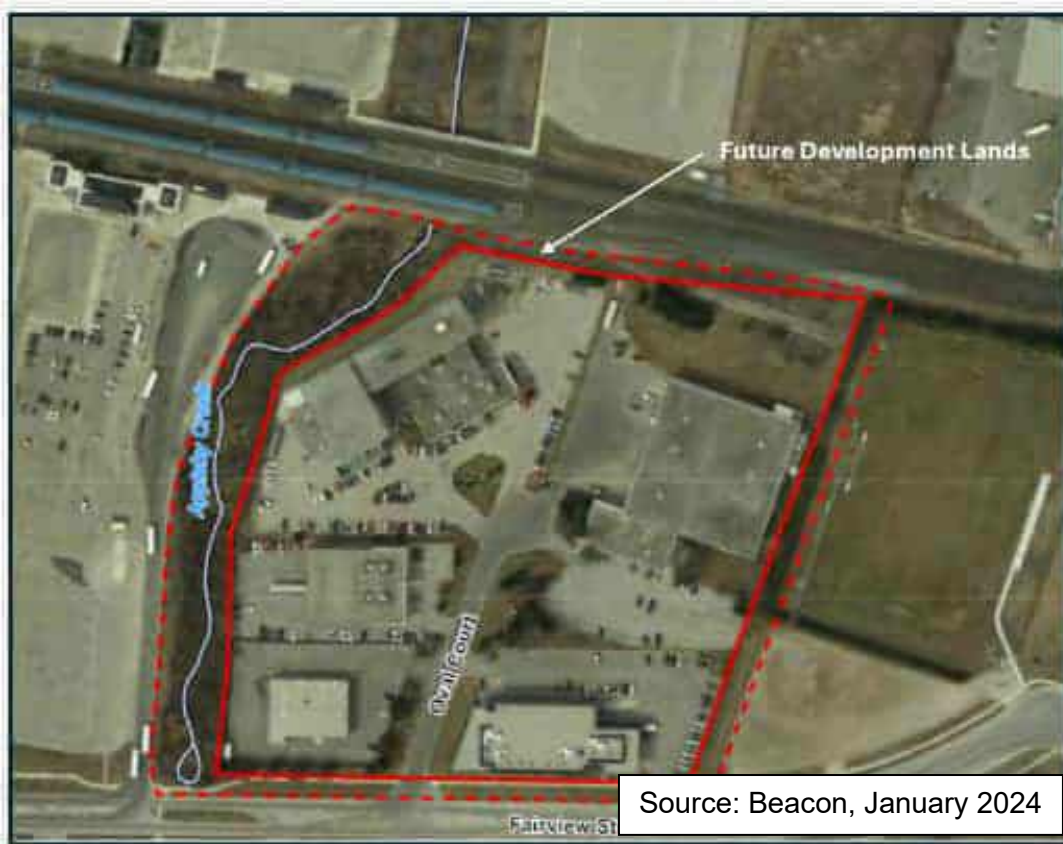
Figure 1: Future Oval Court Development Limits

Similar to Option 2, this alternative investigated replacing the existing Fairview Road bridge with a larger span, however the intention of this alternative was to widen the bridge enough to pass the Regional Storm. This widening would improve hydraulic conveyance with limited risk of road inundation. A hydraulic assessment of the bridge was undertaken using a larger bridge span of 60 m to pass the Regional Storm. This alternative provided a significant increase in the hydraulic conveyance capacity through the crossing, removing at least six (6) buildings from the floodplain and increasing the available table lands within the Oval Court property. Figure 1 illustrates the future development lands at Oval Court.

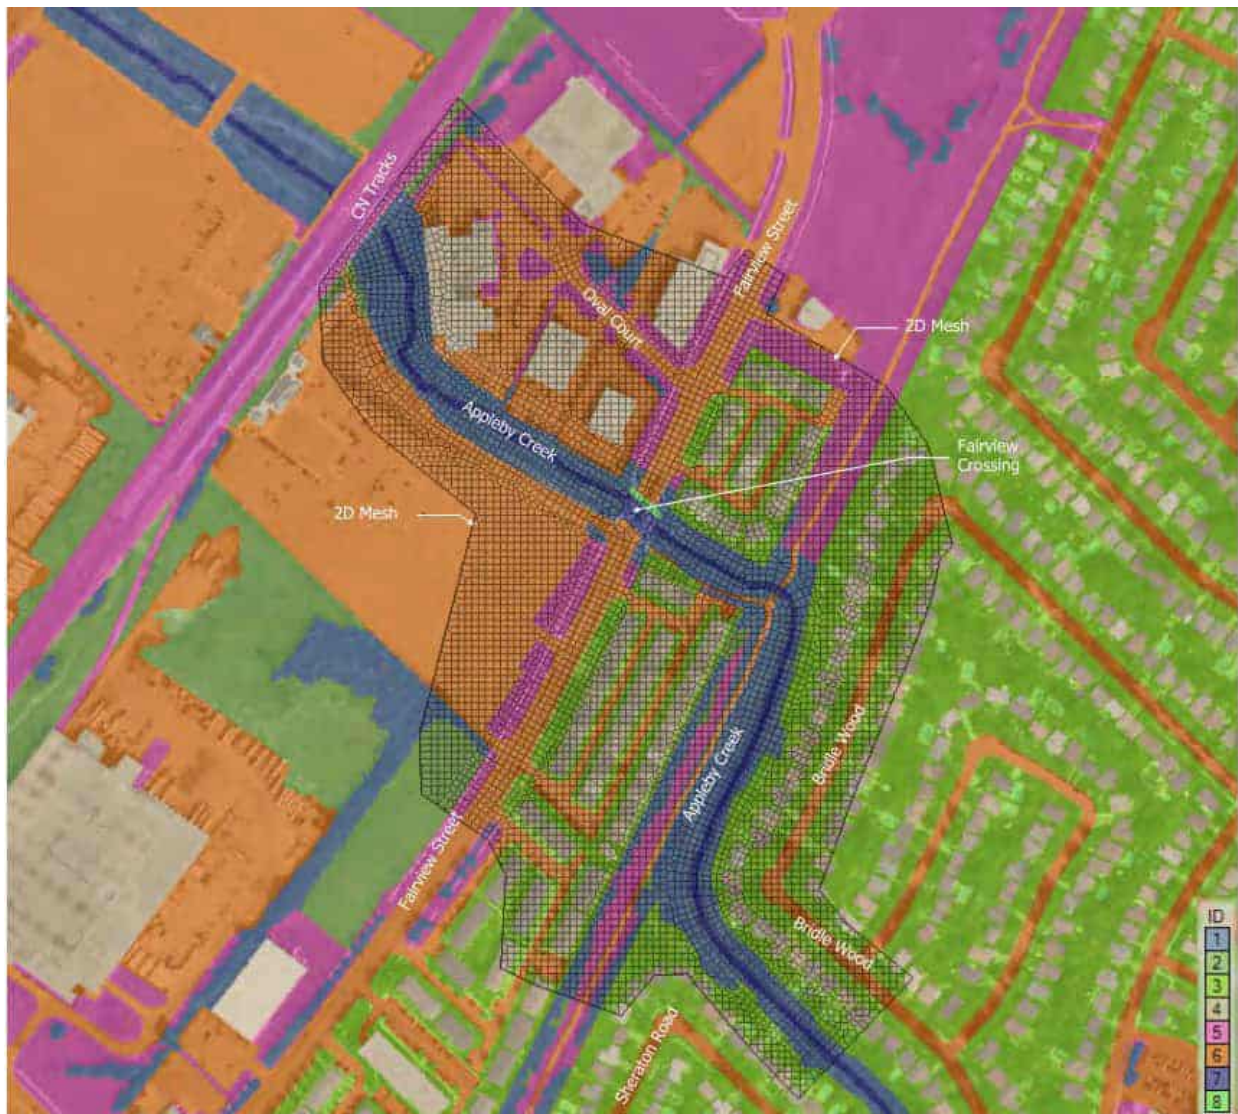
Figure 3: Manning's 'n' Layer

A land classification layer was defined in HEC RAS. Figure 3 illustrates the polygons used to define each Manning's 'n' value. Table 5 outlines the Manning's 'n' value defined for each land type. Note that these values and the polygons have been maintained from the CH model.

Land Use	ID	Manning's 'n'
Forest	1	0.080
Field	2	0.055
Urban Residential	3	0.035
Building	4	1.000
Grass	5	0.045
Impervious	6	0.020
Low Flow	7	0.035
Overbank	8	0.013

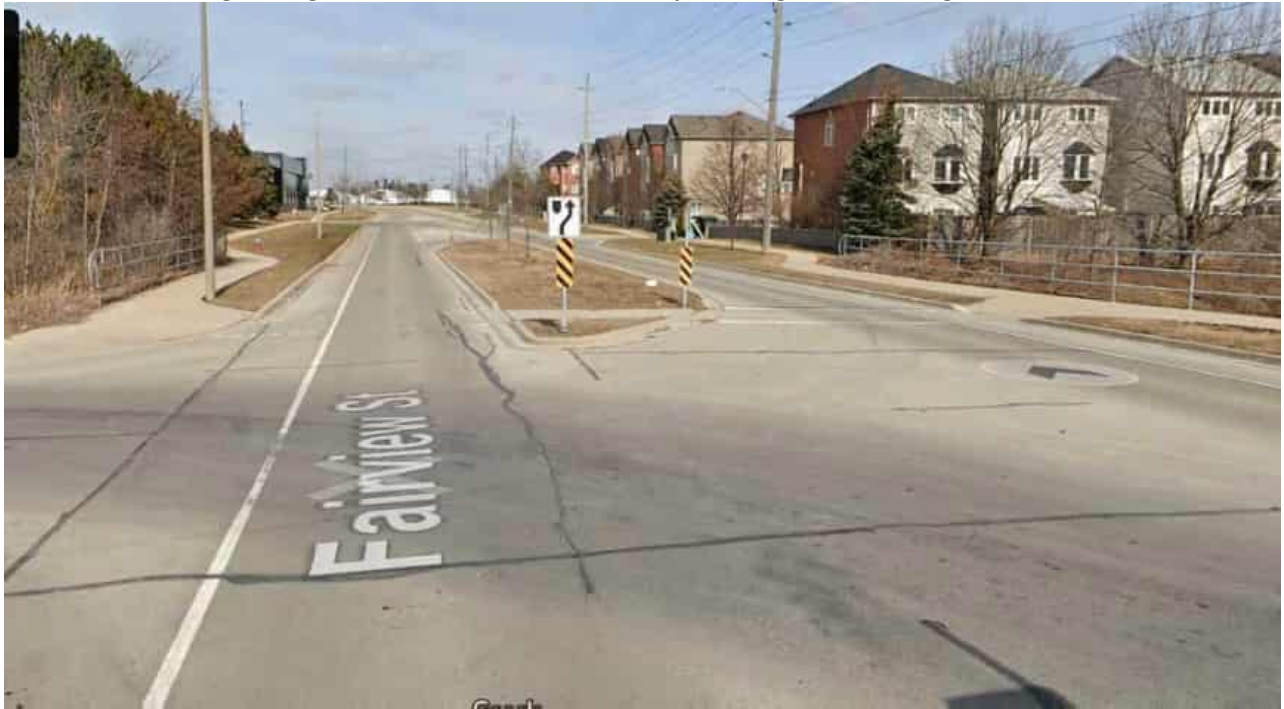
Photo 1: Creek and Fairview Street bridge (looking northwest - Upstream)

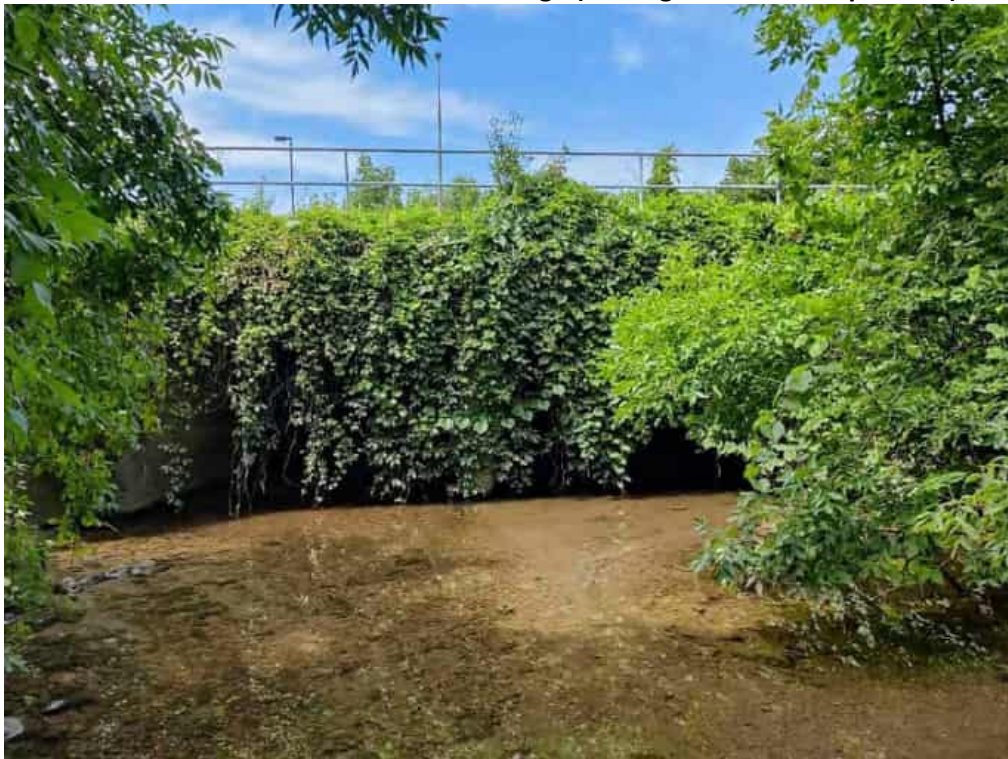
Photo 2: Creek and Fairview Street Bridge (looking southeast - Downstream)

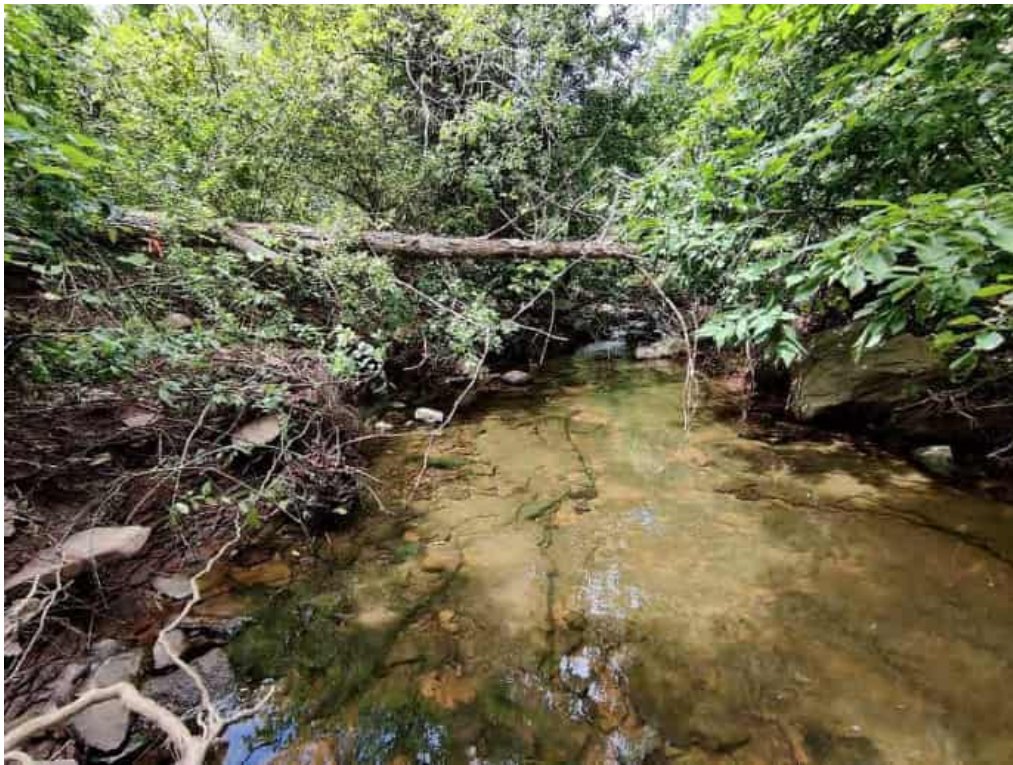
Photo 3: Creek conditions near Fairview Street – Bedrock at creek bed and lower portion of creek bank slope (looking northwest - upstream)

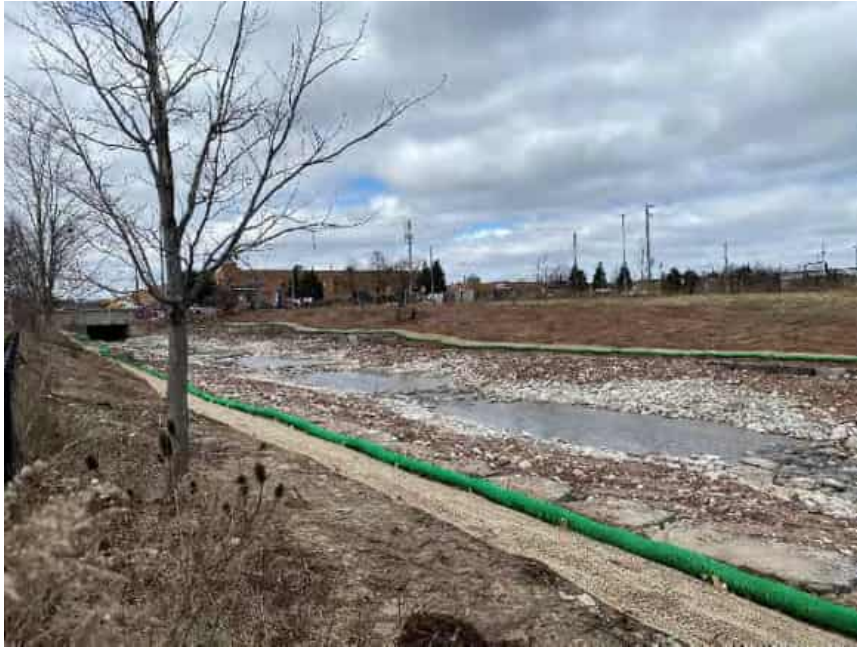
Photo 1: Creek realignment and erosion rehabilitation measures implemented upstream of the Subject Lands

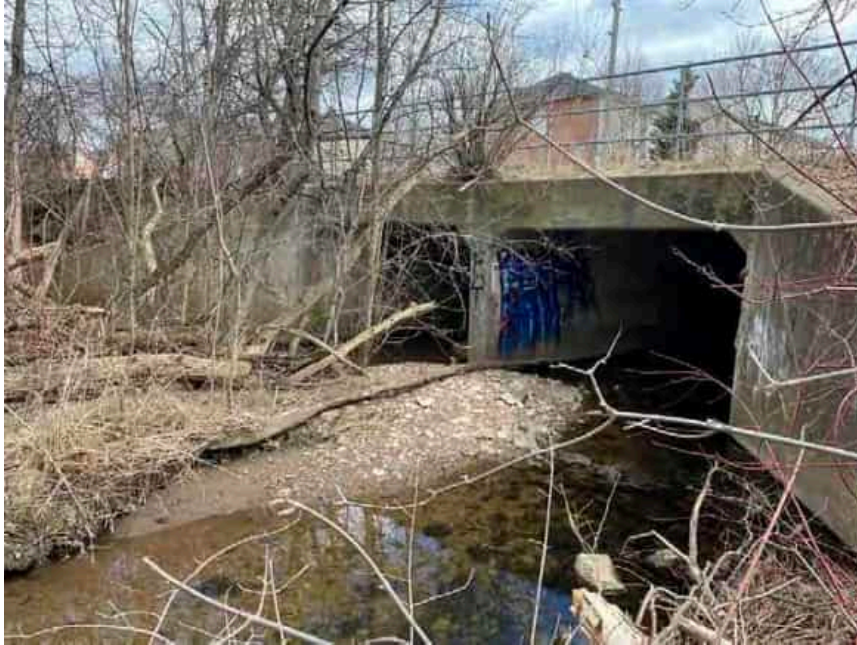
Photo 7: Existing culvert inlet

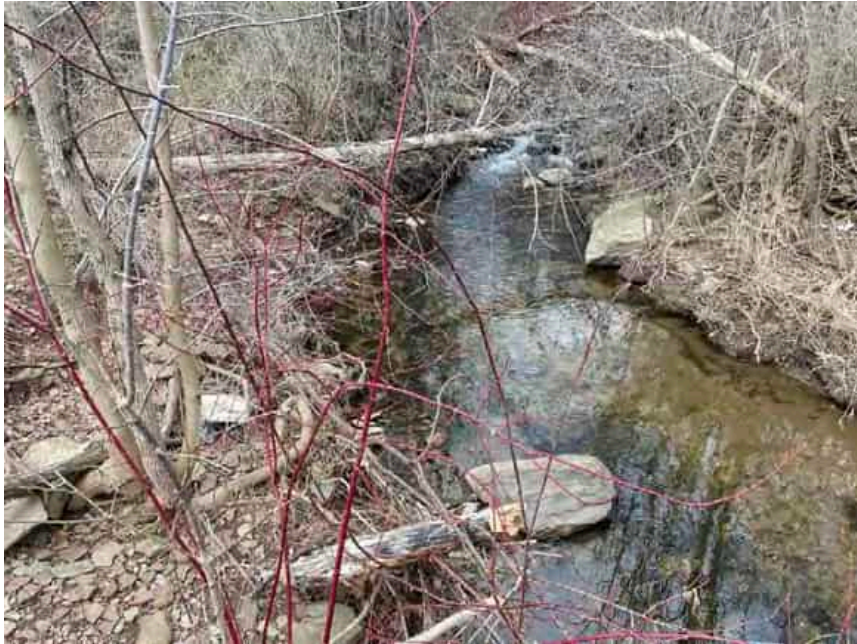
Photo 9: Existing culvert outlet at Fairview Street

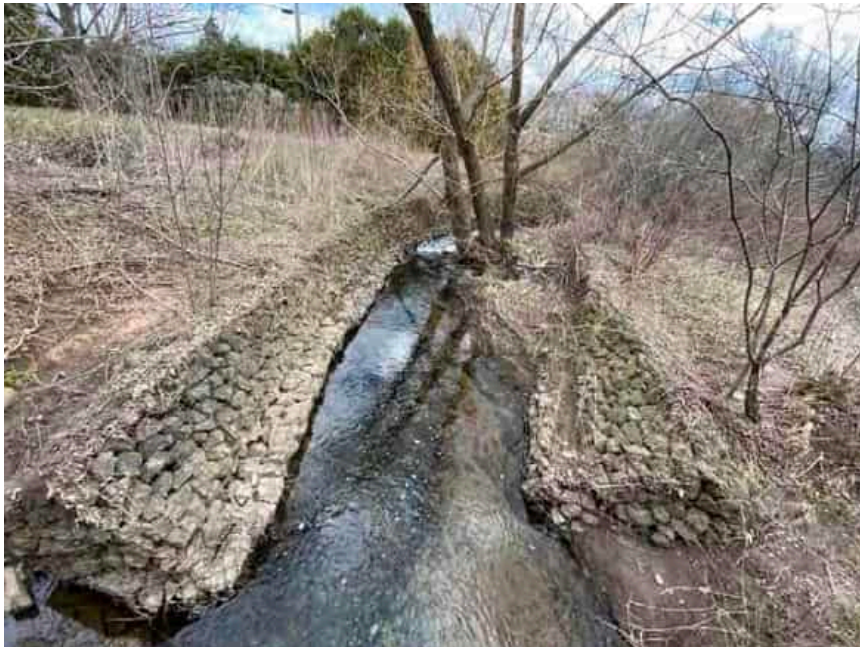
Photo 12: Appleby Creek facing downstream from the existing pedestrian bridge at the downstream extent of the Study Area

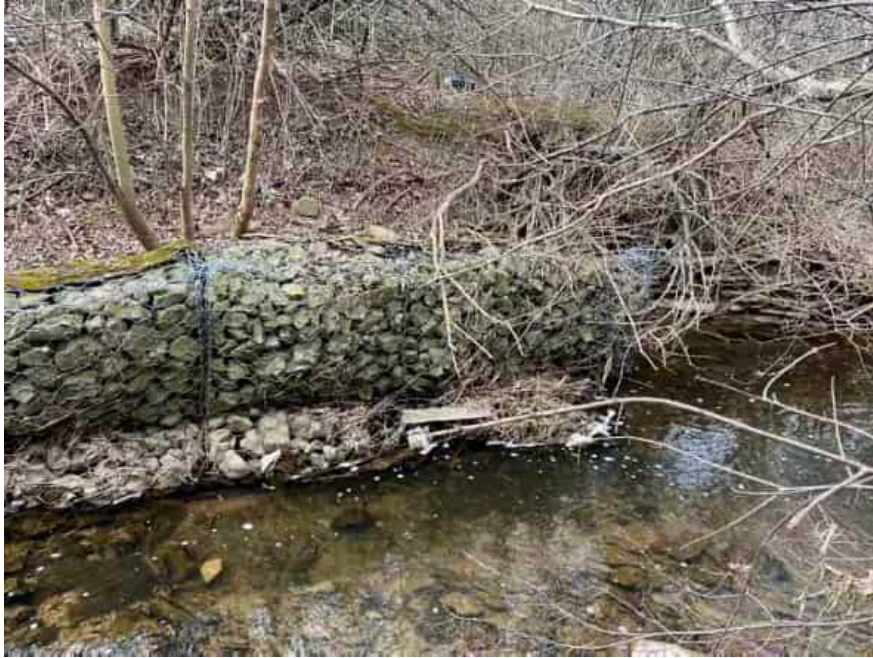
Photo 13: Failing gabion baskets along the west bank near reach 2

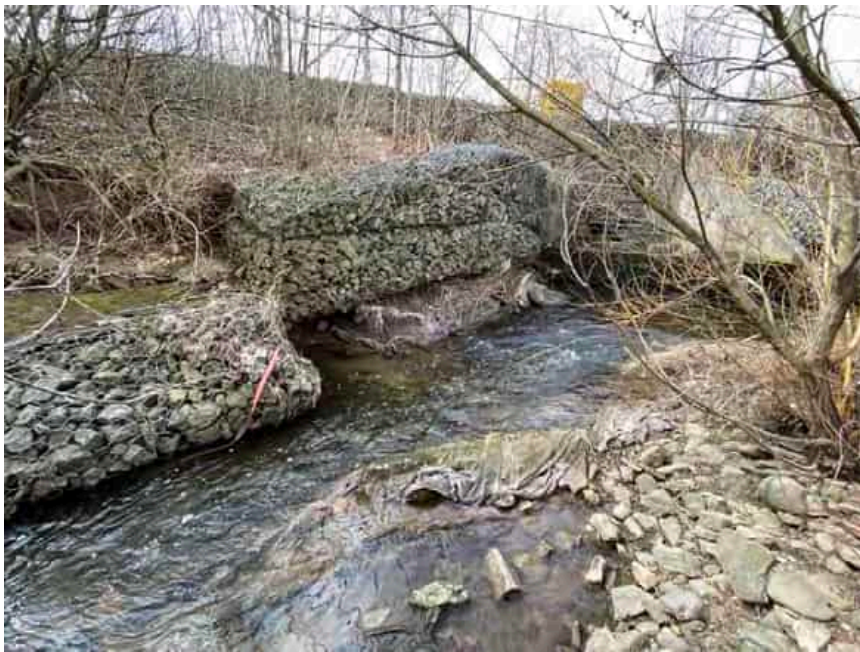
Photo 15: Gabion baskets along the west bank adjacent to the Appleby GO parking lot stormwater outfall

Reach	Location (Beacon, 2024)	Summary of Conditions (Beacon, 2024)	Current site conditions (March 2024) consistent with Beacon (2024) Report	Erosion Concerns
				Gabion baskets emptying along right bank (Photo 15).
Reach 4	Approximately 40 m upstream of Fairview Street crossing.	Run Substrate: bedrock (dominant), shale, boulder, gravel No in-stream vegetation Undercut banks Beyond the reach: barrier to fish passage approximately 2 m upstream of the Fairview Street Crossing.	Consistent with the reported conditions	Undercut banks were observed on both the east and west banks. Erosion visible near the culvert headwall along the left bank.
Downstream of the Fairview Street	100 meters downstream of Fairview Street crossing.	Scour pool, run Substrate (pool): bedrock (dominant), cobble, gravel Substrate (run): cobble (dominant), shale, gravel, boulder Beyond the Beacon (2024) study area confirmed by Burnside:	Consistent with the reported conditions	Bank erosion is steep along bend of the run approximately 20 m downstream of the Fairview Street crossing, with bank heights 0.5-1 m high above the stream . Shale bedrock visible is also in the area of extensive erosion. Bank erosion present along west bank

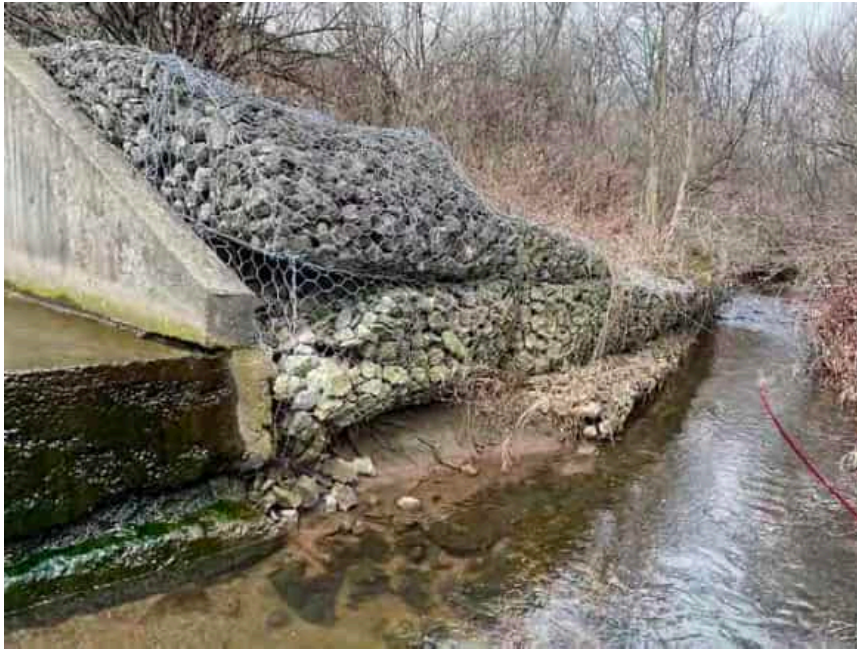
Photo 16: Gabion baskets along the east bank of reach 3

Reach	Location (Beacon, 2024)	Summary of Conditions (Beacon, 2024)	Current site conditions (March 2024) consistent with Beacon (2024) Report	Erosion Concerns
				<p>are failing at the base level, causing angular stone to fall into the watercourse (Photos 13 – 14).</p> <p>Undercutting was observed underneath the gabion baskets described above.</p>
Reach 3	Approximately 100 m upstream of Fairview Street crossing (10 m long)	<p>Riffle</p> <p>Substrate: cobble (dominant), shale, cobble, gravel</p> <p>No in-stream vegetation</p> <p>Undercut banks present</p> <p>Large woody debris present</p> <p>> 80% overhead cover</p>	Consistent with the reported conditions	<p>Significant erosion was noted between reach 3 and reach 4.</p> <p>Considerable erosion was noted at the stormwater outfall adjacent to the parking area of Branthaven Homes. The underlying geotextile fabric beneath the round river stone of the outfall structure is visible, with the placed round river stone falling into Appleby Creek. Bank erosion is steep, with bank heights >1m above the stream (Photos 16 – 17).</p>

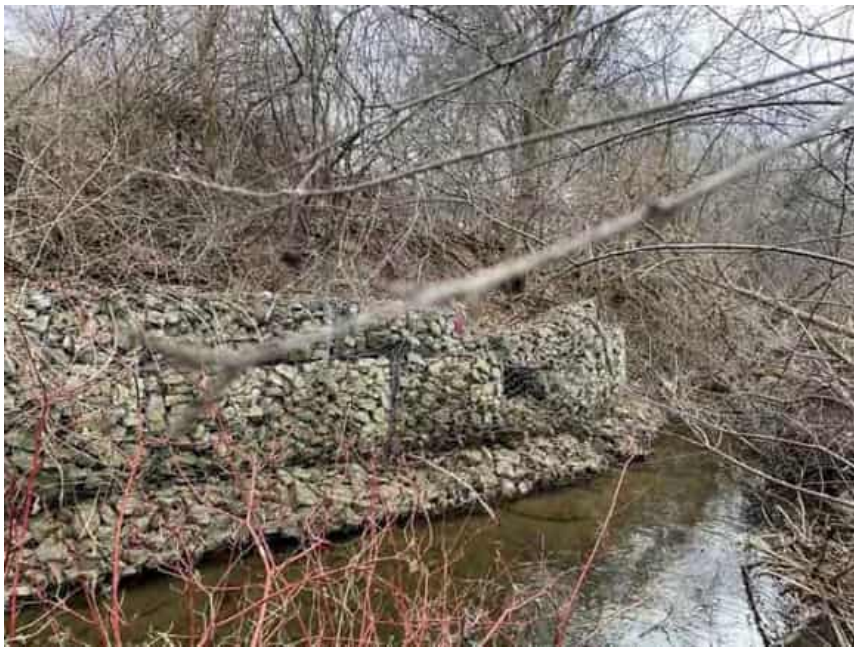
Photo 17: Erosion at the stormwater outfall adjacent to the parking area of Branthaven Homes

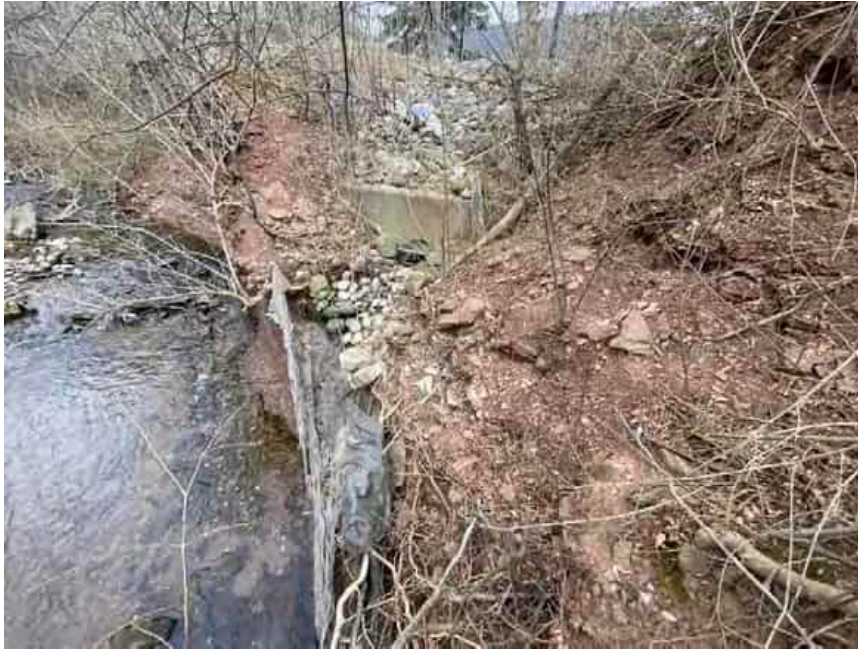
Photo 18: Bank erosion immediately upstream of stormwater outfall adjacent to the parking area of Branthaven Homes

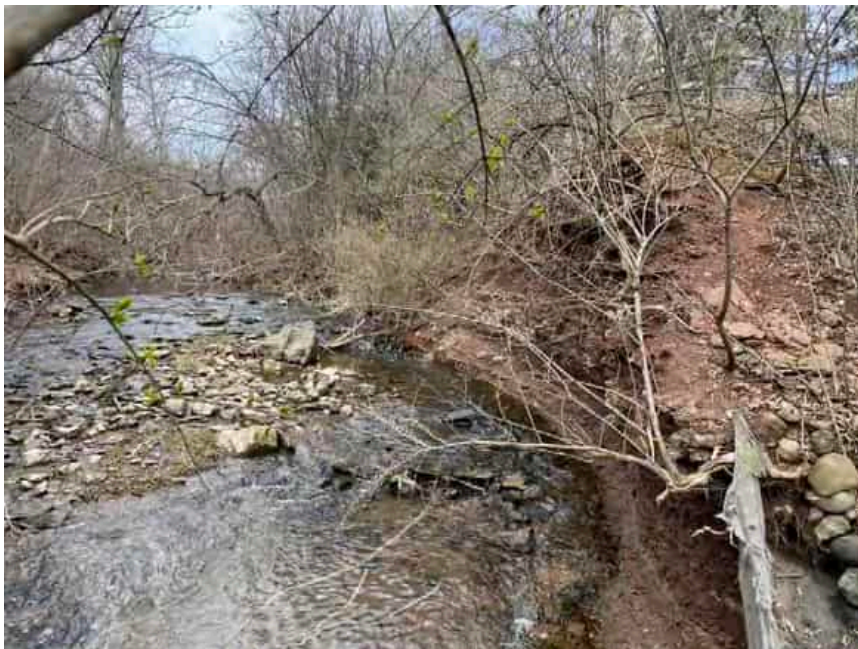
Photo 19: Bank erosion located 20 m downstream of the Fairview Street crossing

Reach	Location (Beacon, 2024)	Summary of Conditions (Beacon, 2024)	Current site conditions (March 2024) consistent with Beacon (2024) Report	Erosion Concerns
		<p>Deeper pools are present along the bend downstream of the run</p> <p>Substrate (pool): bedrock with fine silts, shale</p> <p>No in-stream vegetation</p> <p>Cover: 50%</p> <p>Root wads (shrubs), grasses, and trees present</p> <p>Large and small woody debris present</p> <p>Undercut banks</p> <p>Channel hardening: gabion baskets</p>		<p>approximately 70 m downstream of the Fairview Street crossing (Photo 19).</p>

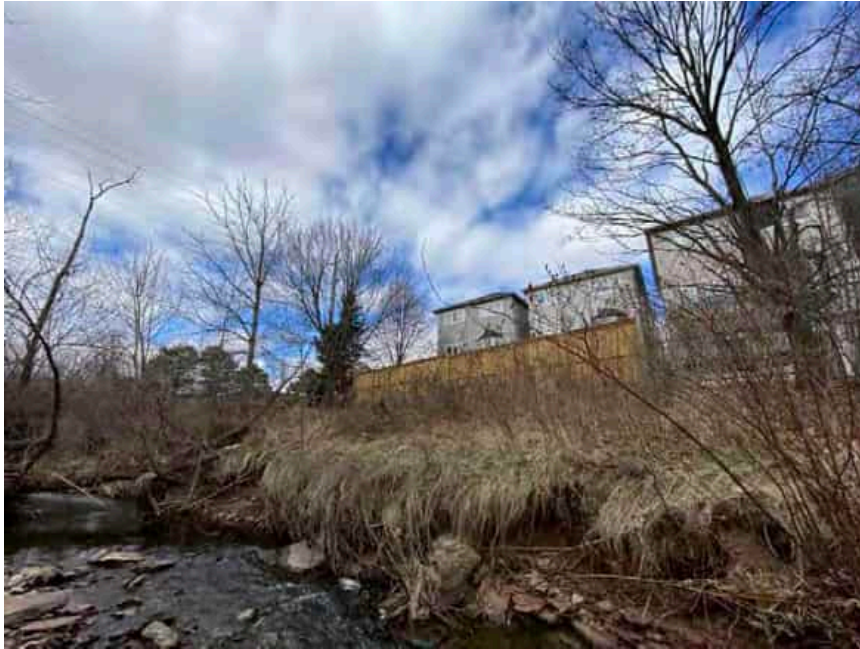
Photo 20: Bank erosion located approximately 70 m downstream of the Fairview Street crossing

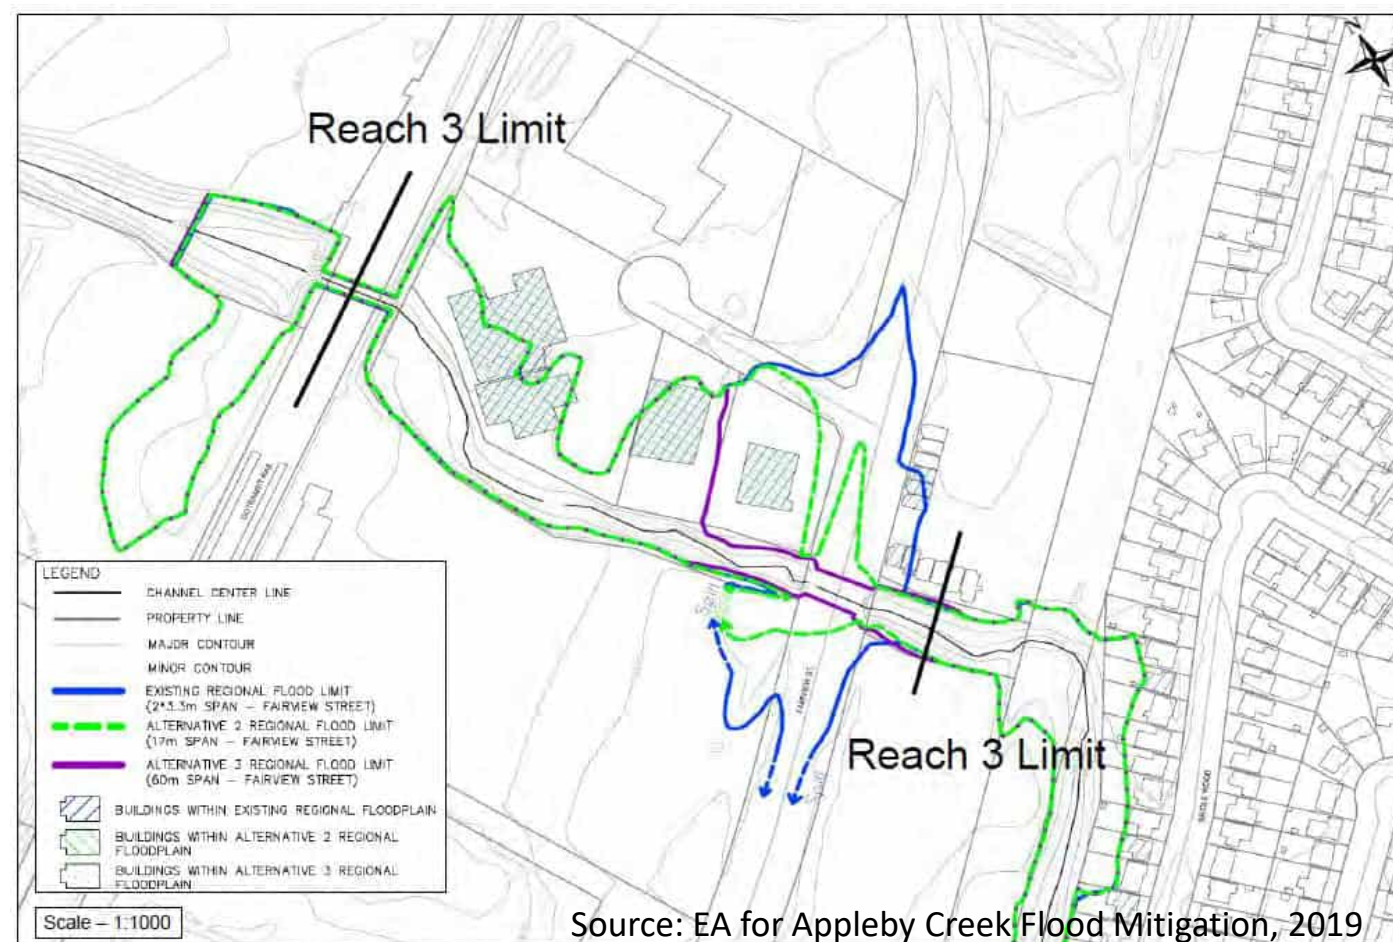
Flood Conditions - Fairview Street Crossing

2019 MCEA Preferred Solution (Option 2)

- Fairview Street crossing structure 17m wide to pass the 100-year storm
- maintains the existing road surface elevation
- four (4) buildings on the Oval Court Lands would be located within the Regional floodplain
- water would overtop Fairview Road under Regional storm conditions

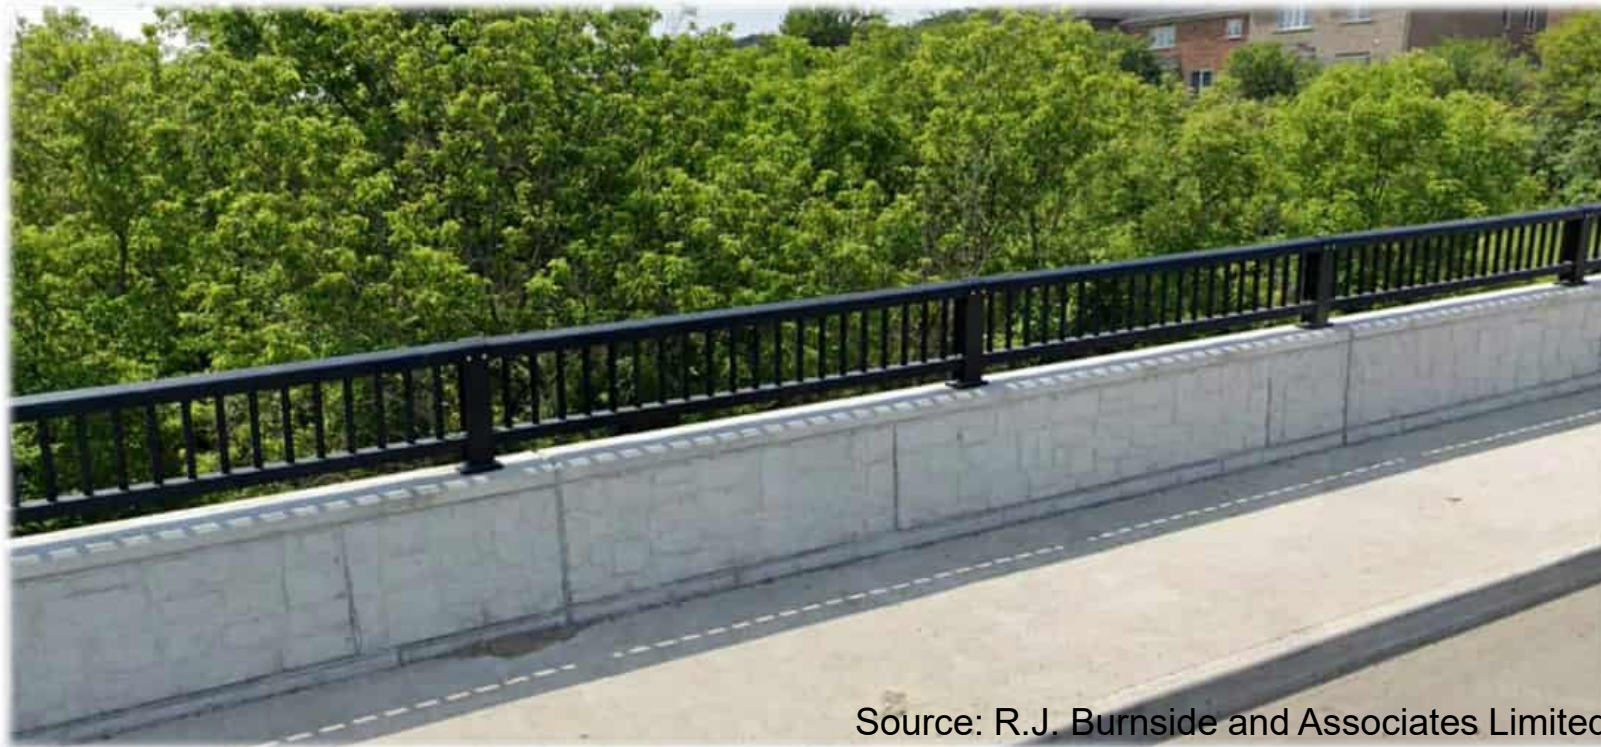
Parapet Wall with Patterned Concrete and Pedestrian Height Handrail

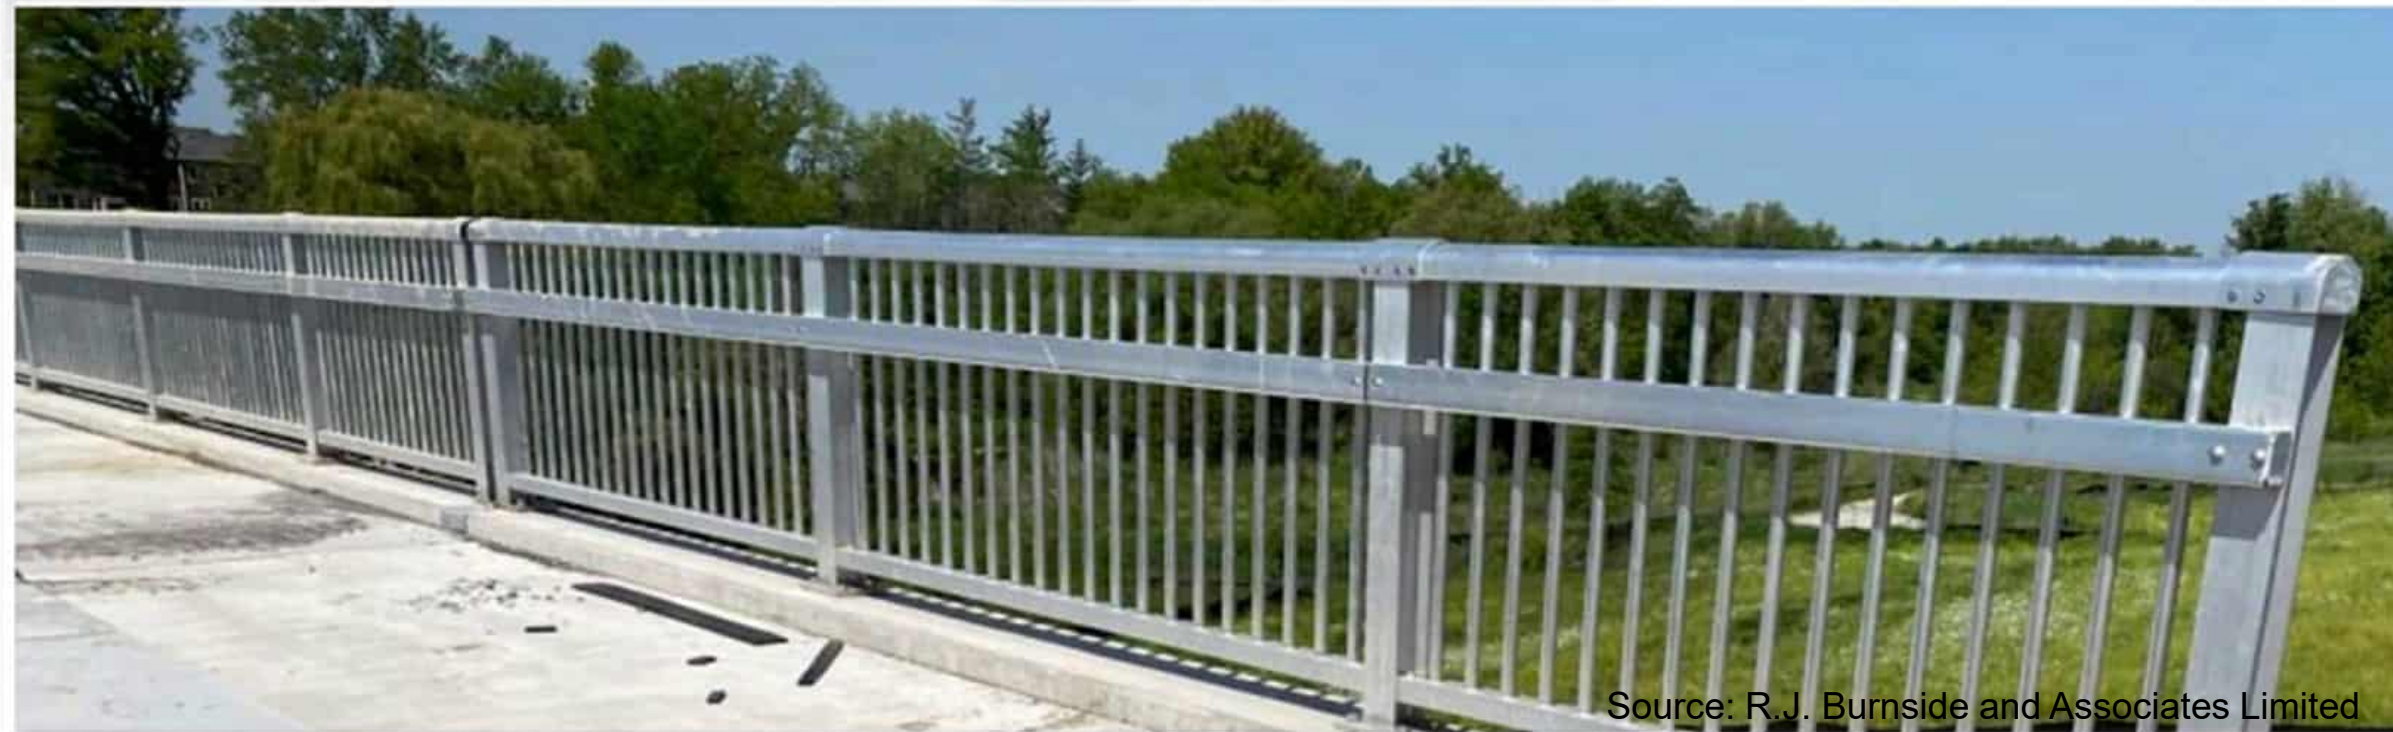
Pedestrian Guard Only, with Bicycle Height Handrail

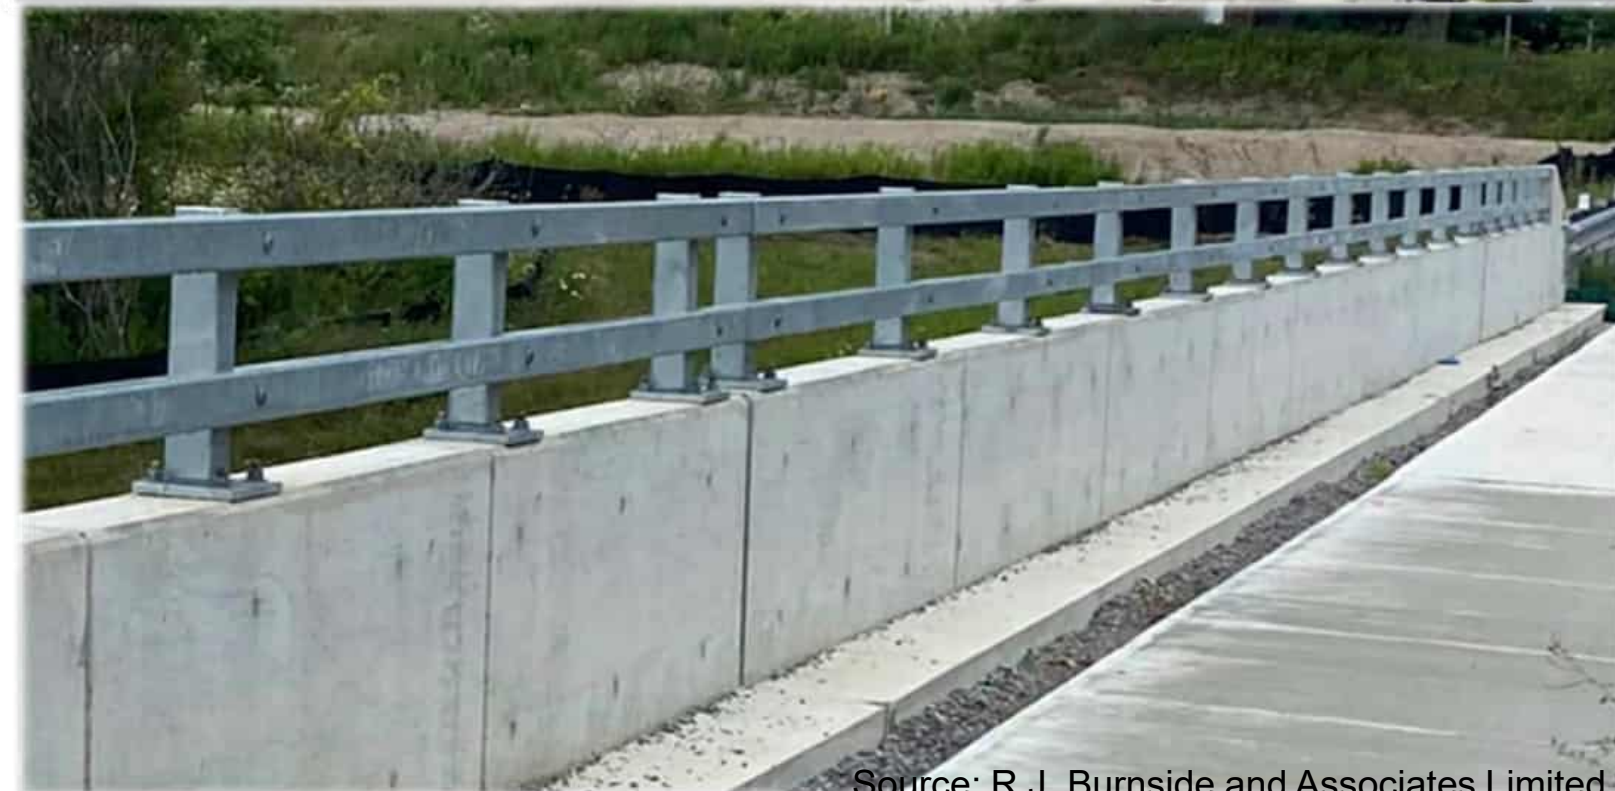
Parapet Wall with Plain Concrete and Bicycle Height Handrail

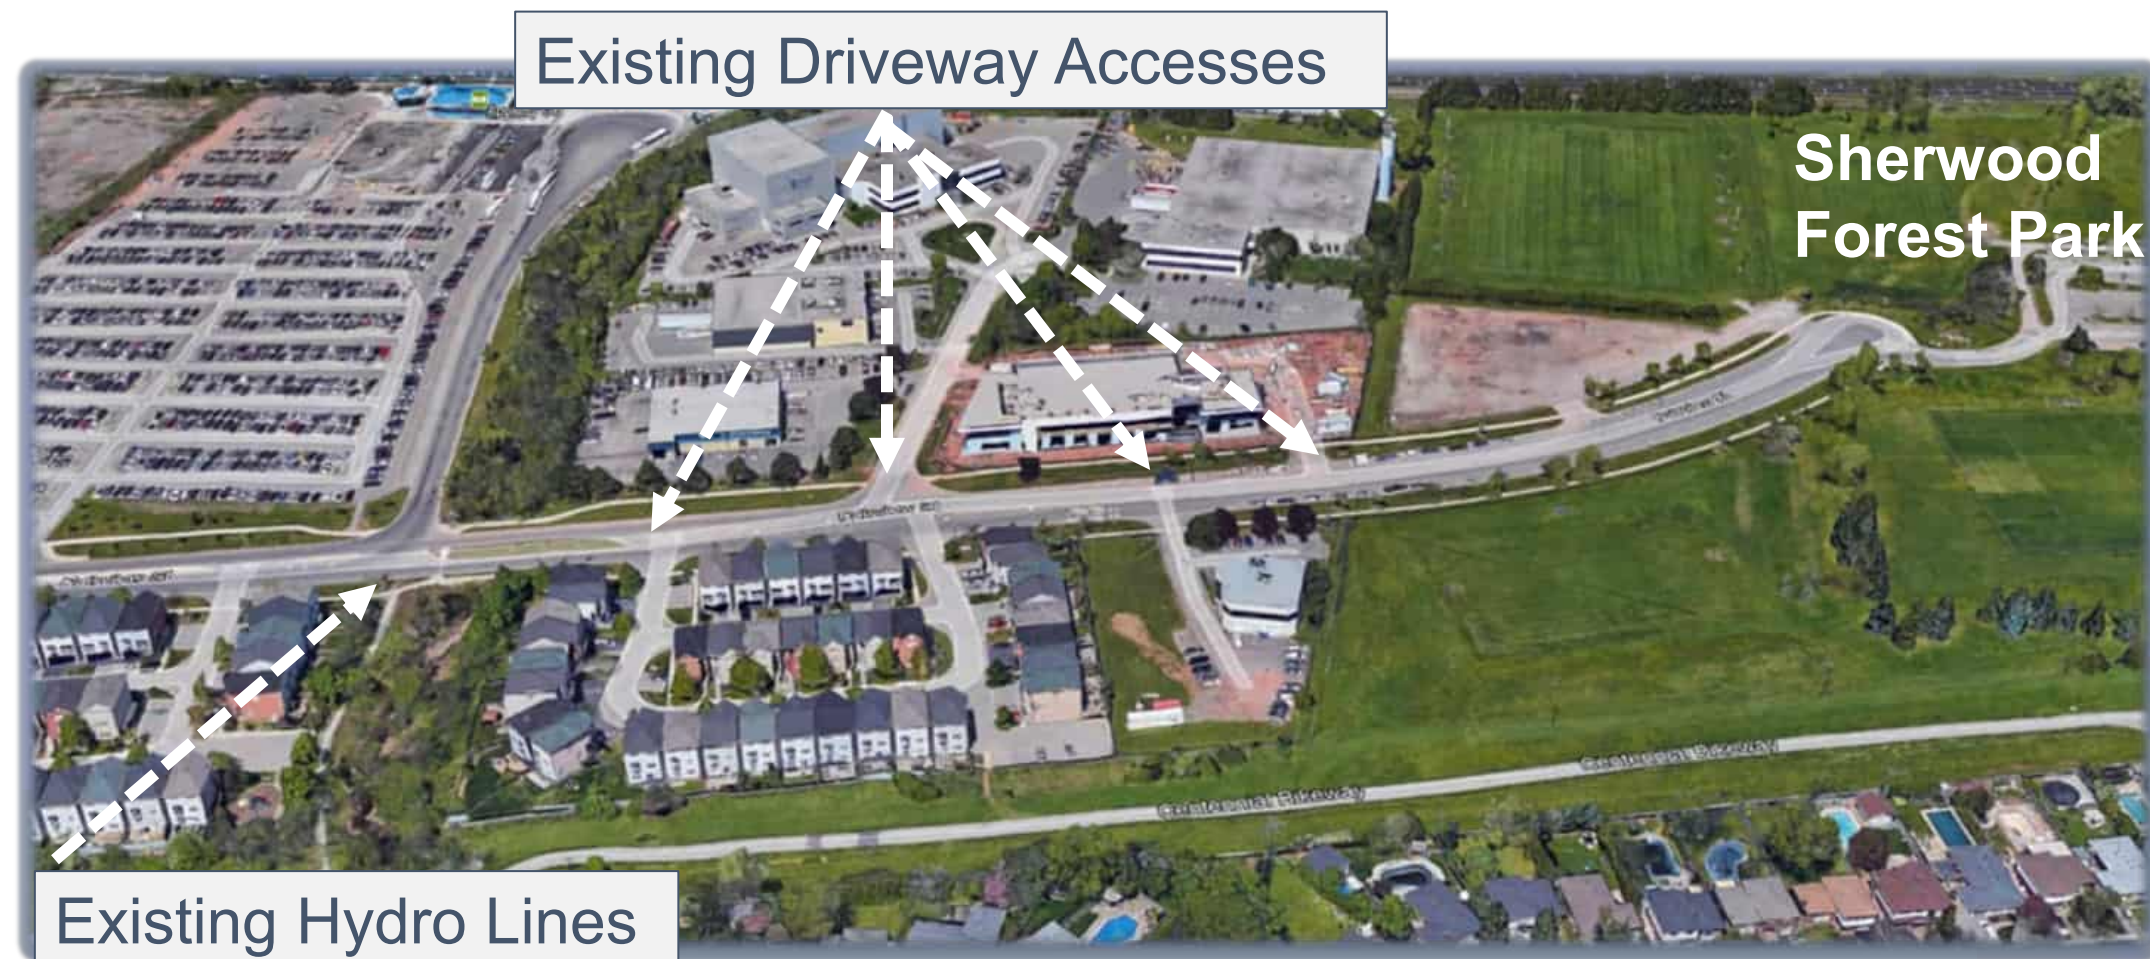
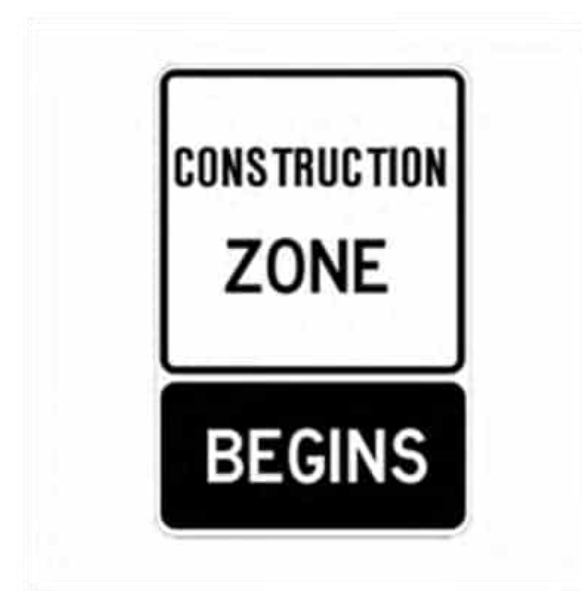
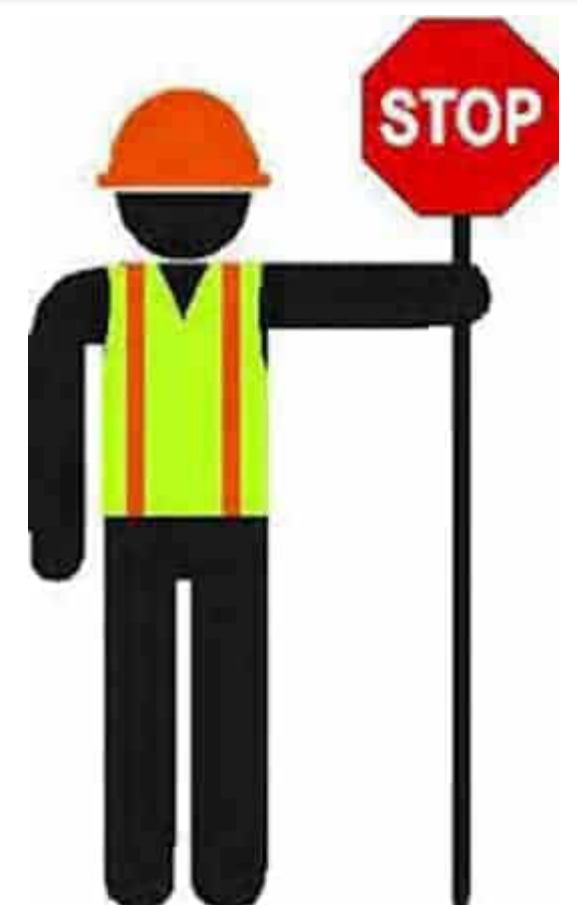
Stage 1

- Provide one lane in each direction throughout construction.
- Maintain access to driveways and entrances throughout construction.
- Potential for temporary traffic disruption at specific times to be managed by traffic control personnel.

- Remove centre medians and west boulevard and portions of the sidewalk at the bus entrance road
- Provide a temporary paved road in areas of removals
