Tuck Creek Detailed Design for Erosion Site 5, 6, 7

Dundas Street to Headon Road

The Erosion Control Environmental Assessment (EA) Study completed in 2022 identified channel erosion and slope destabilization within the Tuck Creek corridor for three distinct study areas: Harvester Road to Hydro Right of Way, Palmer Drive to CN Rail, and Dundas Street to Headon Road, posing risks to private property, aquatic habitat, and public safety.

The focus of this project is to address the erosion concerns and implement erosion control measures, including bank protection, minor channel realignment, regrading and restoration of the channel bed, and the implementation of a vegetation restoration plan.

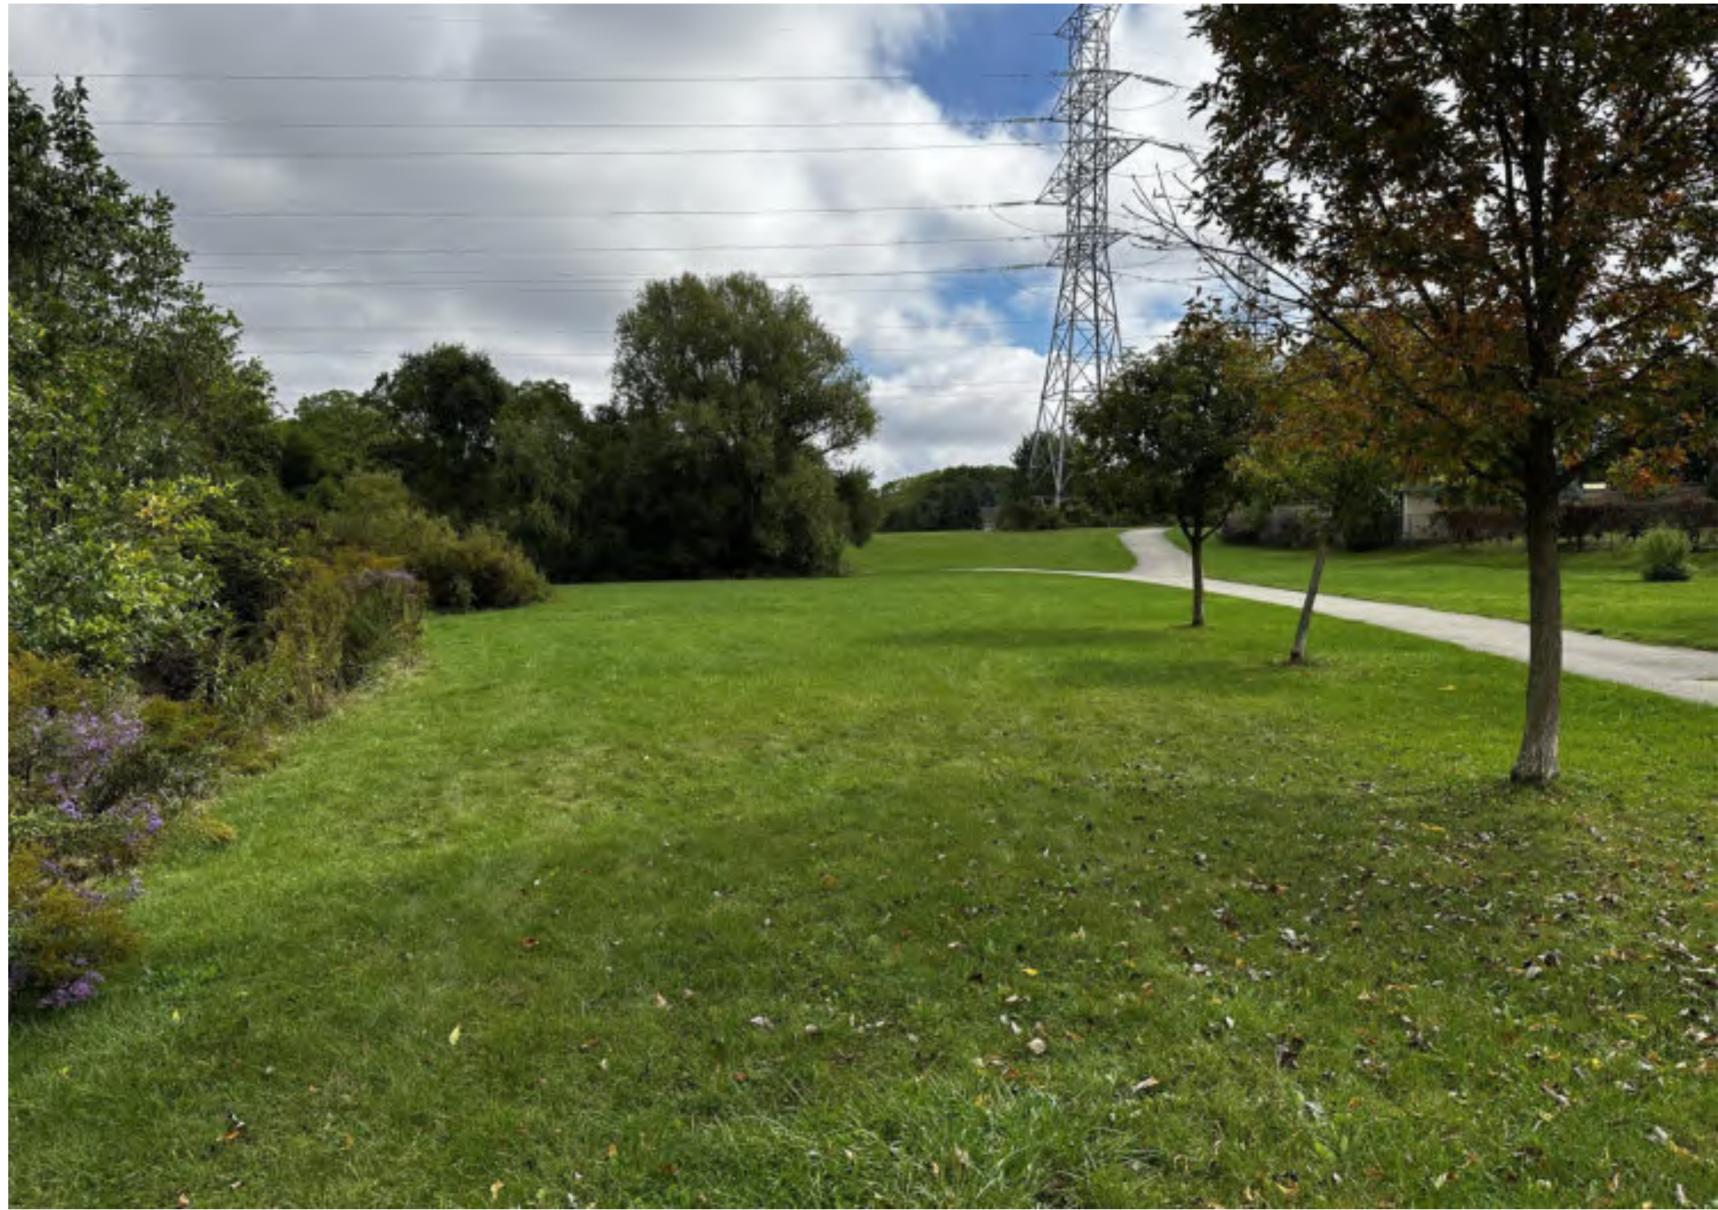
Photo A – Access Route Through Hydro Corridor

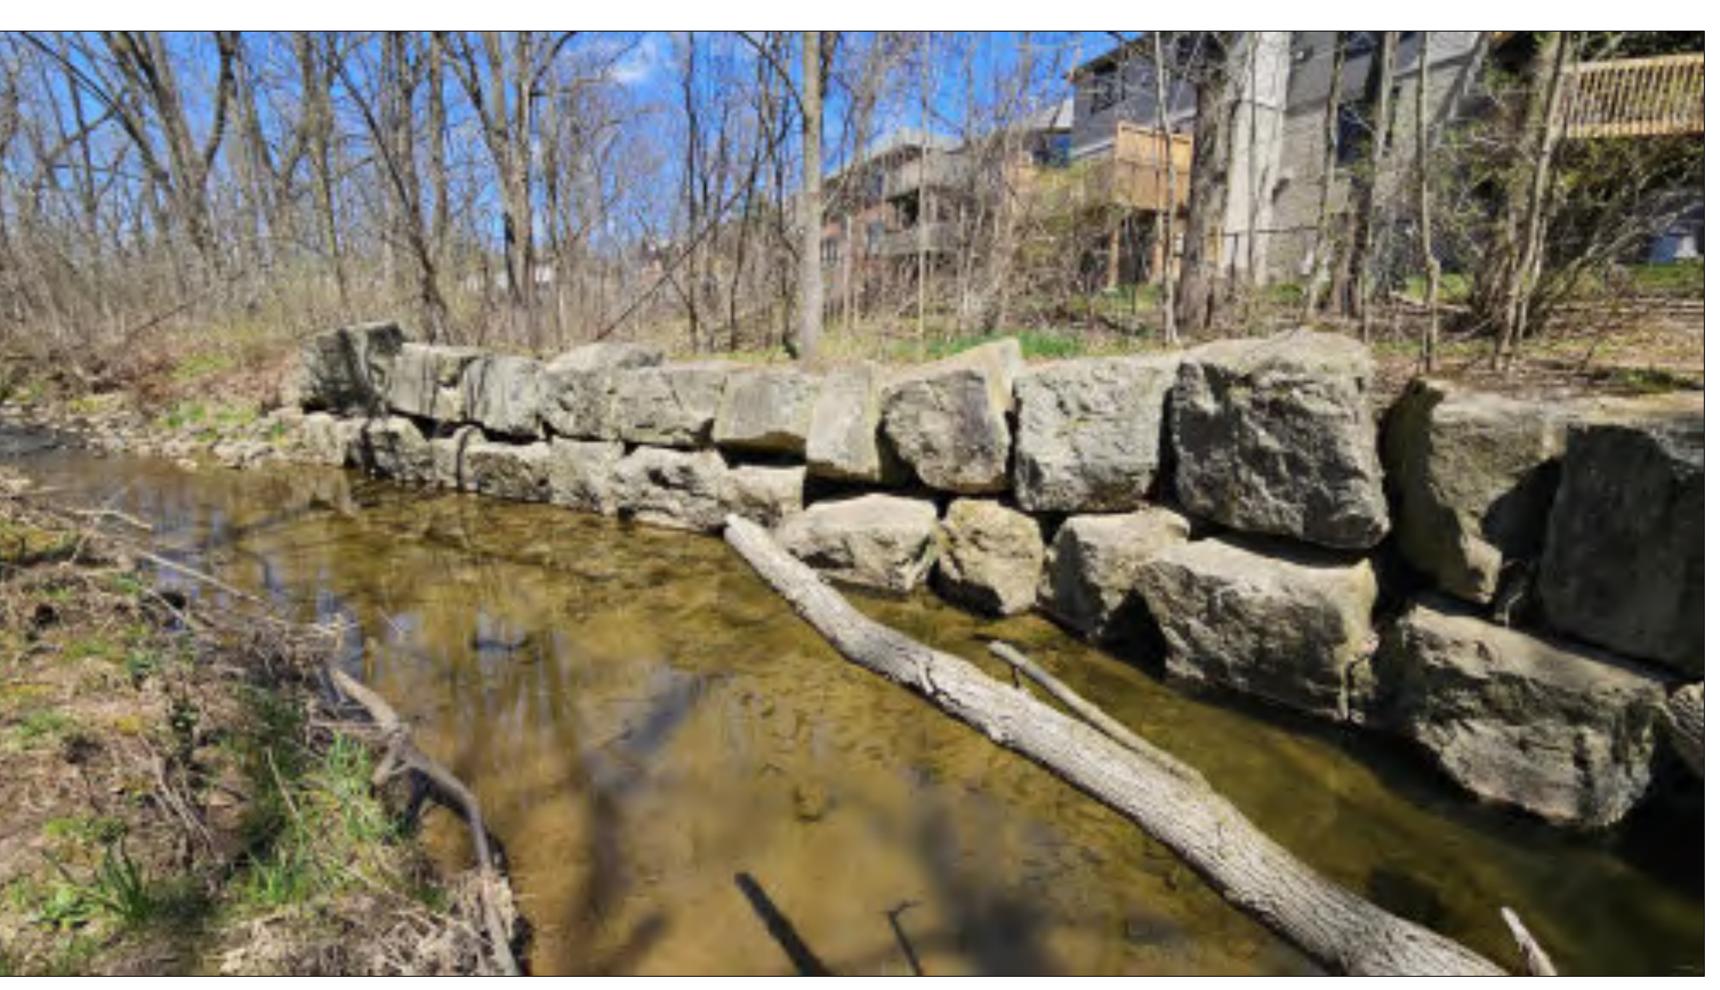
Photo C – Arrmourstone Wall in a Deteriorated Condition

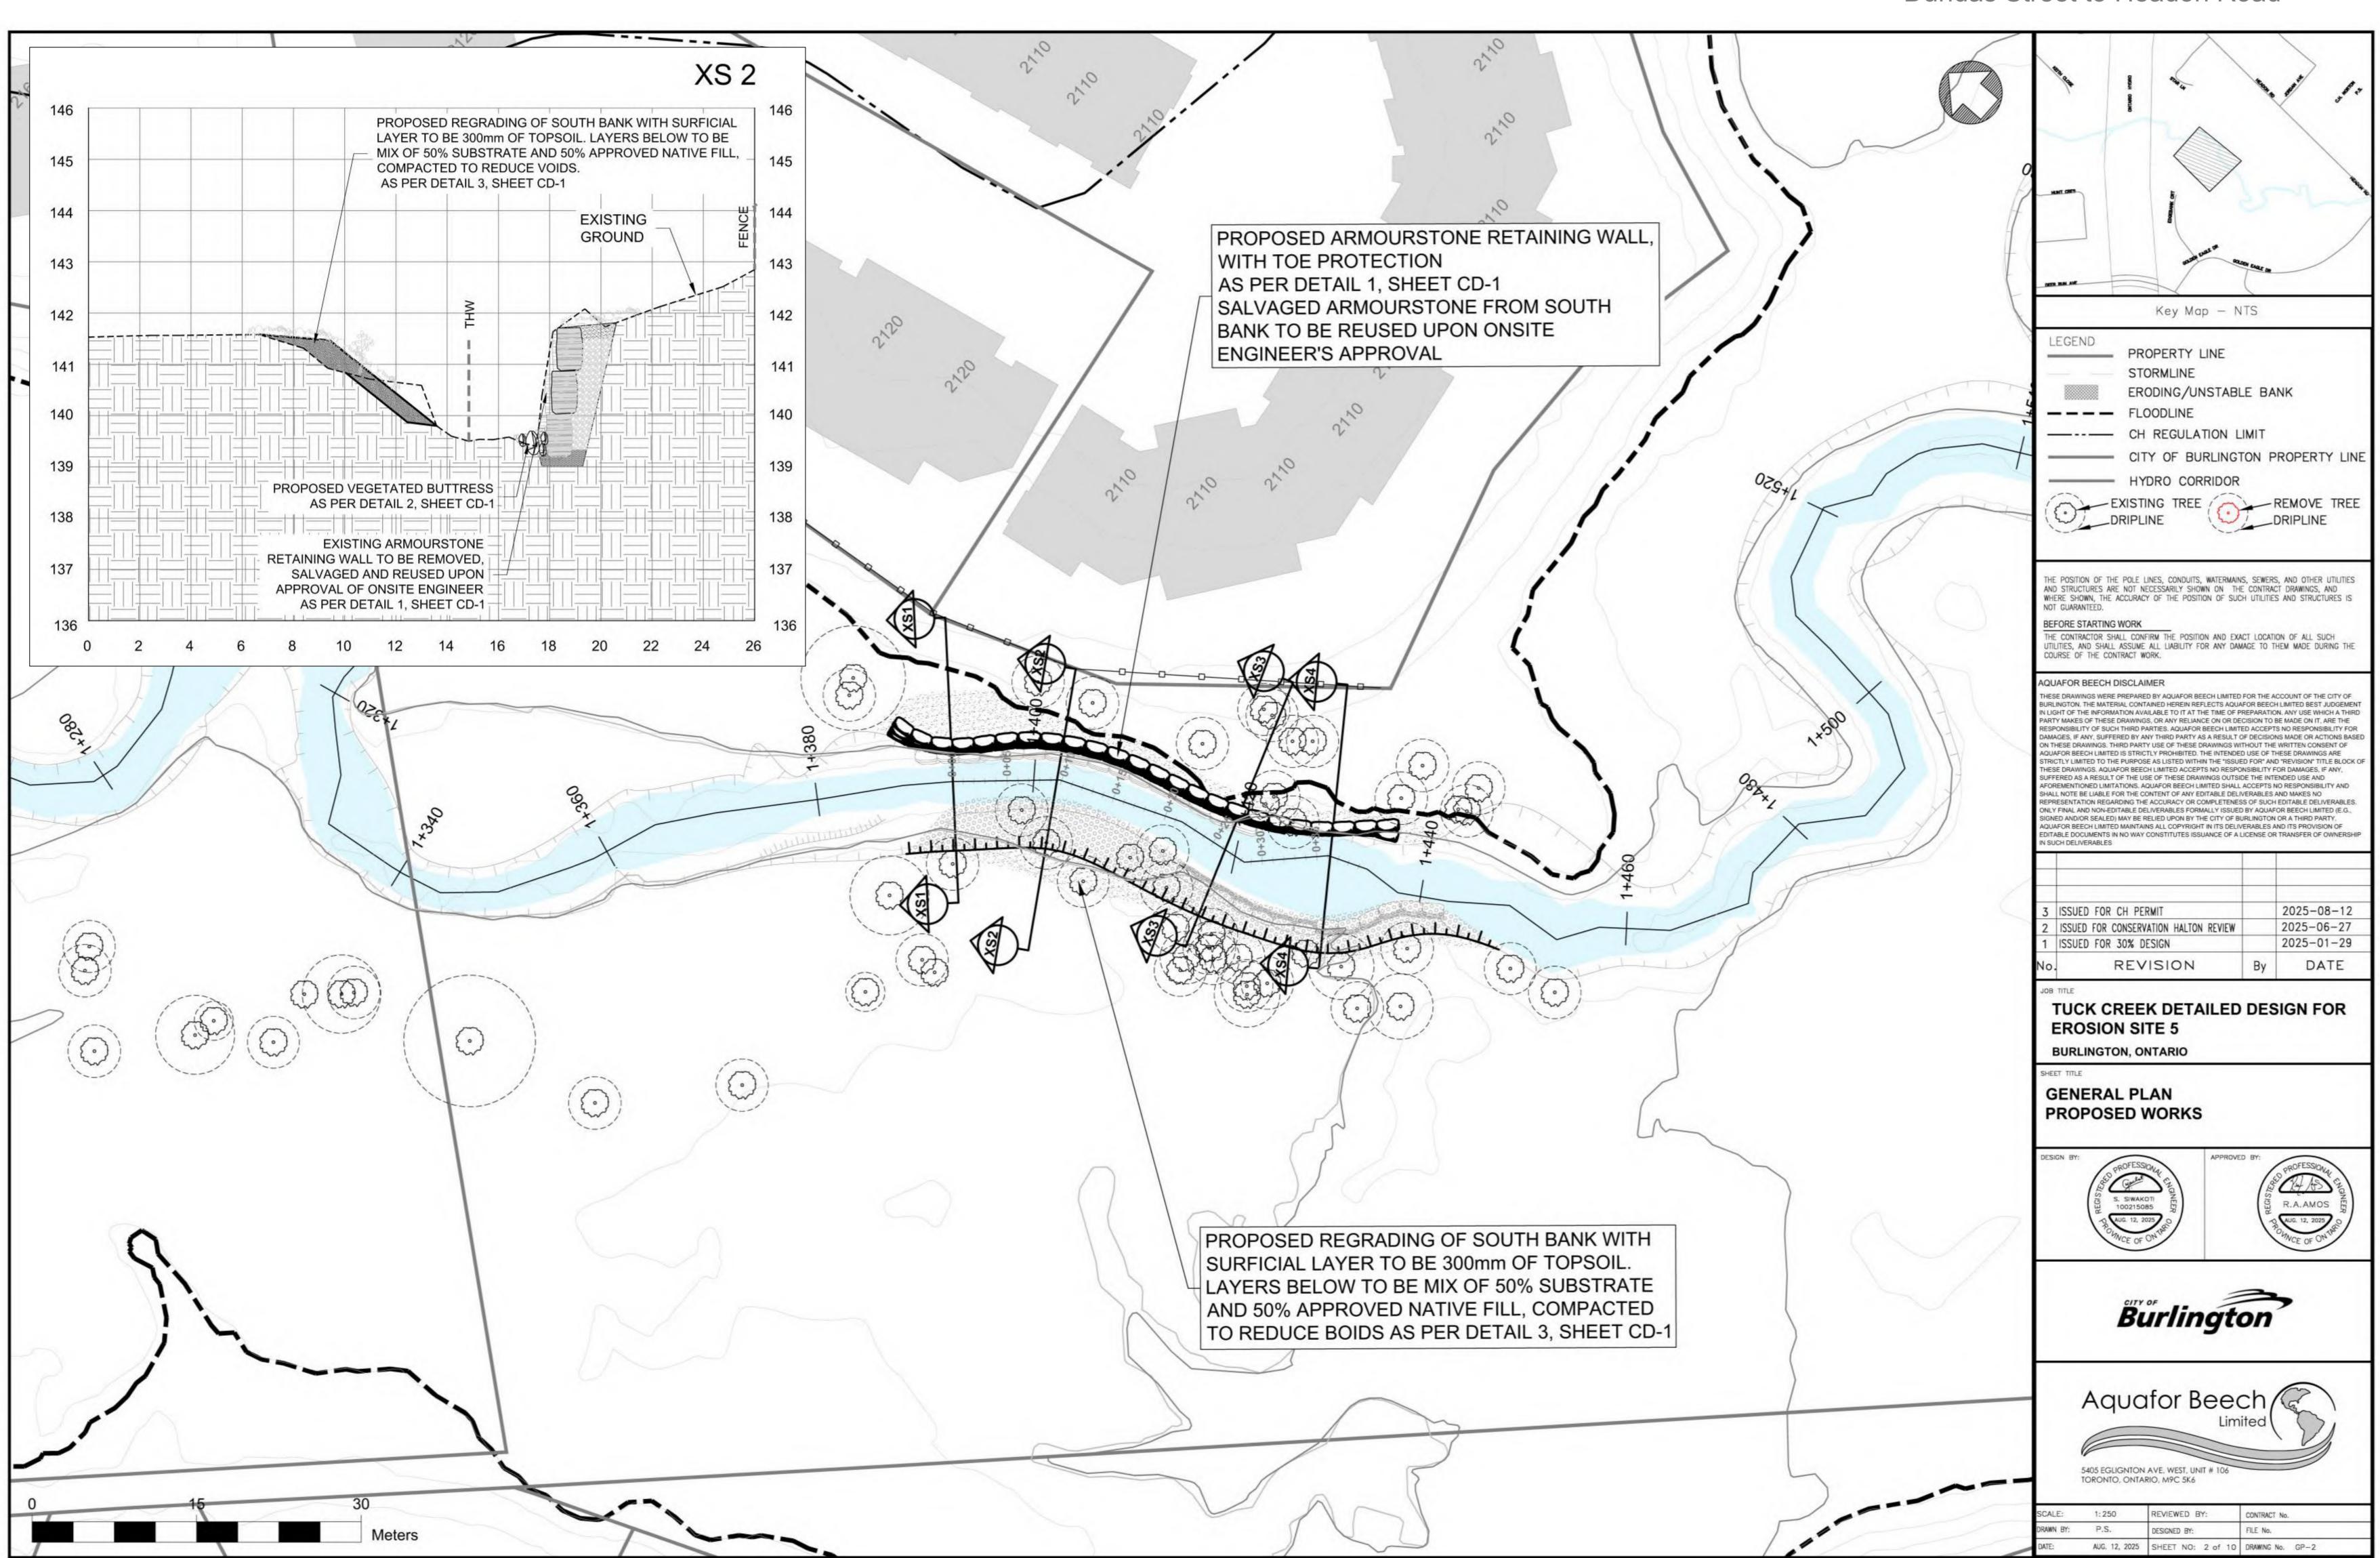
## SITE 5: GENERAL PLAN – PROPOSED WORKS

- Minor channel realignment and regrading of the bank including restoration with native plantings
- Regrading and restoration of the channel bed with natural riffle pool morphology
- Installation of toe protection for the armourstone retaining wall
- Installation of vegetated buttress with boulder toe protection to prevent channel erosion with potted shrubs
- Restoration of the work area through implementation of a comprehensive vegetation restoration plan

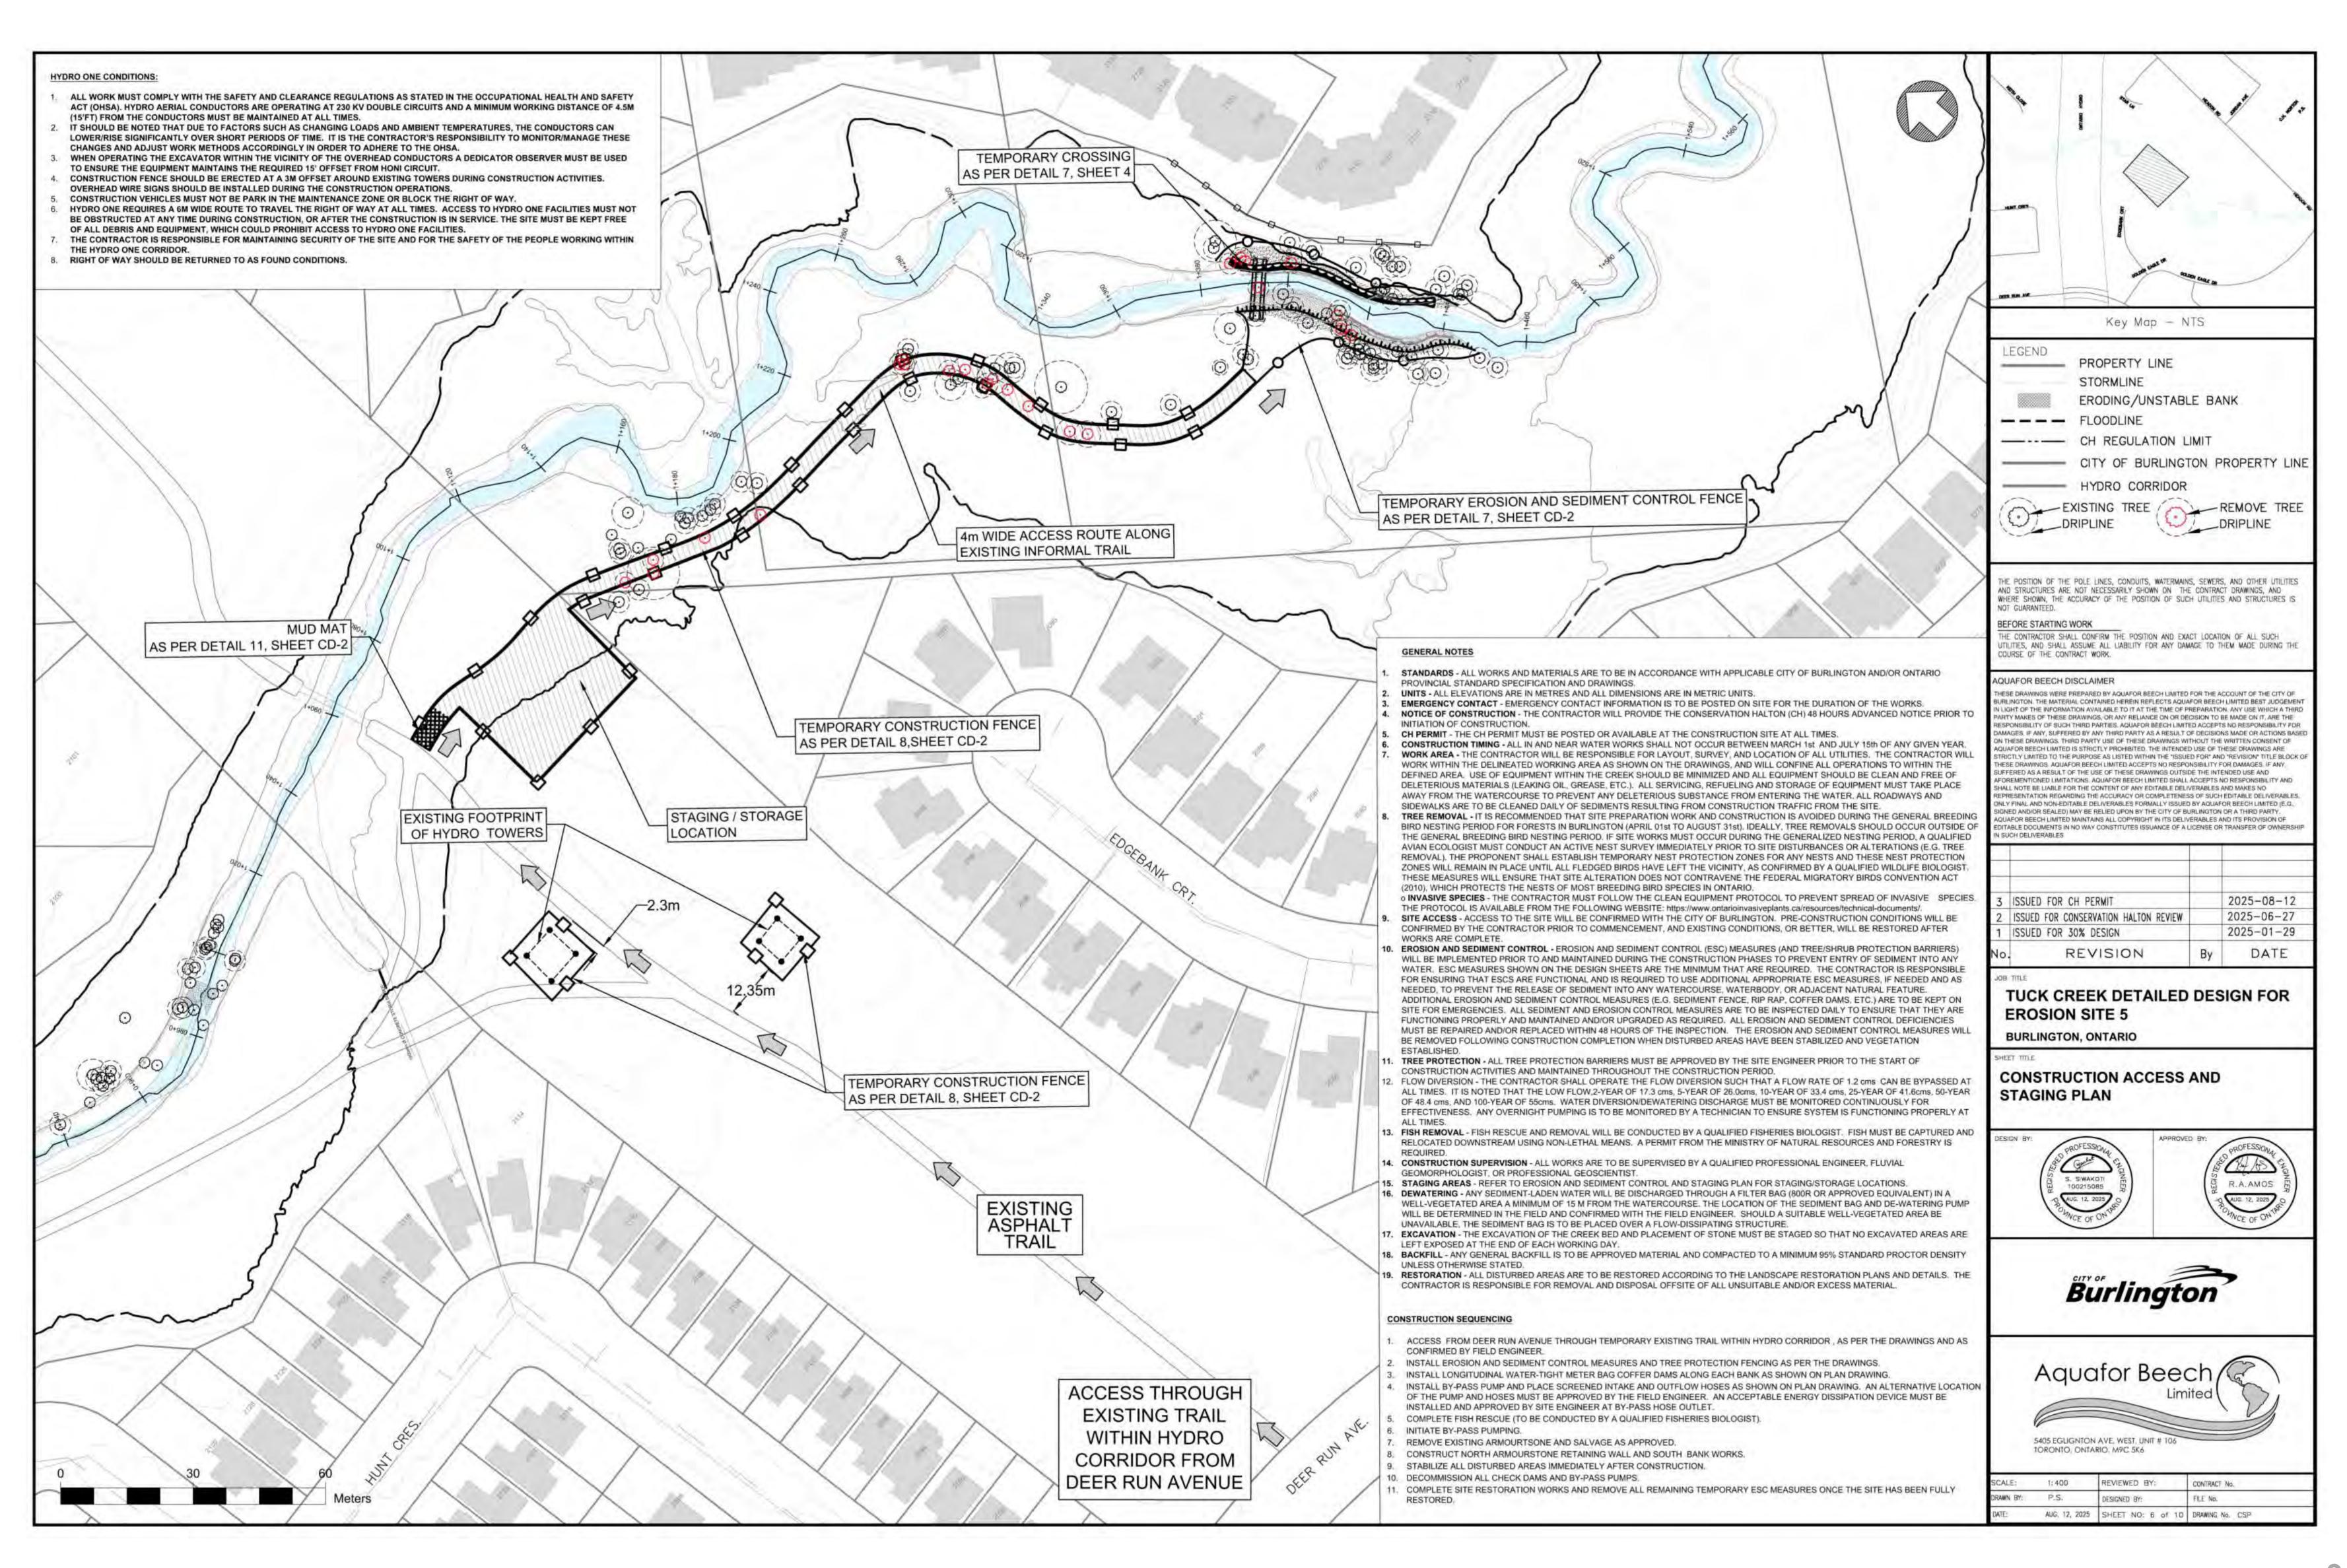
### SITE 5: CONSTRUCTION ACCESS AND STAGING PLAN

- Access to Erosion Site #5 via Deer Run Avenue through Hydro Corridor
- Access to Erosion Site #6 via Deer Run Avenue through Hydro Corridor
- Access to Erosion Site #7 via Driftwood Drive

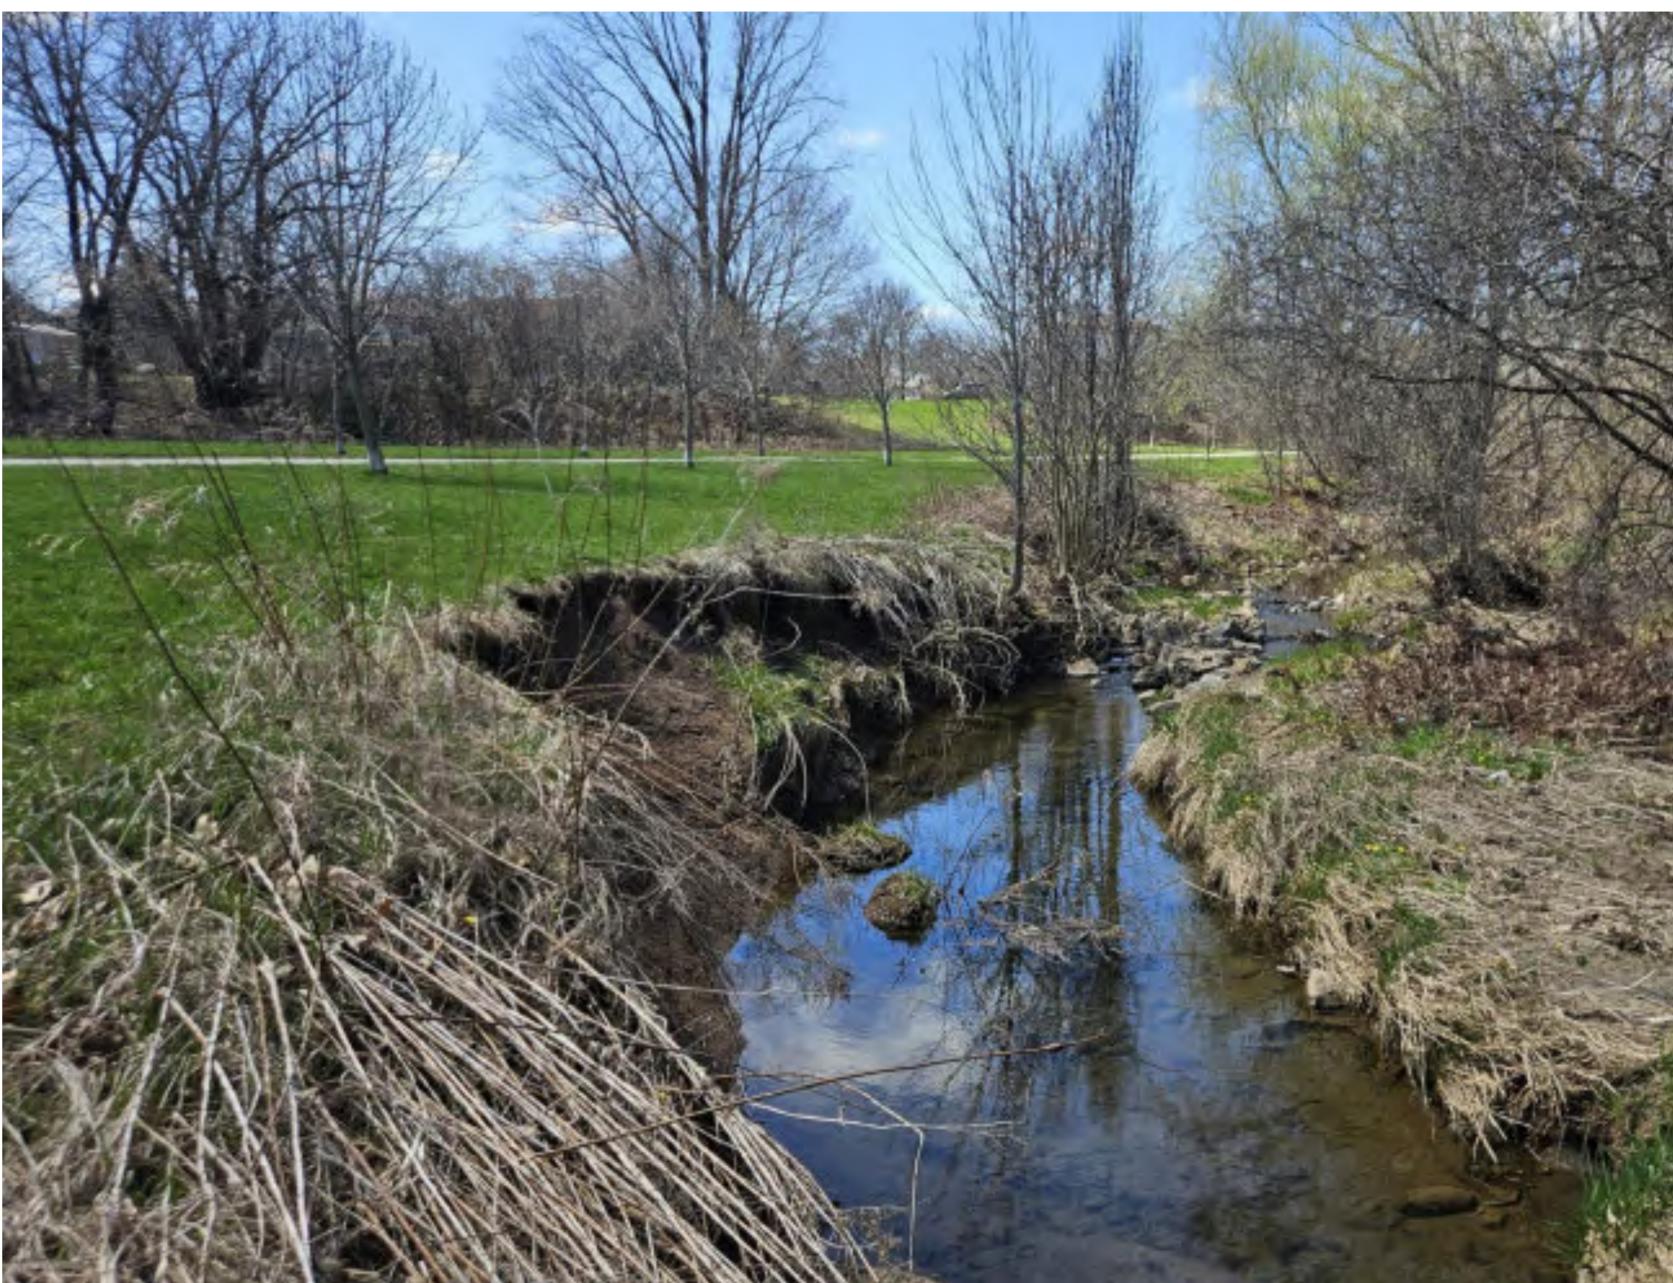
Photo B – Outflanked Concrete Weir with Downstream Terrafix Blocks Lining Channel

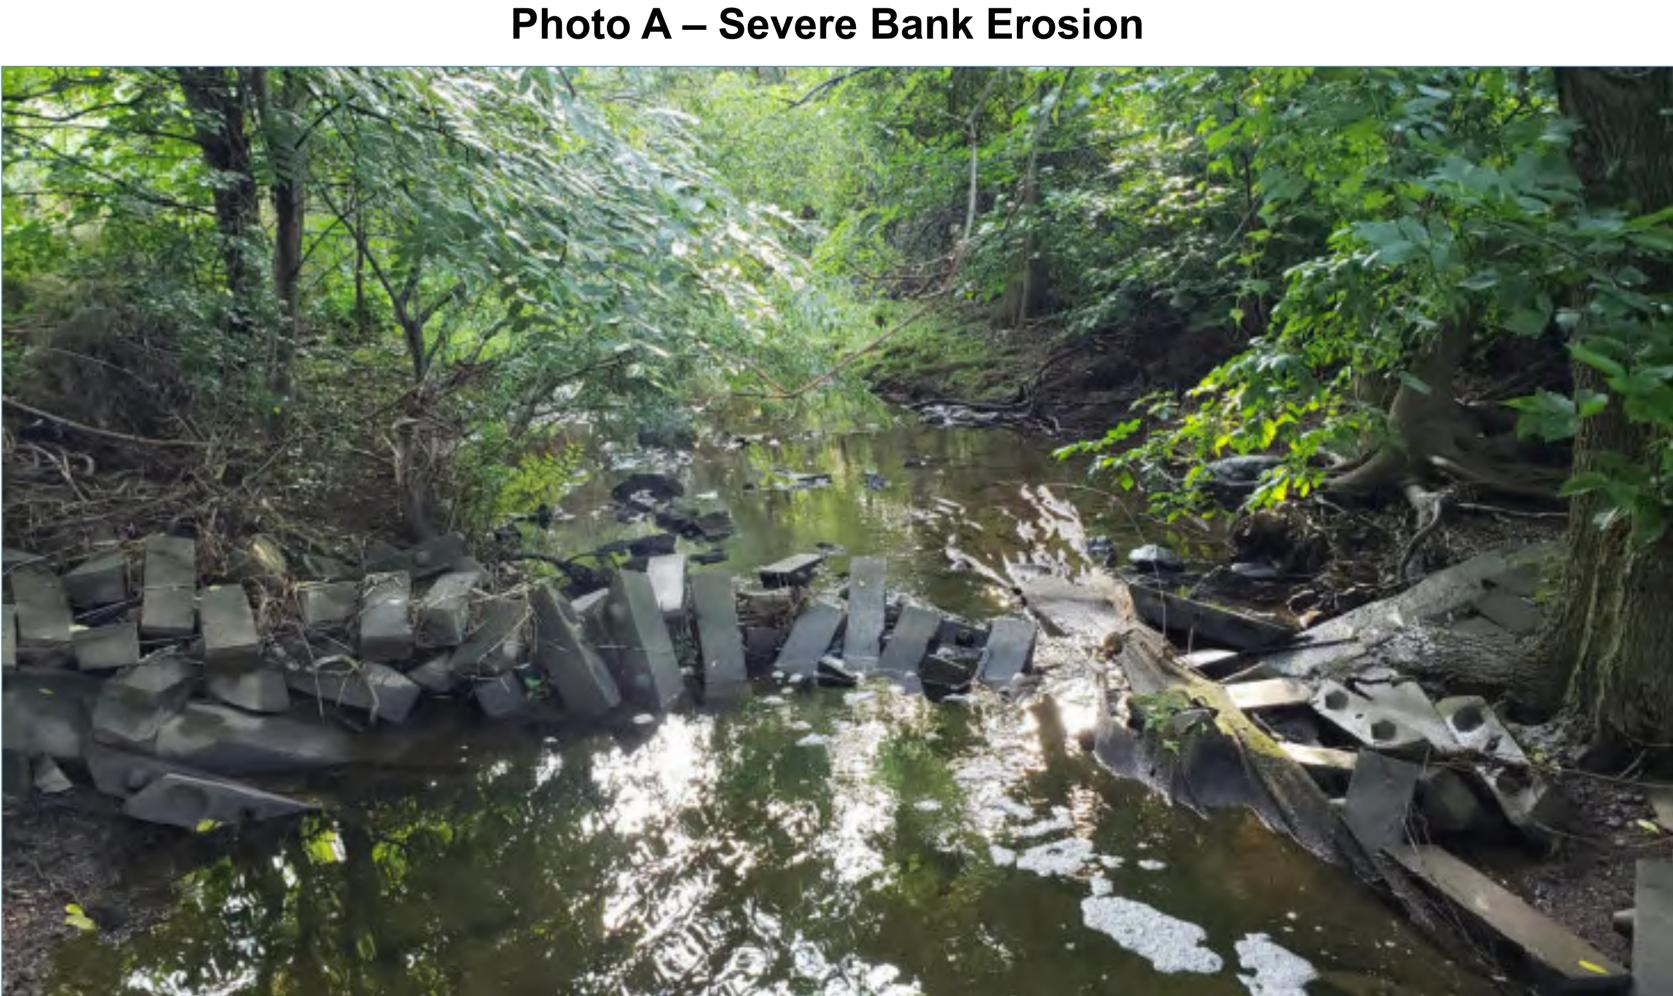
Photo C – Failed Terrafix Blocks Downstream of Concrete Weir

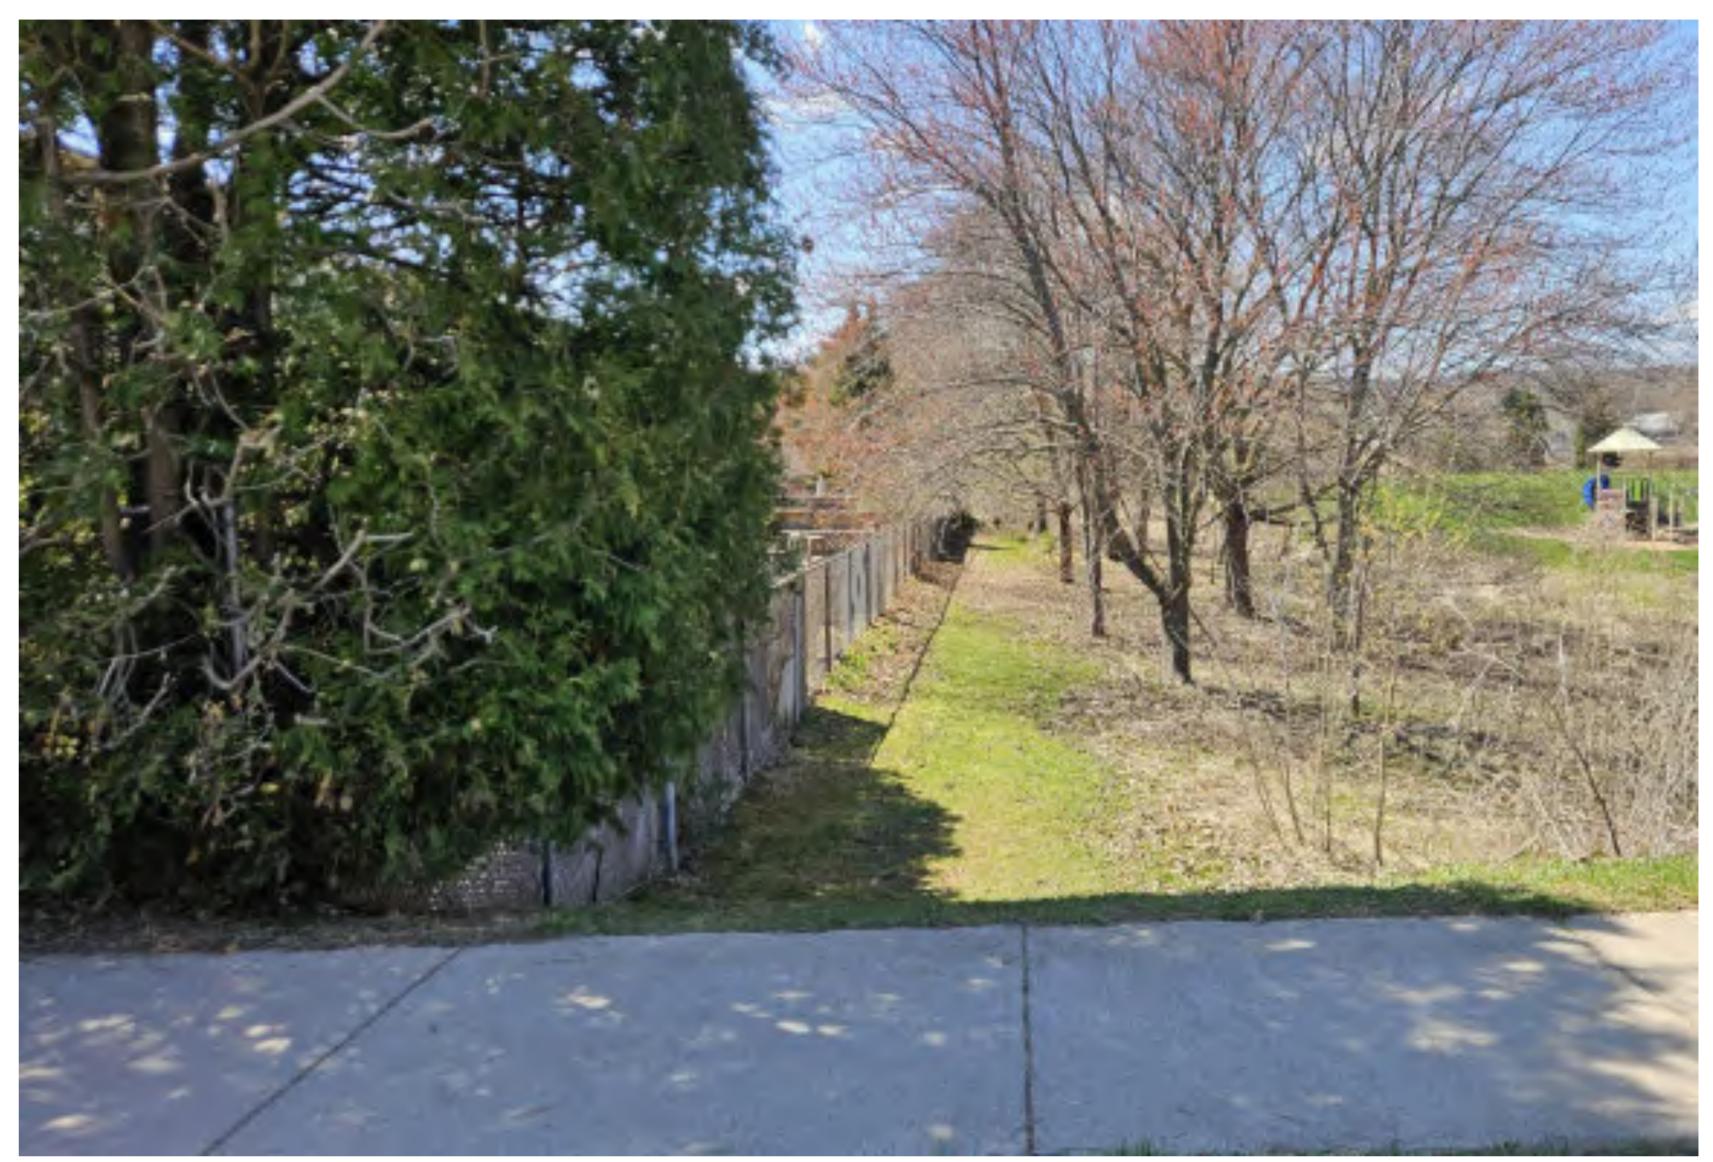
Photo D – Access Route from Driftwood Drive

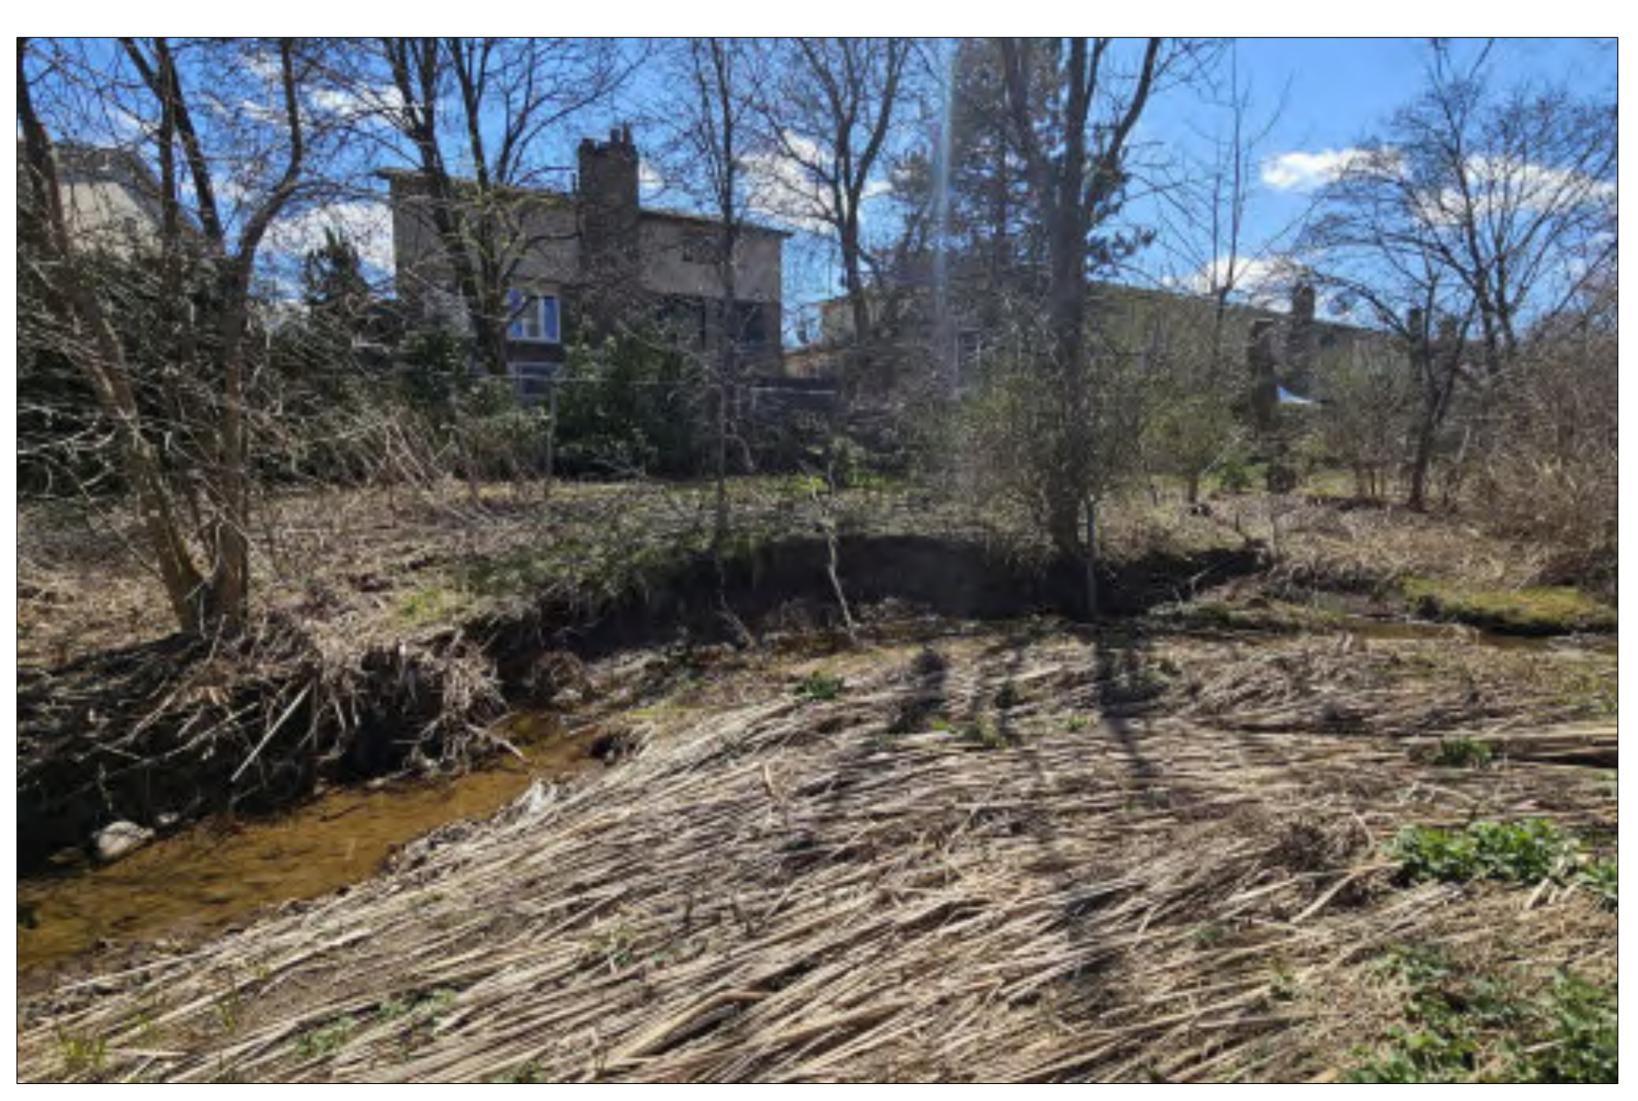
Photo E – Actively Eroding North Bank towards Private Properties

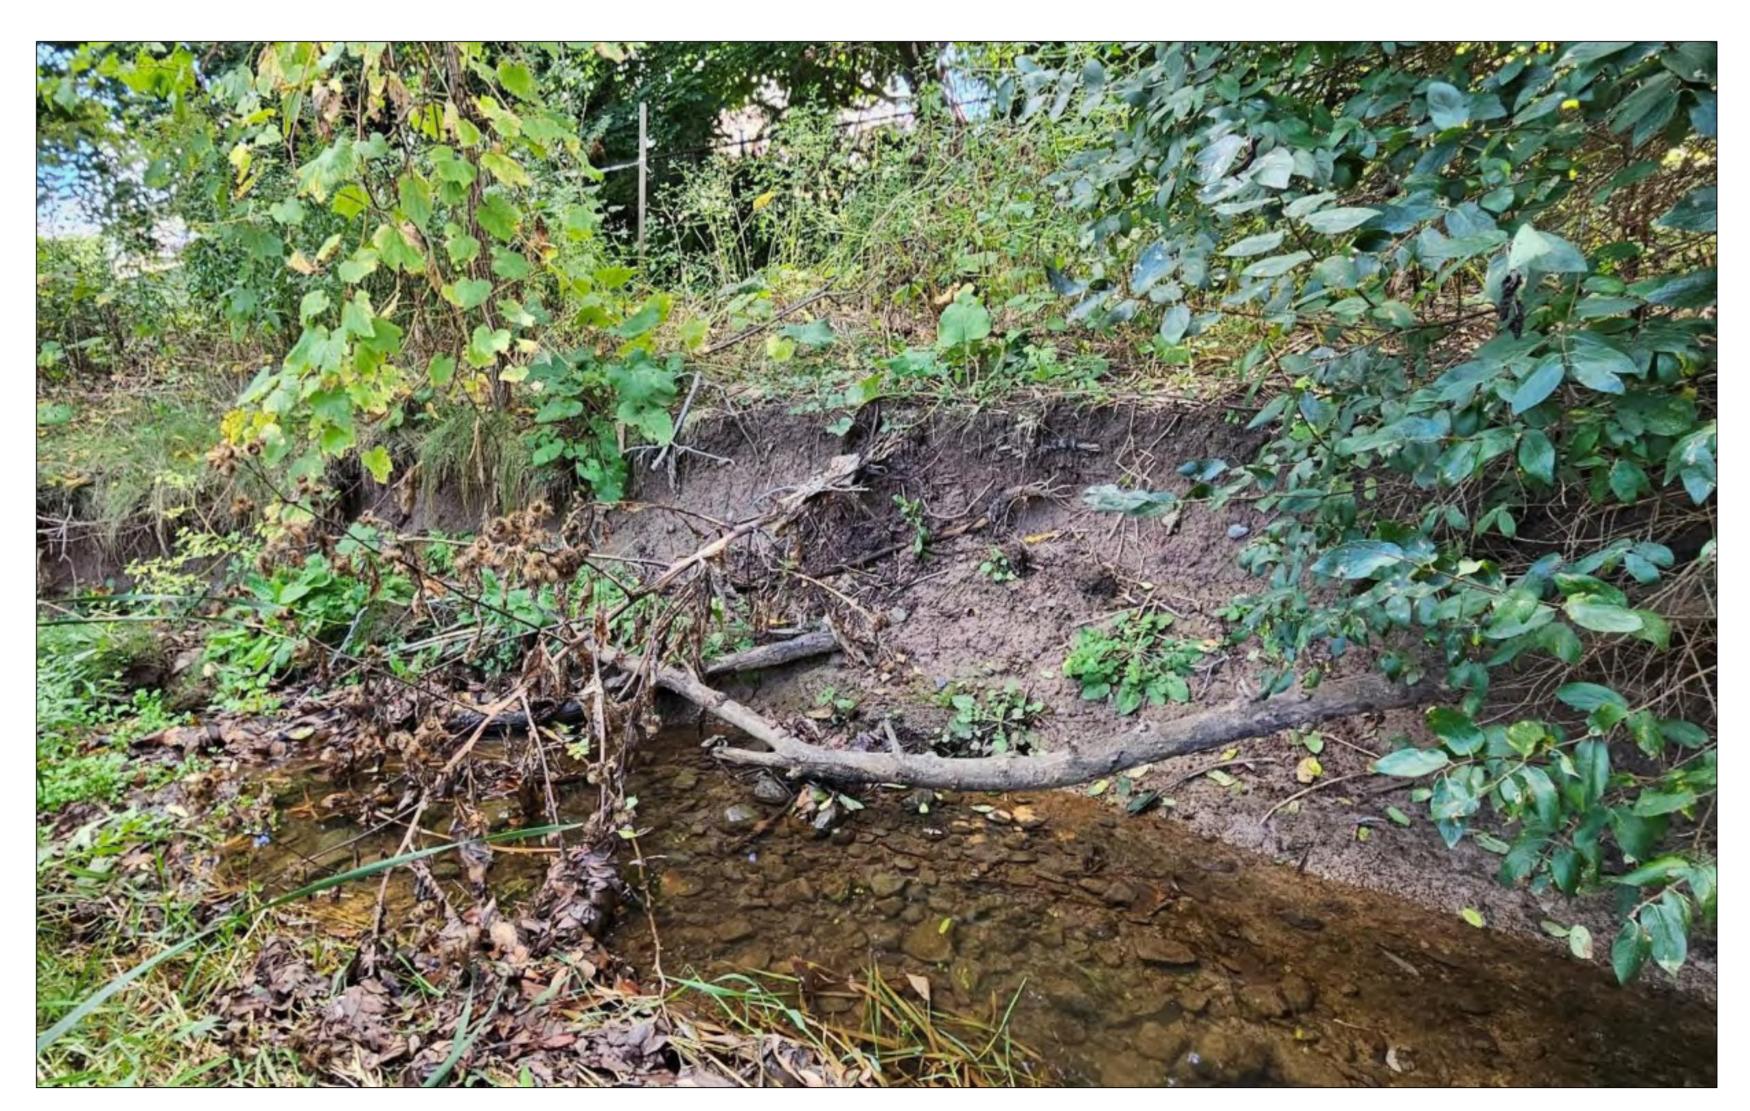
Photo F – Eroding North Bank – Looking East
