# PHASE ONE ENVIRONMENTAL SITE ASSESSMENT

Trinity Point  
8700 Dufferin Street  
Vaughan, Ontario

**2072 Lakeshore Road | Burlington,  
Ontario**

**File No.** 22-282 Rev 2

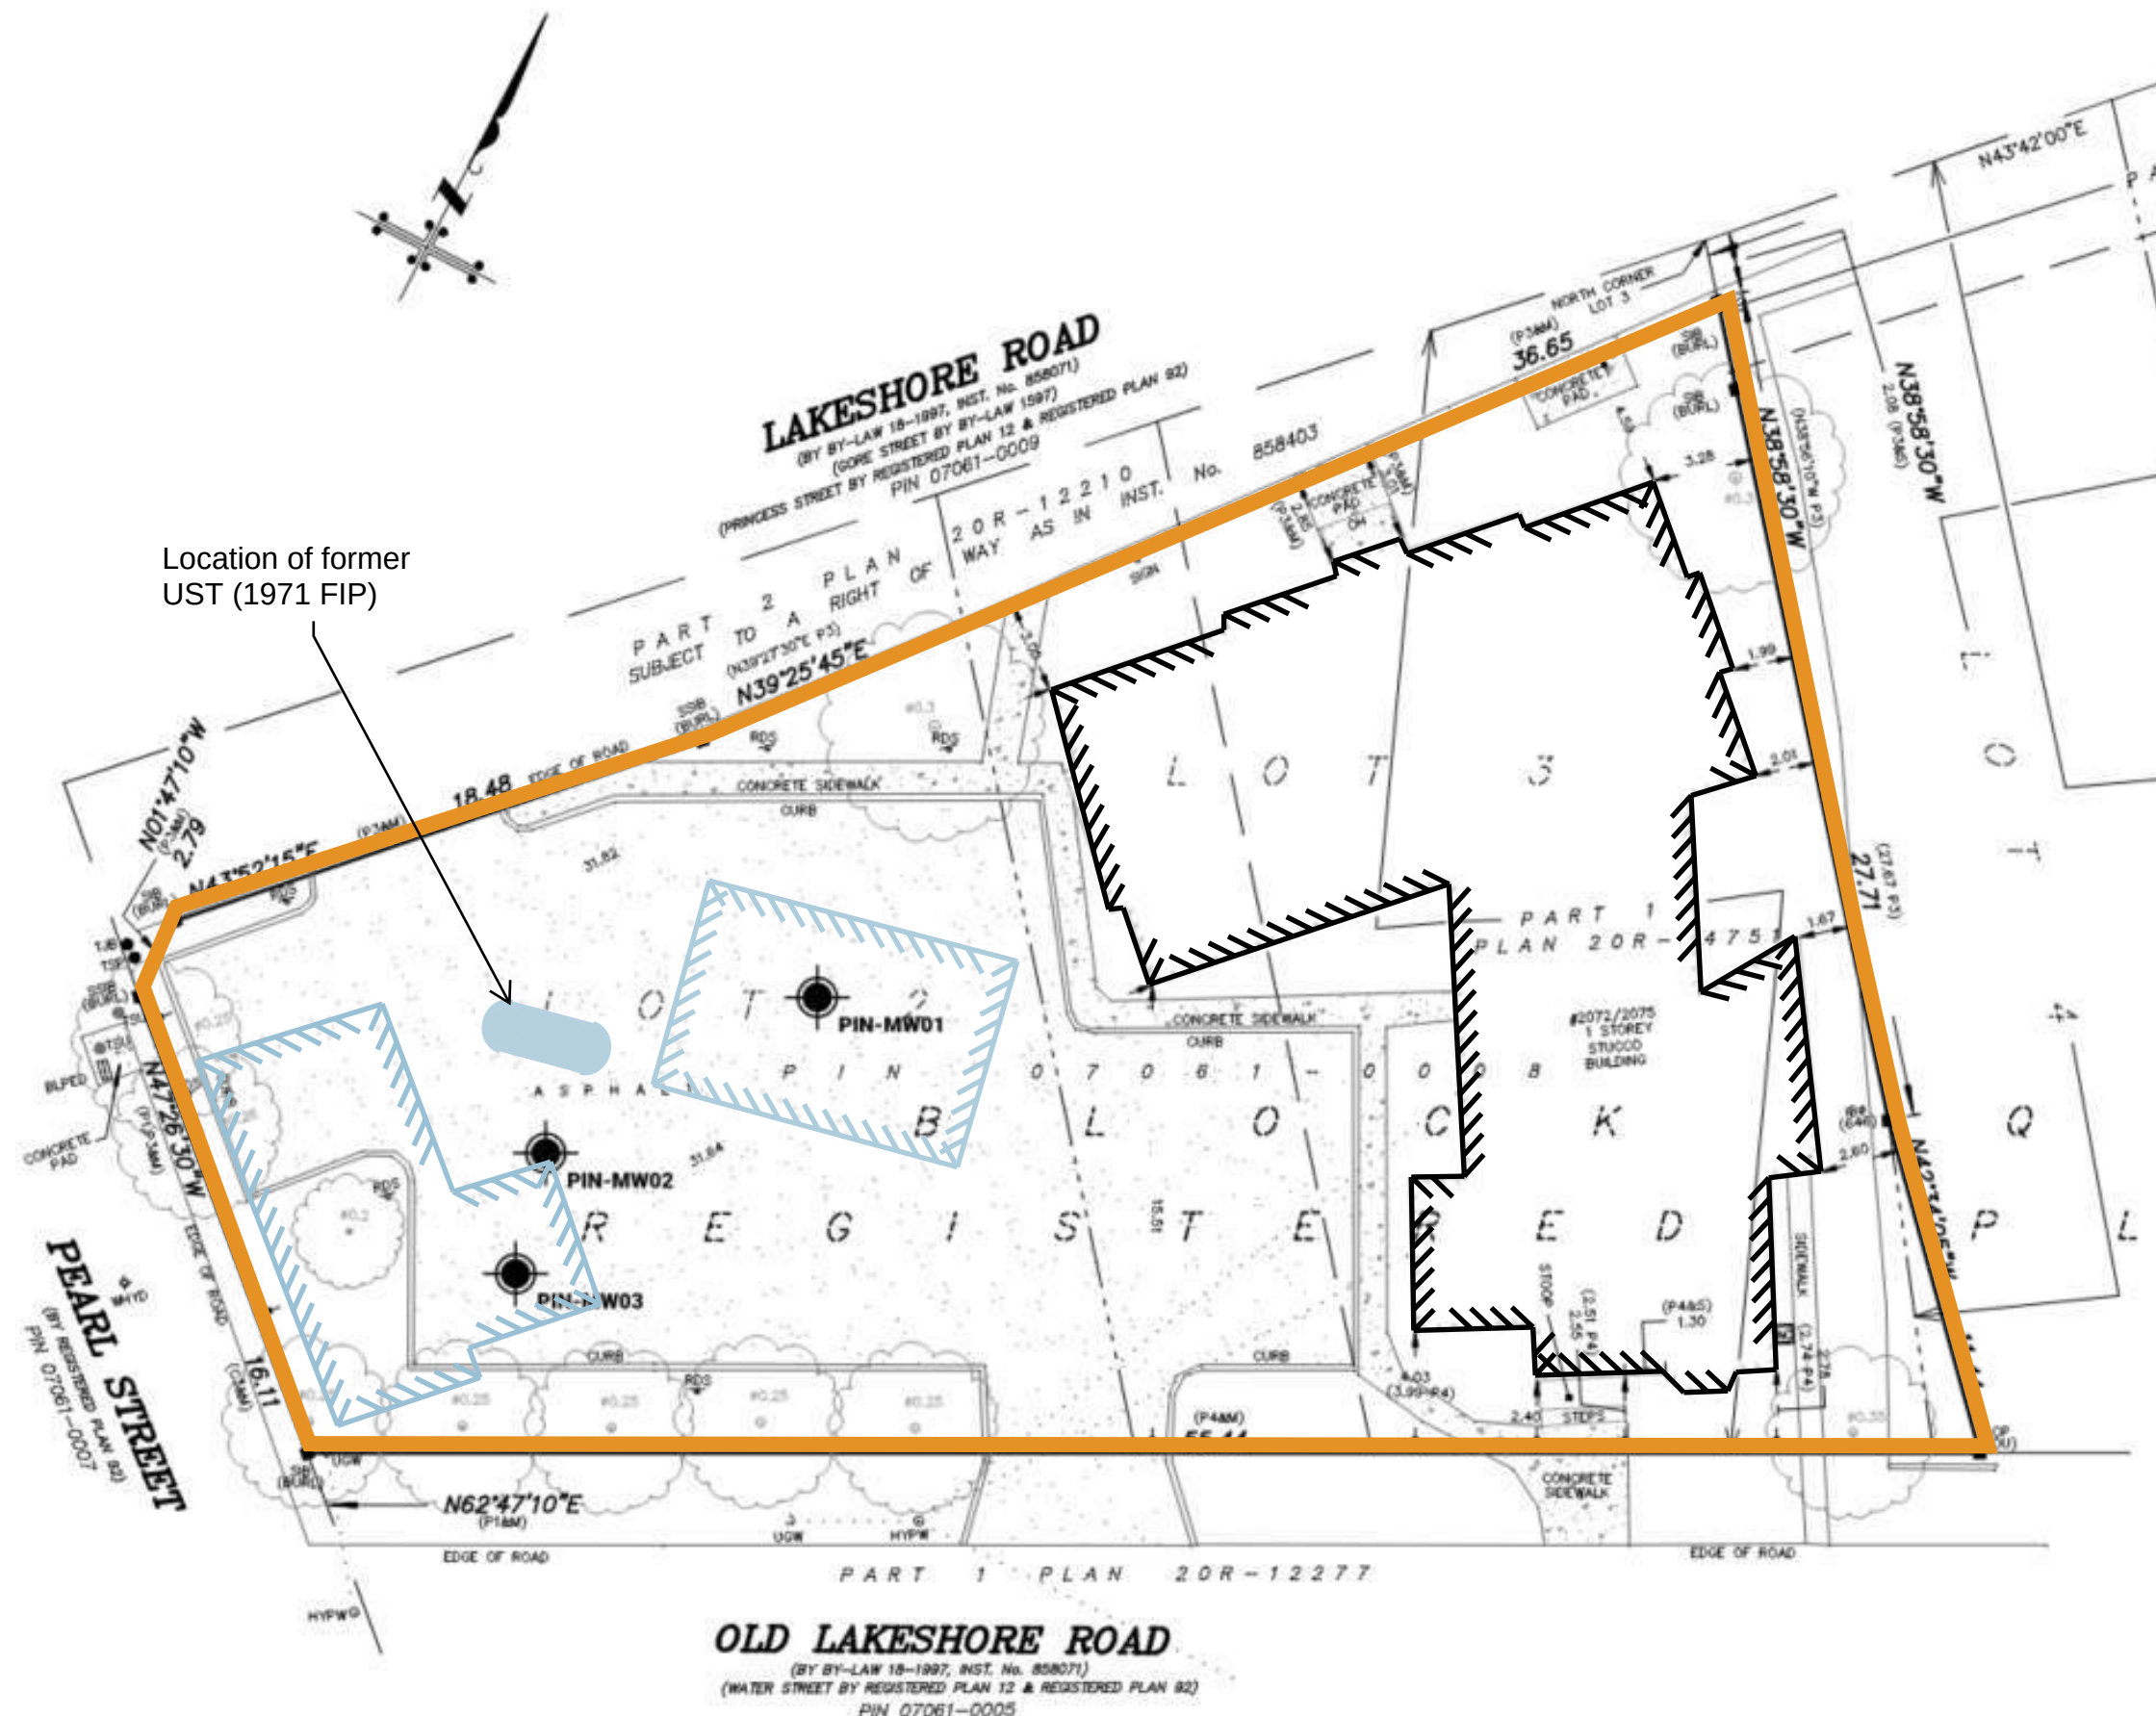
**FIGURE 2**

The Property is currently occupied by an existing 1-storey building which is a slab-on-grade structure with no basements. The building is presently surrounded by asphalt surface parking and landscaping. The Property is considered to be in commercial land use by the Ontario Ministry of the Environment, Conservation and Parks (MECP). It is understood that the Phase One Property will be developed with a high-rise residential tower with seven (7) levels of underground parking, which will be considered to be in residential land use by the MECP. The Phase One ESA has been prepared to support a Record of Site Condition and in accordance with Ontario Regulation 153/04 (O.Reg. 153/04). The Phase One Property is presented in Figure 2.

| Phase One ESA including Figures of the Phase One Study Area, which identify the following: | Phase One ESA Information: |
|---|---|
| Existing buildings and structures | Existing building and structures are presented in Figure 2. |

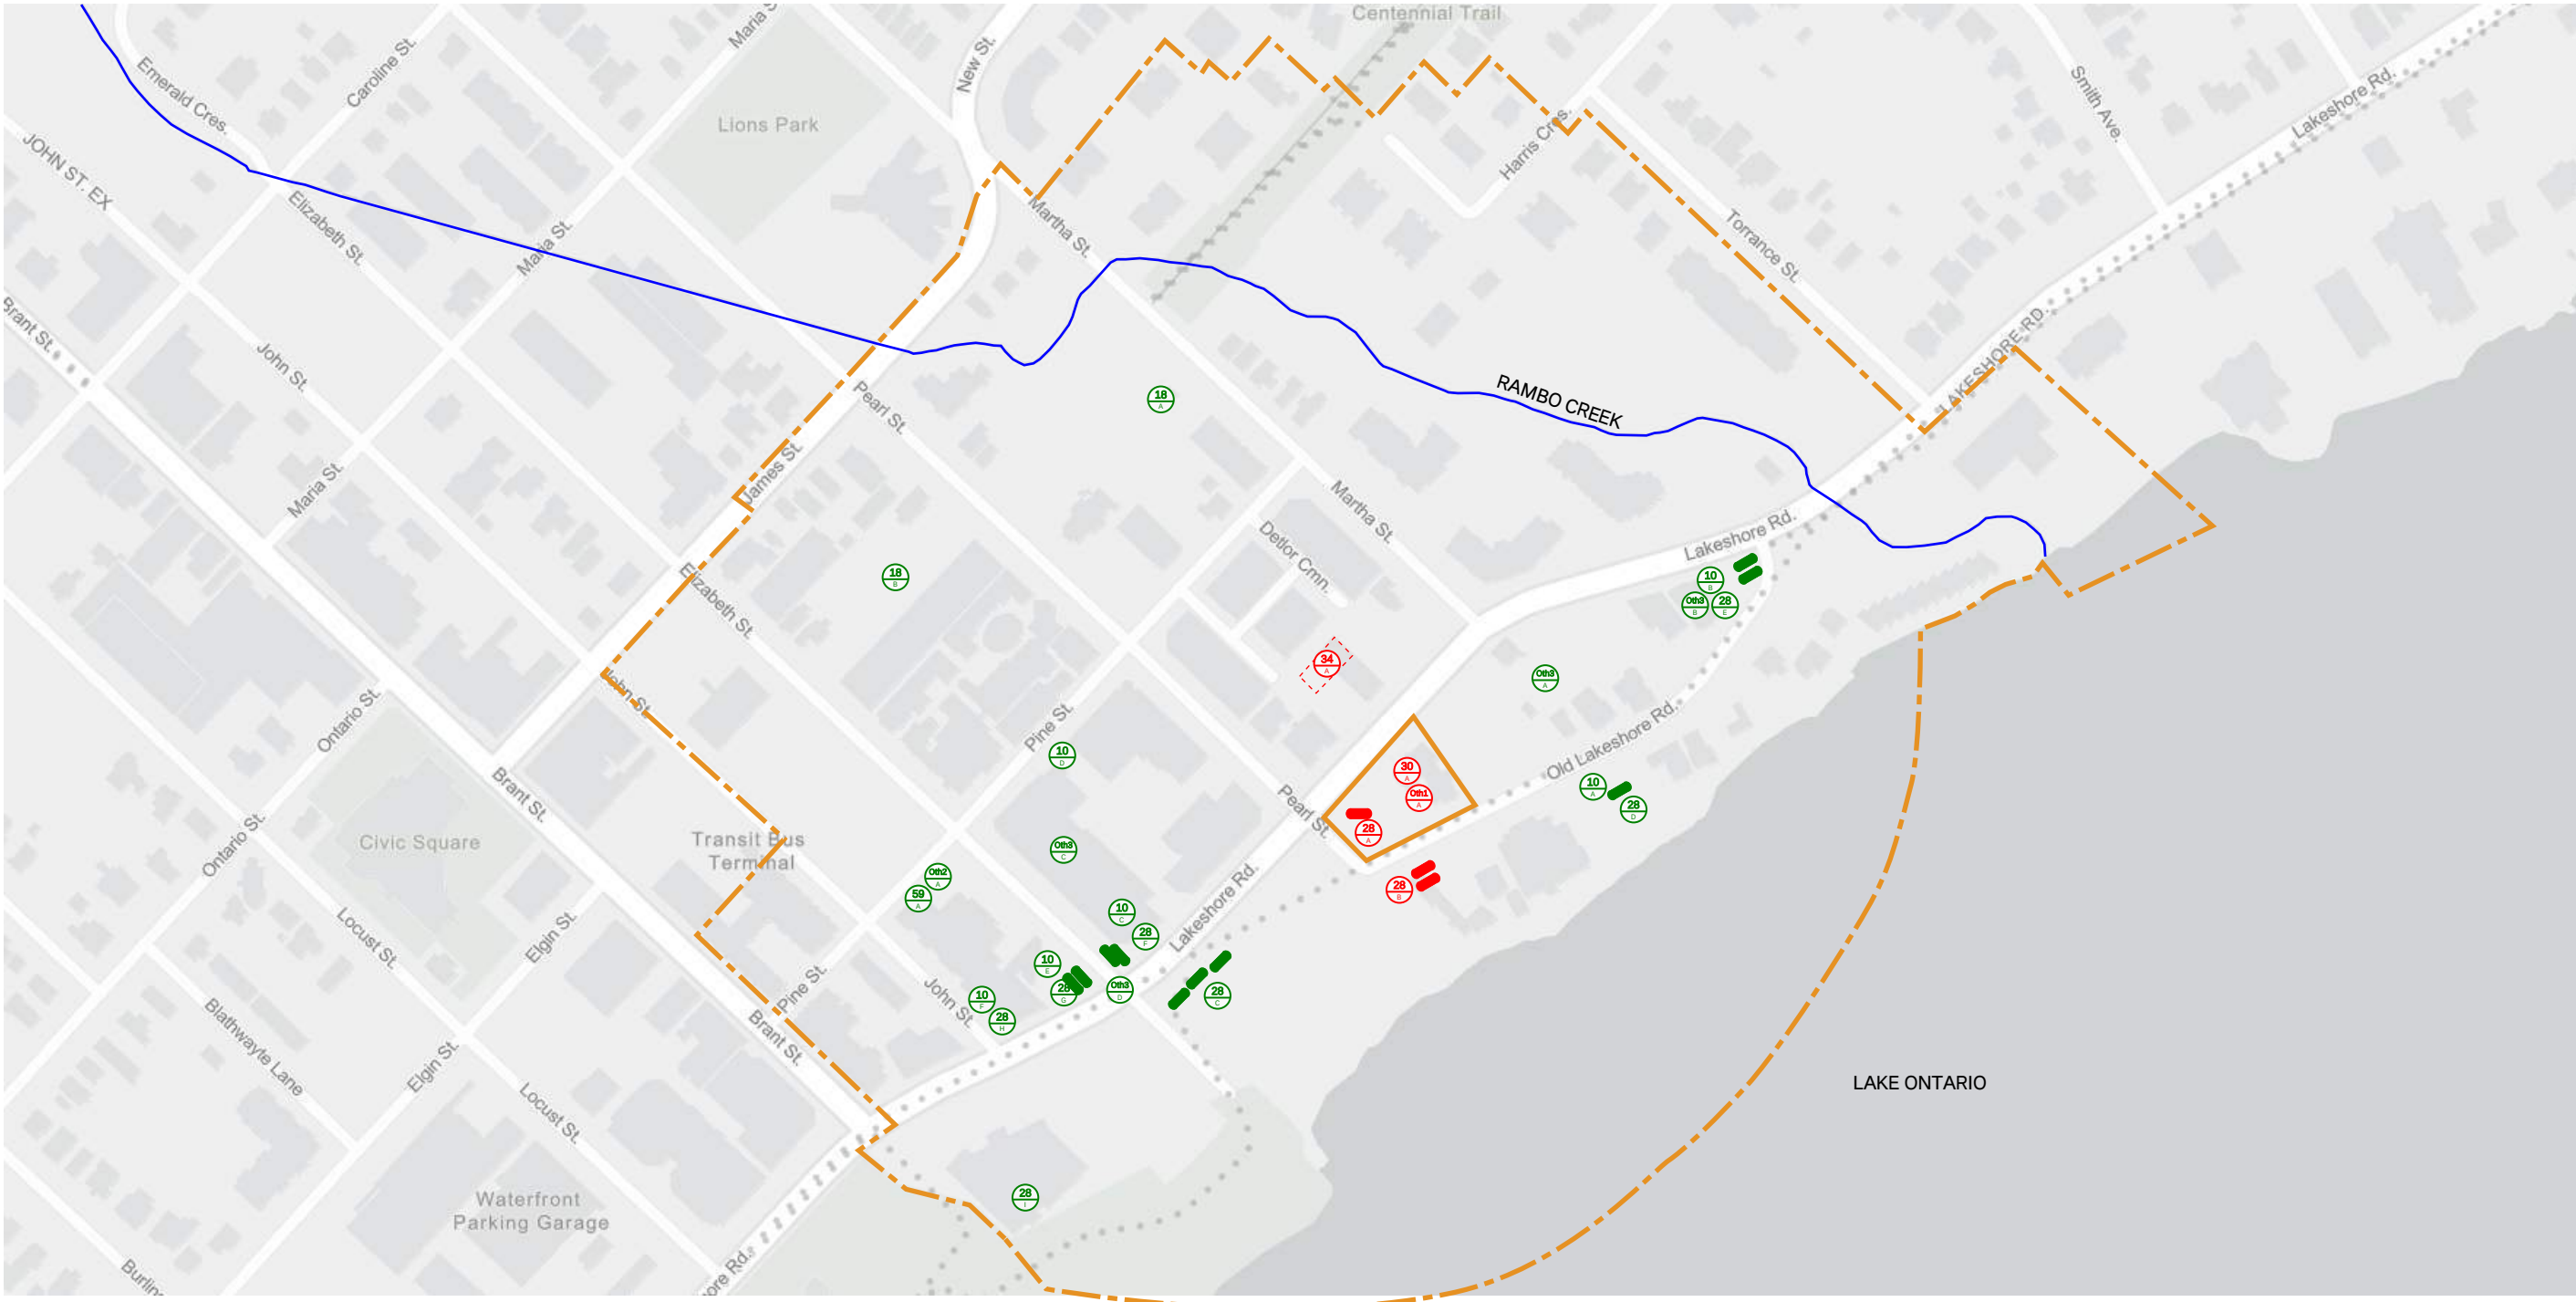
Figure No  
**FIGURE 4**

| Phase One ESA including Figures of the Phase One Study Area, which identify the following: | Phase One ESA Information: |
|---|---|
| Areas where any PCA has occurred, and locations of tanks in the Phase One Study Area | The location of PCAs and tanks, if any, is shown on Figure 4. |

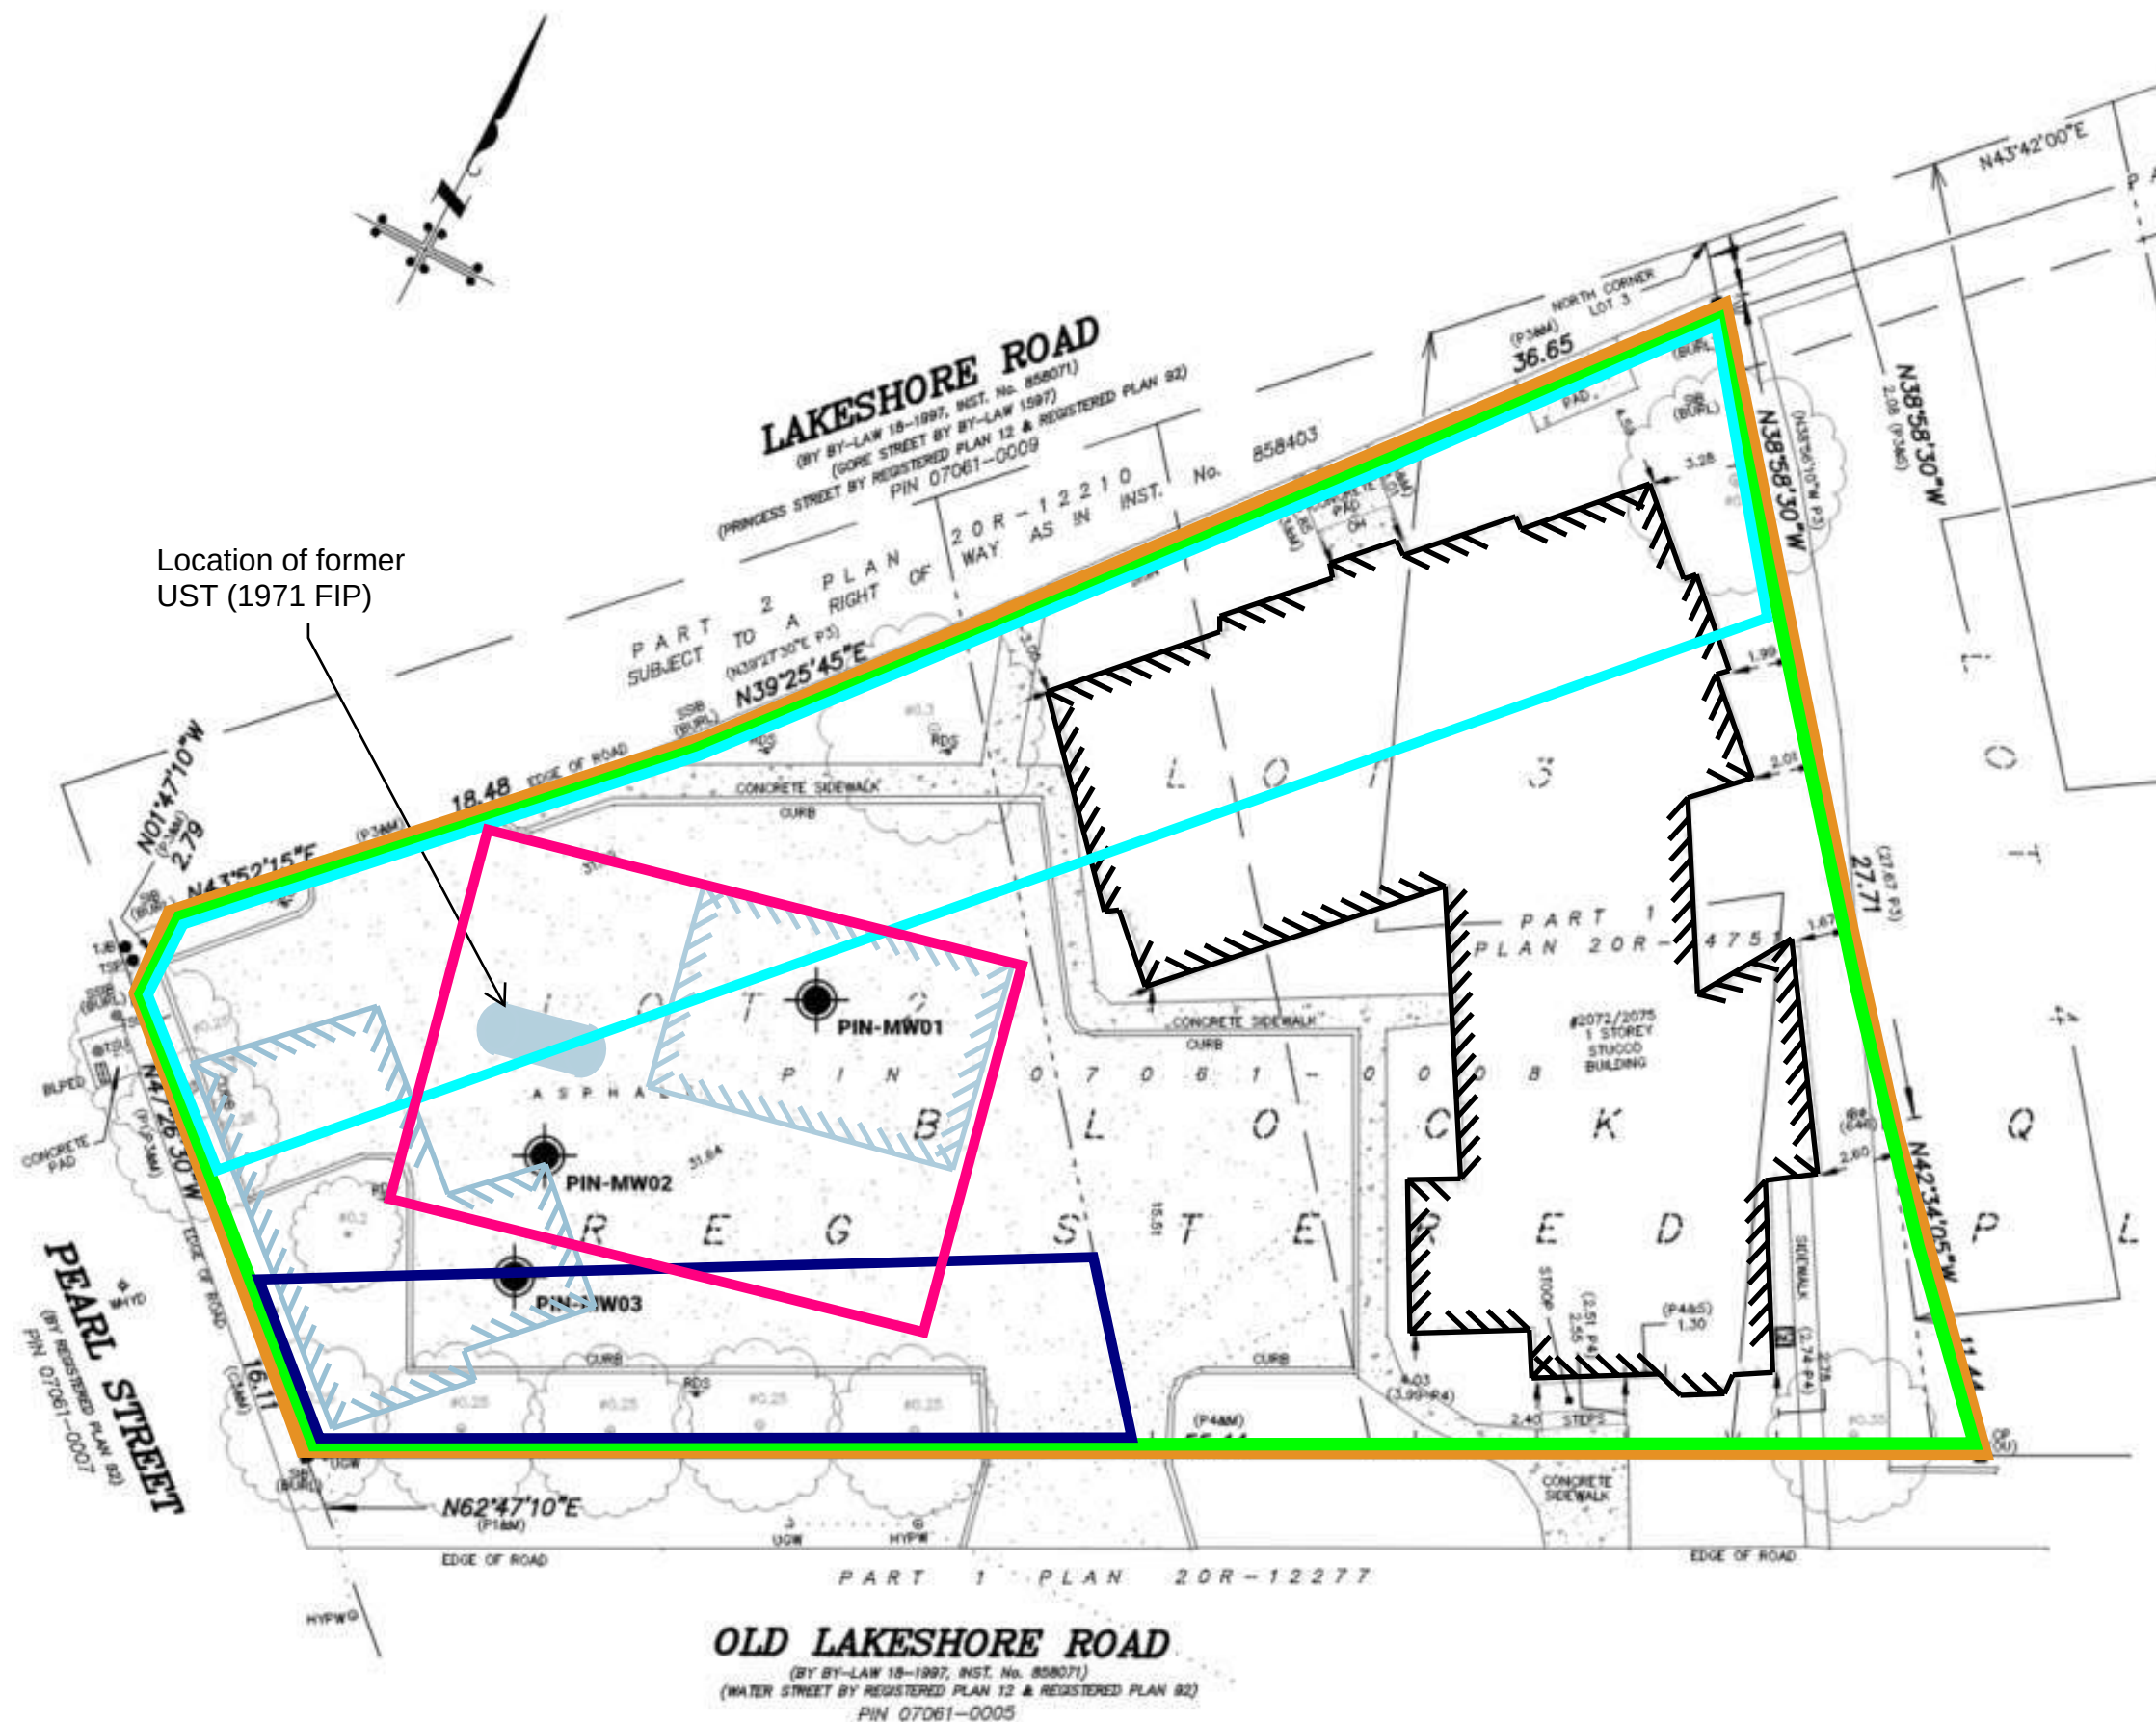
**FIGURE 5**

| Phase One ESA including Figures of the Phase One Study Area, which identify the following: | Phase One ESA Information: |
|---|---|
| APECs on the Phase One Property | The location of APECs on the Phase One Property is shown on Figure 5. |

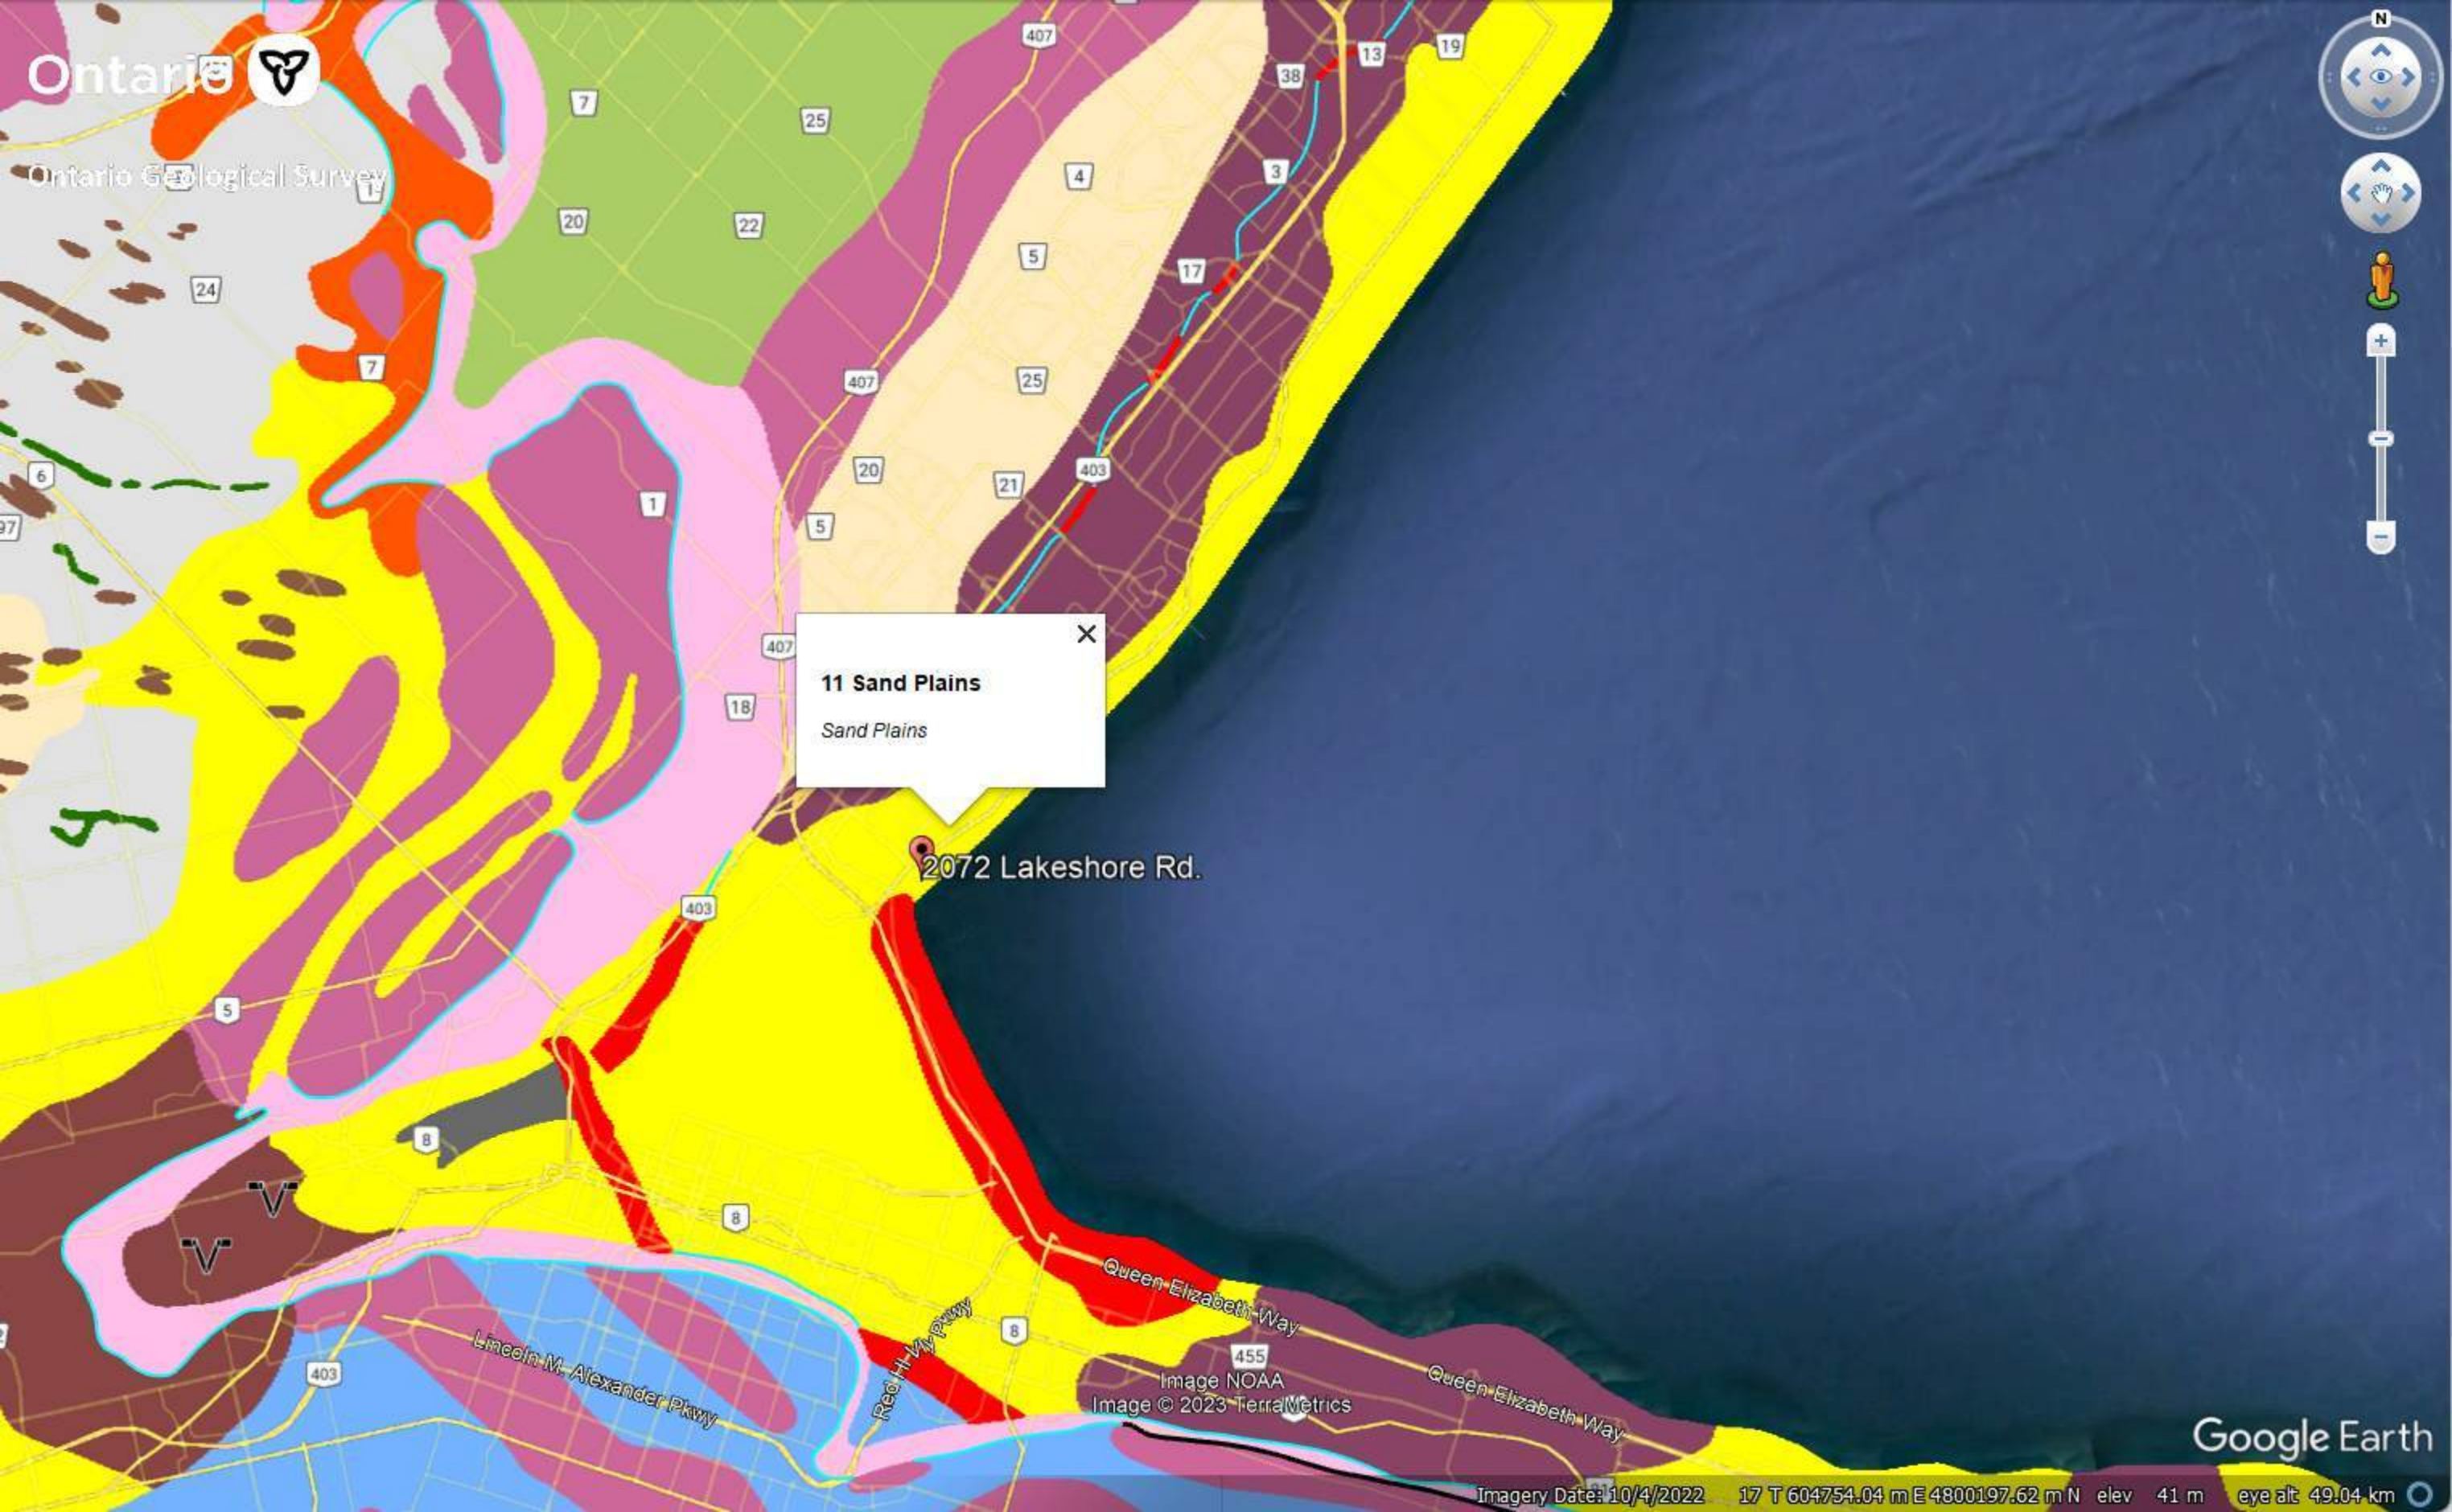
**55a**  
*Shale, limestone, dolostone,  
siltstone  
Queenston Formation*

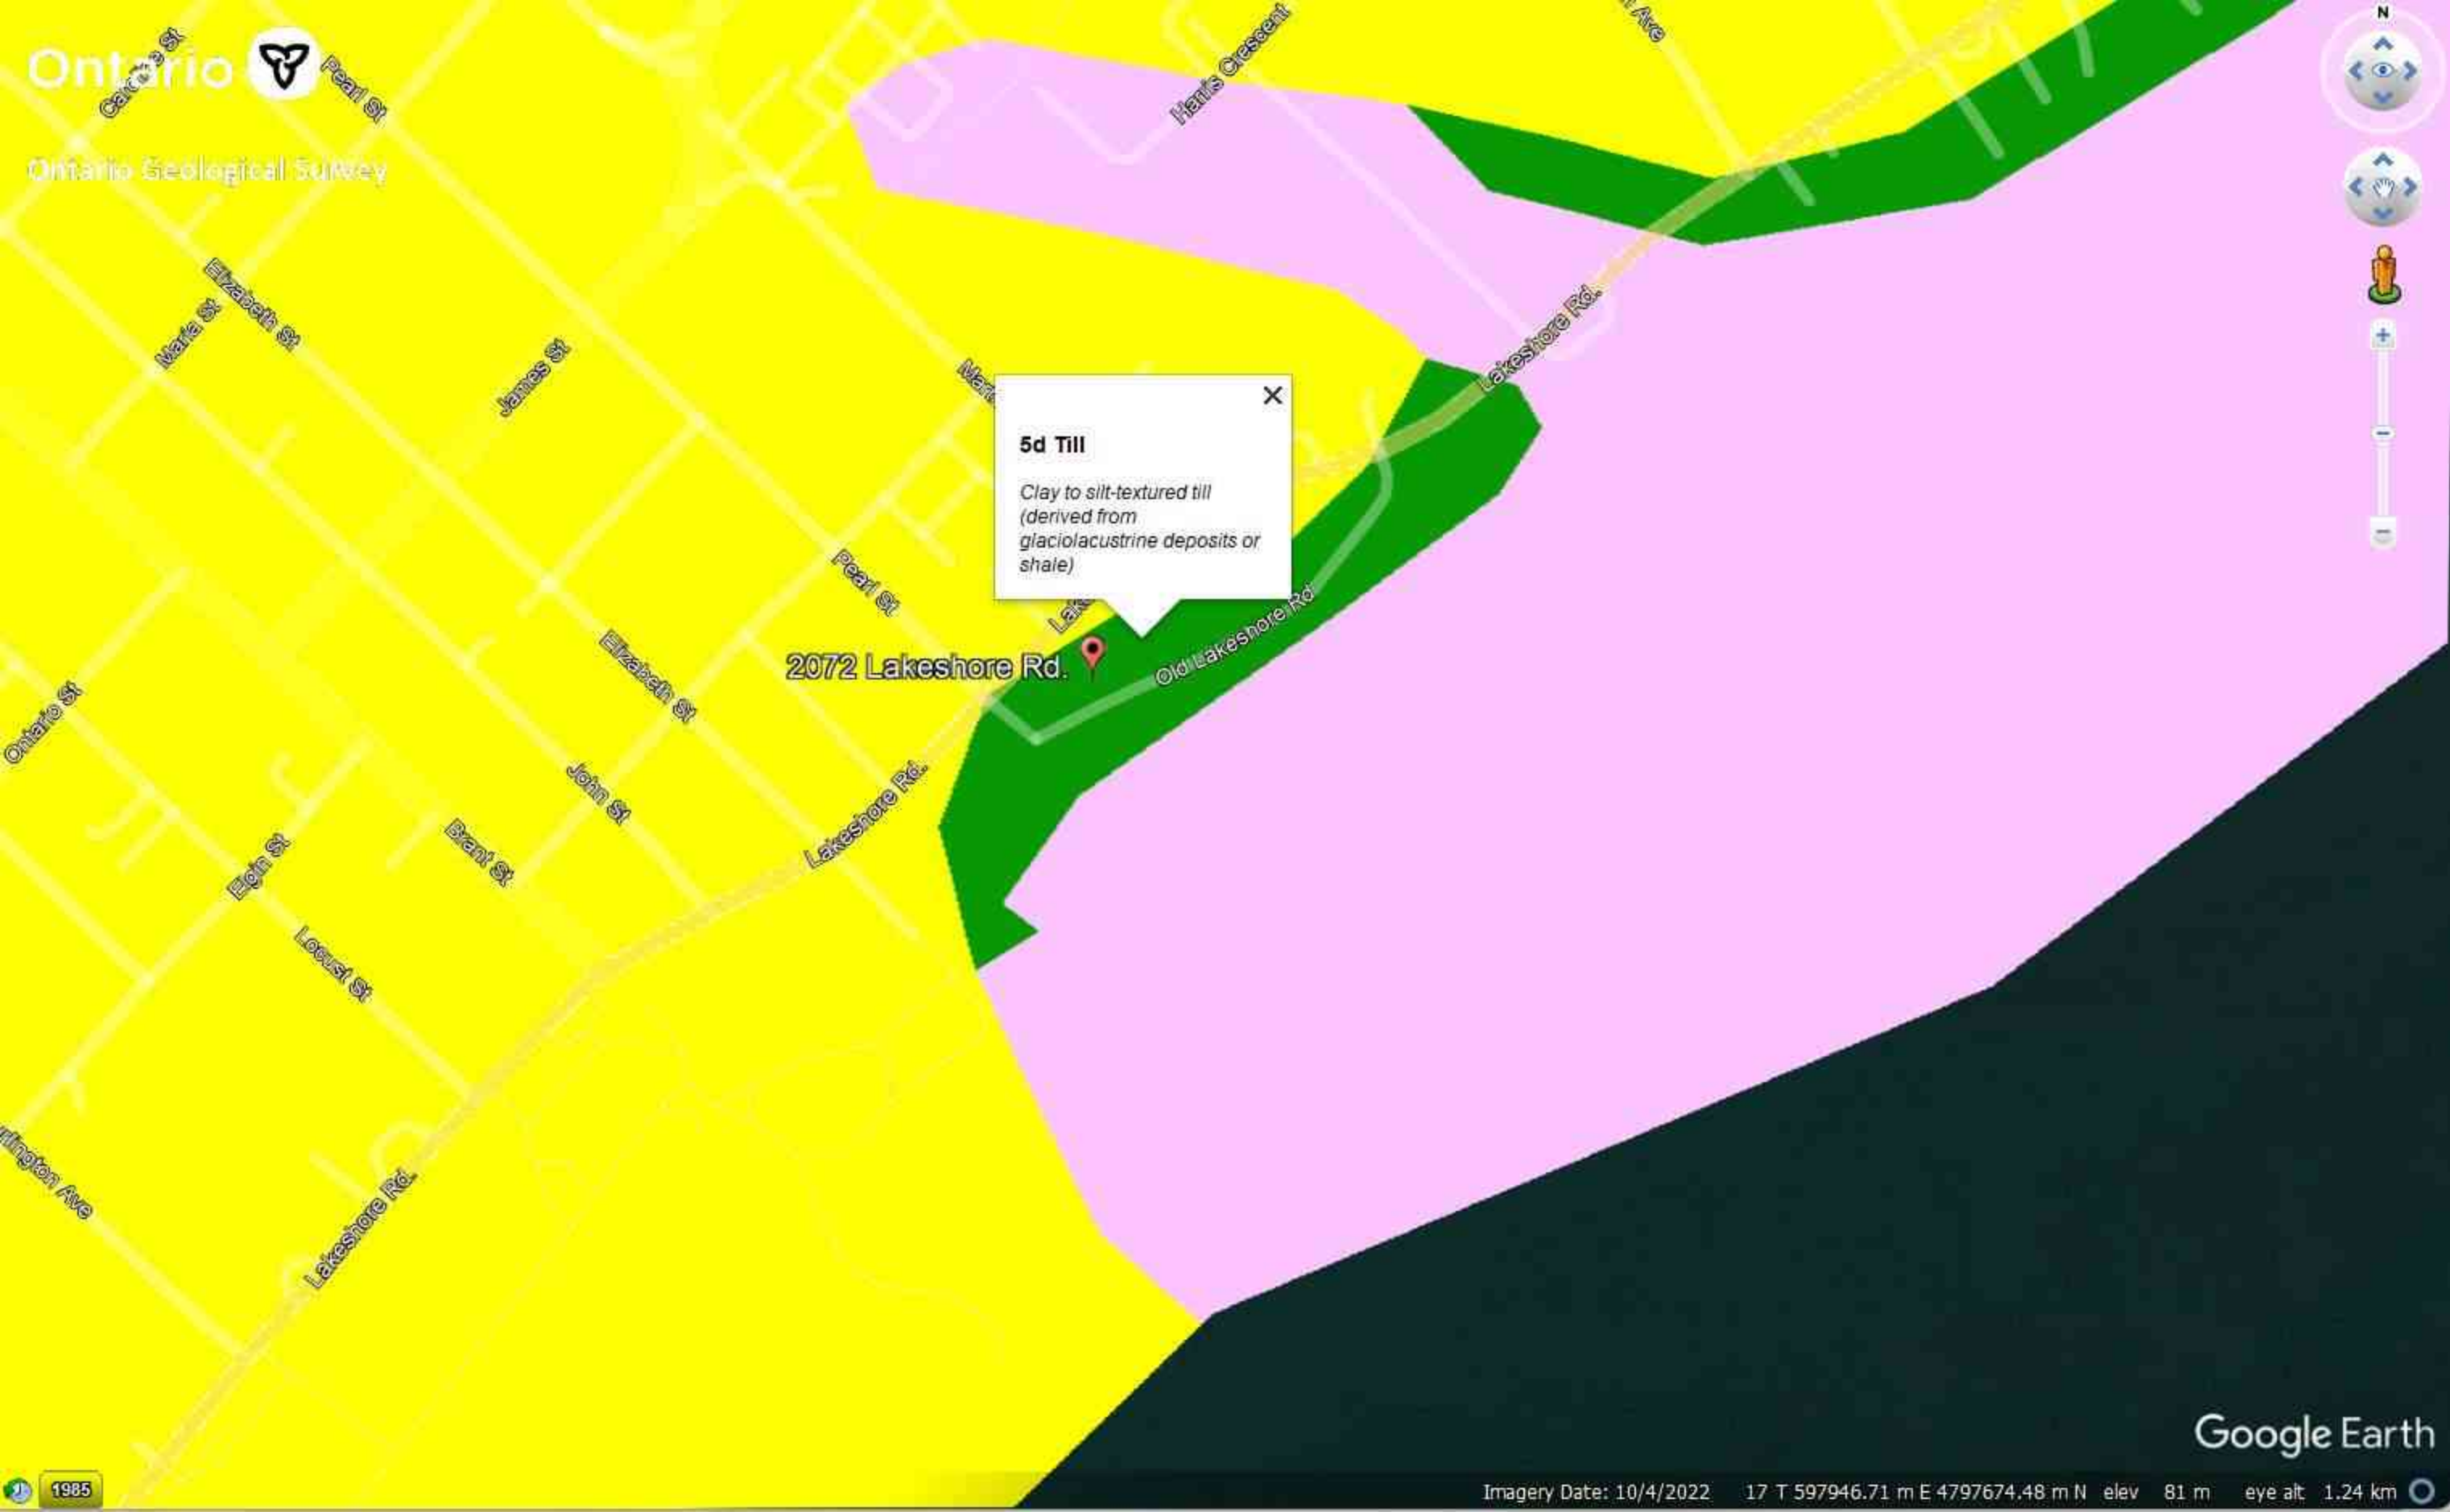
**5d Till**  
Clay to silt-textured till  
(derived from  
glaciolacustrine deposits or  
shale)

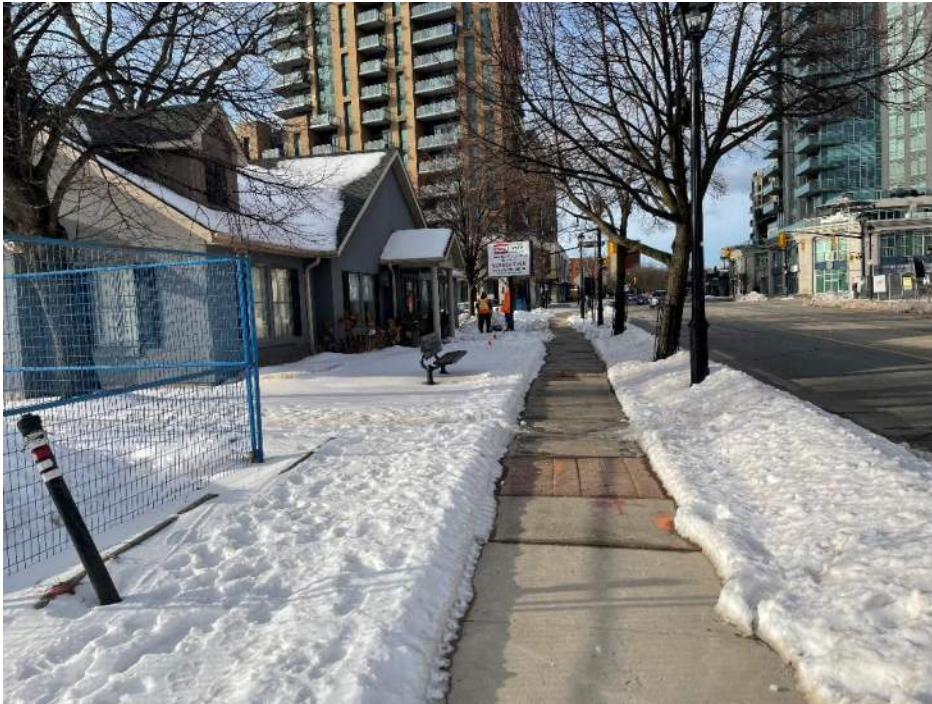
**Photograph 1**

Location: Lakeshore Road

Direction: West

Description: Viewing the north side of the Property.

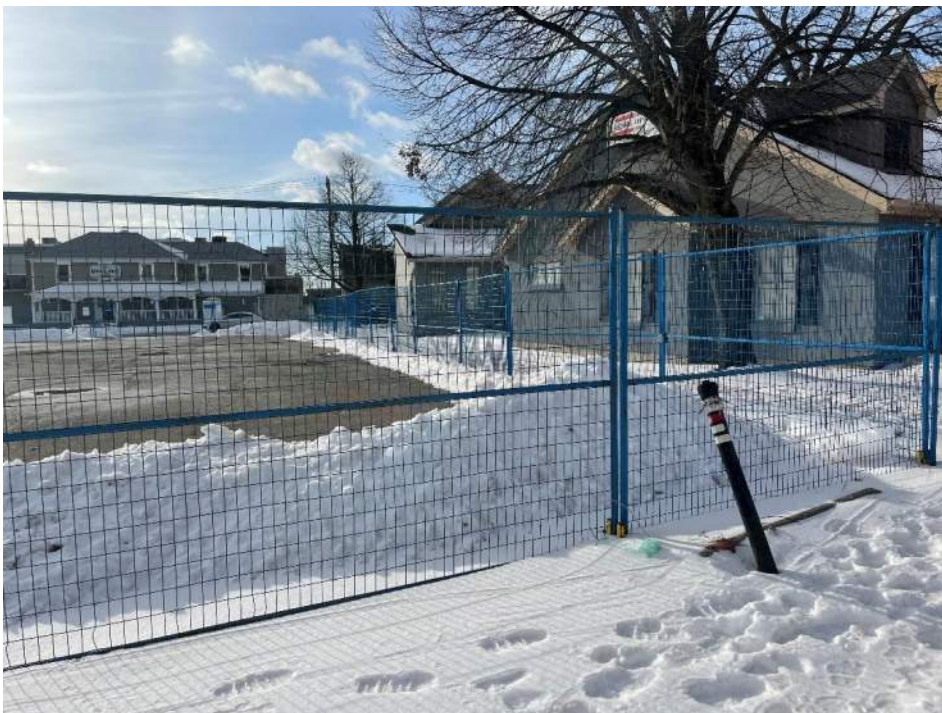
**Photograph 2**

Location: Lakeshore Road

Direction: Southwest

Description: Viewing the east portion the building on the Property.

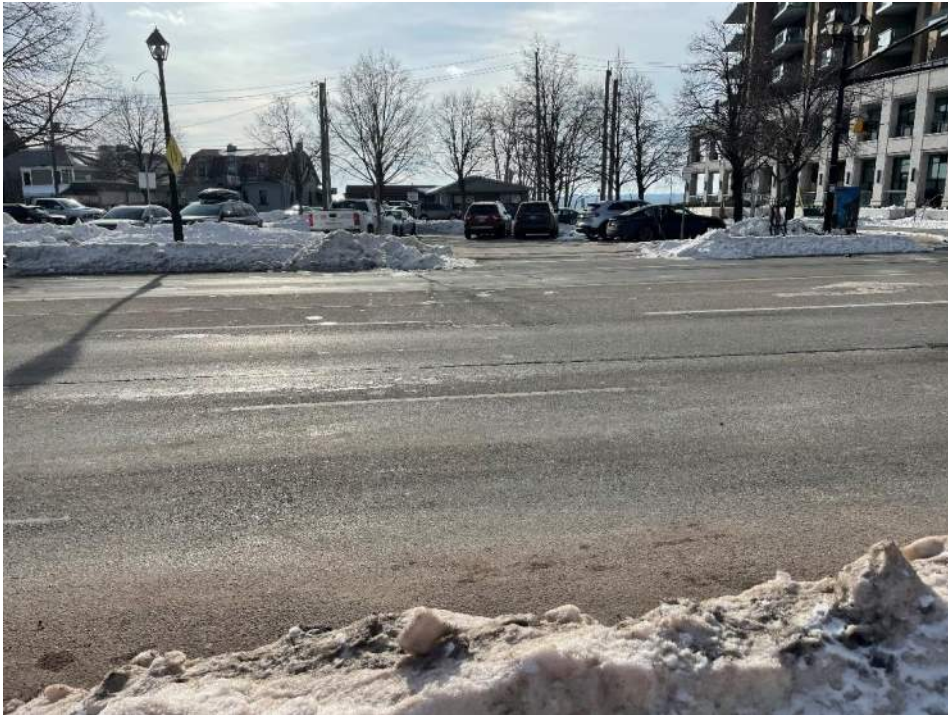
**Photograph 3**

Location: 2069 Lakeshore Road

Direction: South

Description: Viewing the parking lot on the western portion of the Property.

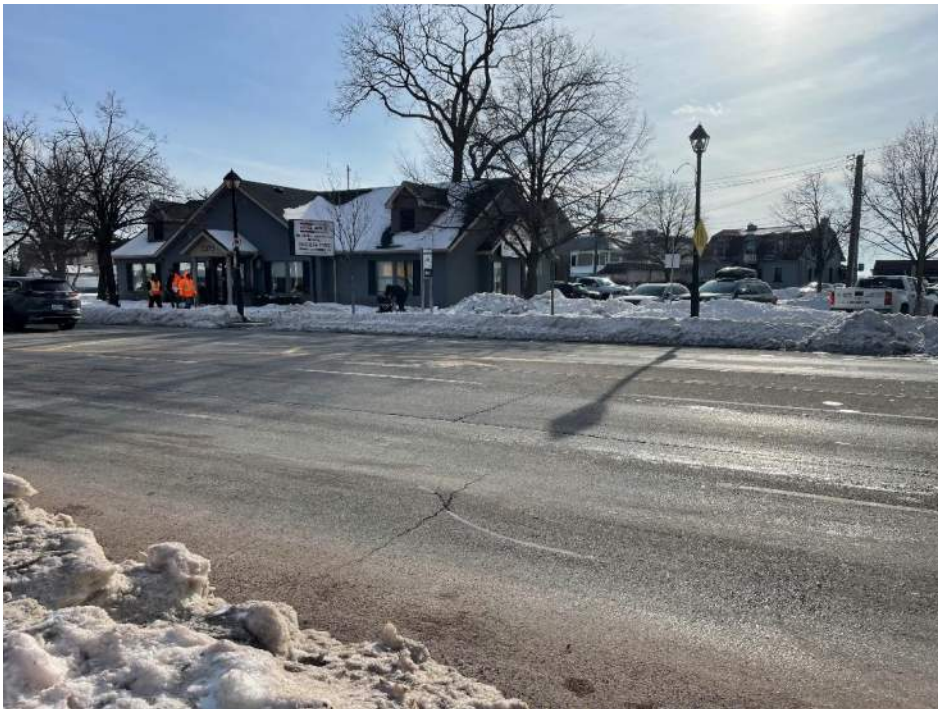
**Photograph 4**

Location: 2069 Lakeshore Road

Direction: Southeast

Description: Exterior of 2072 Lakeshore Road, an office building.

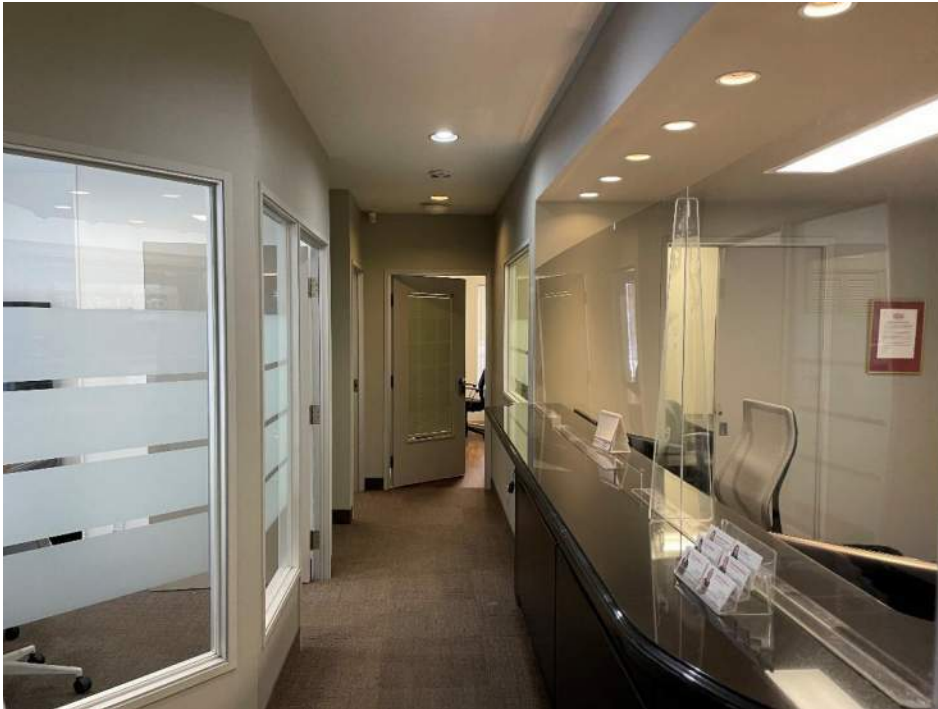
**Photograph 5**

Location: Phase One Property

Direction: North

Description: Interior of 2072 Lakeshore Road, an office building.

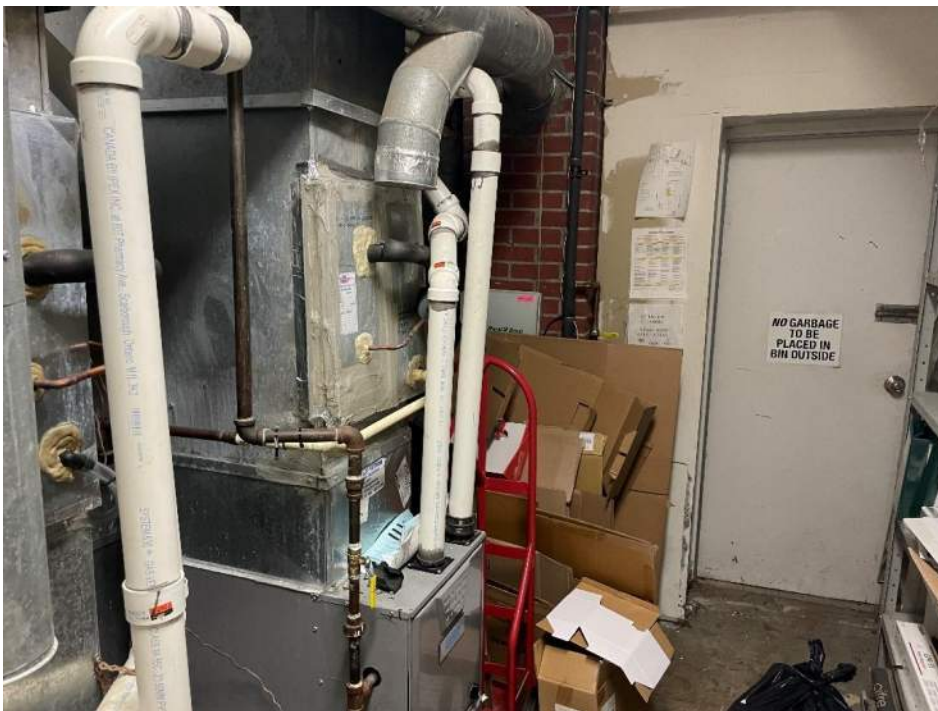
**Photograph 6**

Location: Phase One Property

Direction: West

Description: Interior of 2072 Lakeshore Road, an office building.
