# PHASE ONE ENVIRONMENTAL SITE ASSESSMENT

Trinity Point  
8700 Dufferin Street  
Vaughan, Ontario

**2072 Lakeshore Road | Burlington,  
Ontario**

**File No.** 22-282 Rev 2

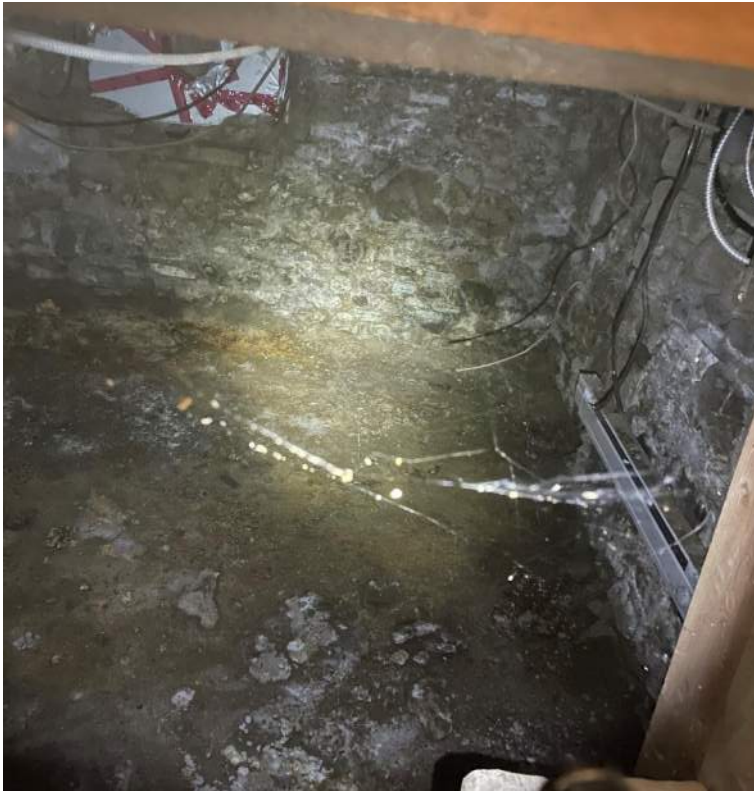
**Photograph 7**

Location: Phase One Property

Direction: West

Description: View of the crawl space under the building.

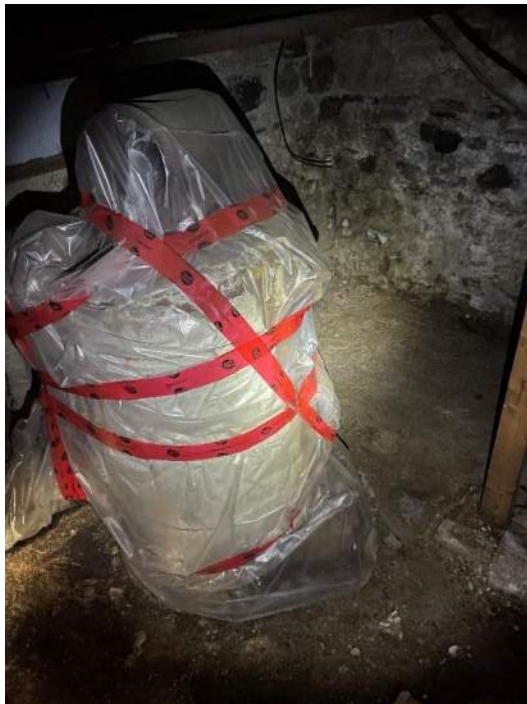
**Photograph 8**

One (1) above ground storage tank (AST) was observed on the Property within the crawlspace under the building. The tank was not in use and wrapped in plastic. No odors or staining were observed in the crawlspace. Grounded is of the opinion that this is a decommissioned storage tank, the use of which is unknown, and is not considered a PCA.

Location: Phase One Property

Description: View of the possible decommissioned tank in the crawl space under the building.
