418 & 422 Guelph Line, Burlington, Ontario

Phase One Environmental Site Assessment

HAM-00801683-A0

2019-10-03

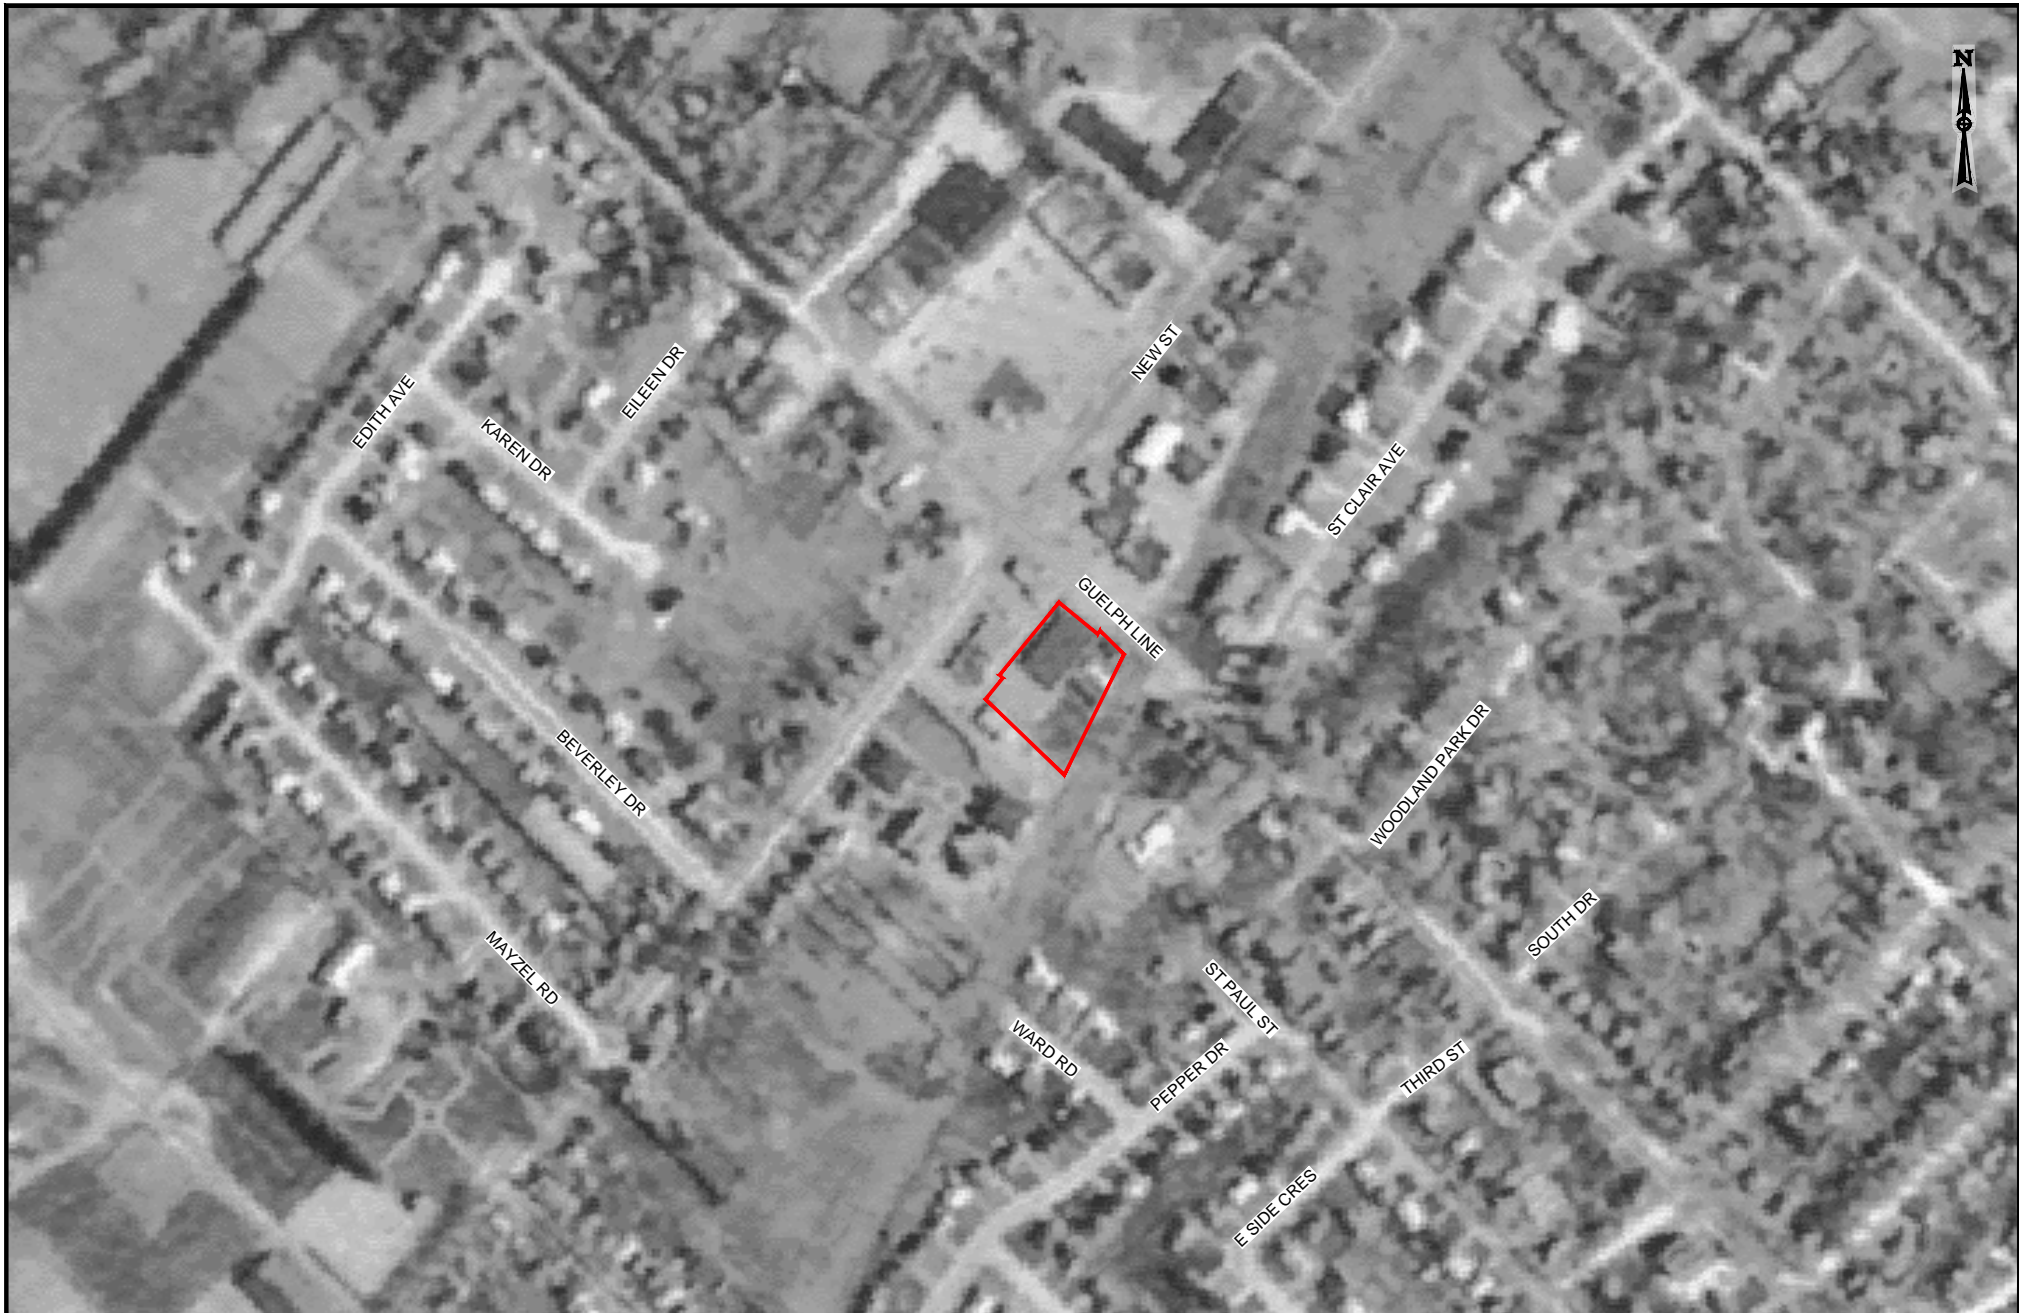
<div>• BUILDINGS • EARTH & ENVIRONMENT • ENERGY • • INDUSTRIAL • INFRASTRUCTURE • SUSTAINABILITY •</div></div>	<div>LEGEND: <div><div></div> APPROXIMATE SITE BOUNDARY</div><div>SCALE 40 20 0 40 80 120 160 200 m</div></div>	<div>TITLE AND LOCATION: 1961 AERIAL PHOTOGRAPH PHASE ONE ESA 418 AND 422 GUELPH LINE, BURLINGTON, ONTARIO</div>		PROJECT NO.:	DWN.:
				HAM-00801683-A0	LE
				SCALE:	CK:
				AS NOTED	SH
				DATE:	FIG. NO.:
				MAY 2019	H-3

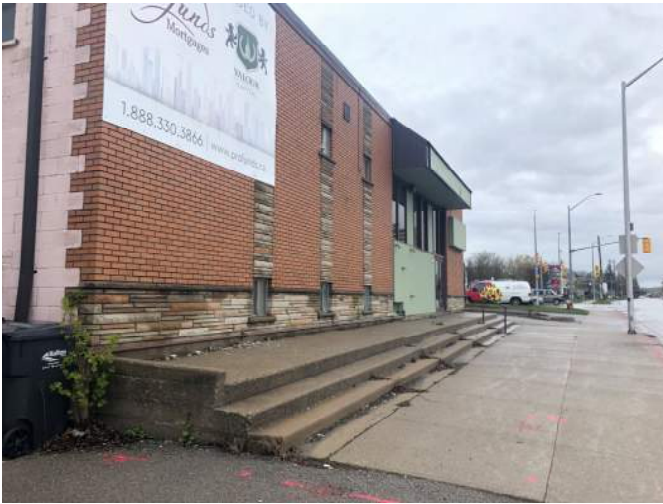
Photo 1: View of the Site building located at 422 Guelph Line. Photograph taken facing northwest.

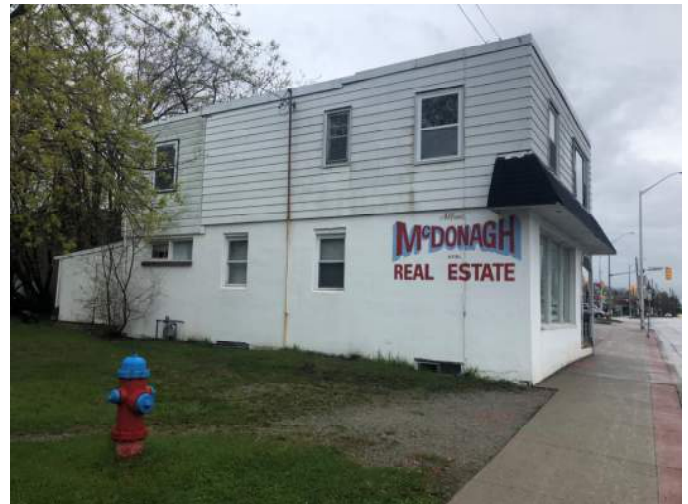
Photo 2: View of the Site building located at 418 Guelph Line. Photograph taken facing northwest.

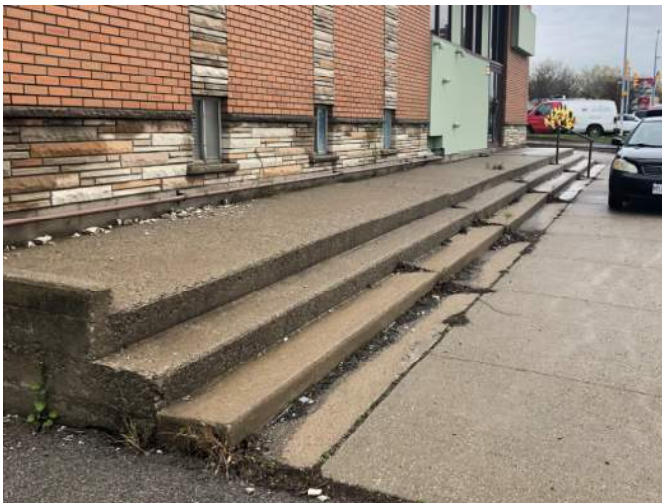
Photo 3: View of the front steps at 422 Guelph Line and reported location of existing UST (Note: these steps are located off-Site).

- A furnace oil UST was noted to exist beneath the steps north adjacent to the Site building addressed as 422 Guelph Line. Fill and vent pipes to the UST were observed in the northeast portion of the basement. Mapping resources indicated the UST appeared to be situated off-Site.

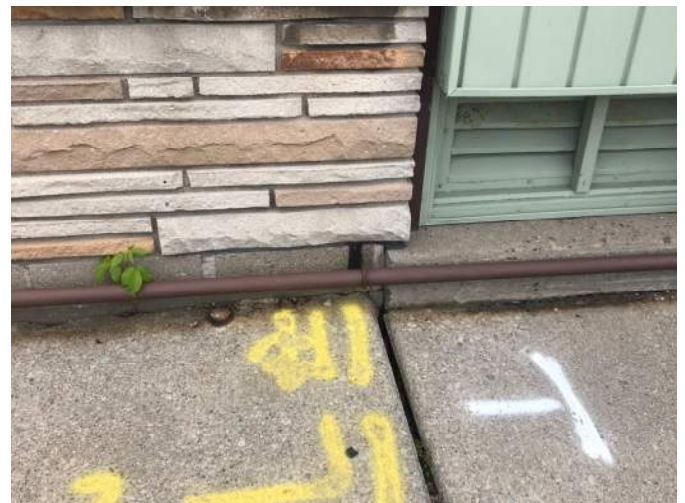
Photo 4: View of the vent/ fill pipes reportedly connected to the exterior UST.

- The Site building addressed as 422 Guelph Line was noted to be heated with oil, and as such, an oil tank is likely to be associated with the fuel source. Vent and fill pipes were observed in the northeast portion of the basement. This aspect is associated with PCA#28- Gasoline and Associated Products Storage in Fixed Tanks.

However, based on the previous reports the building was historically heated using fuel oil that was stored in a UST northeast adjacent to the Site building (off-Site). Pipes connecting to the UST were observed in the basement of the Site building. This aspect is associated with PCA#28- Gasoline and Associated Products Storage in Fixed Tanks.

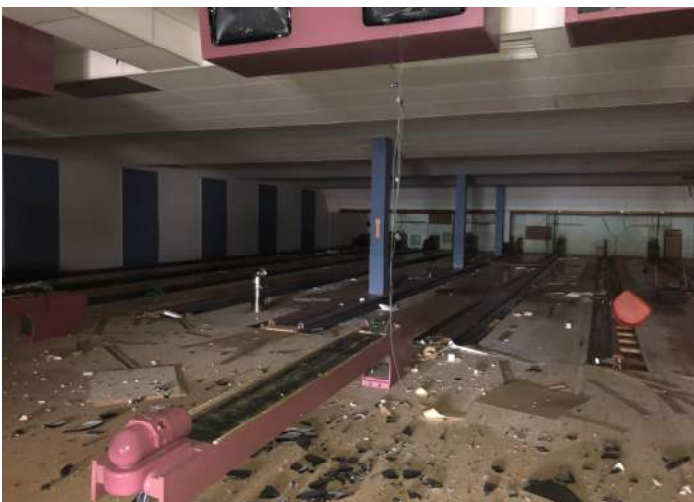
Photo 5: View of the main bowling area at 422 Guelph Line.

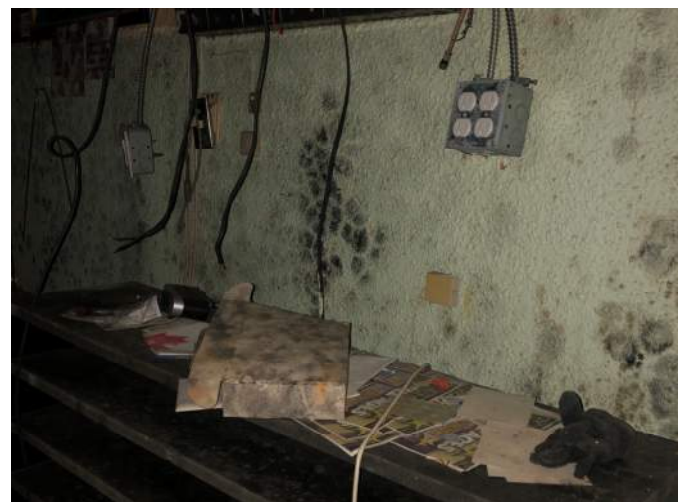
Photo 6: View of the black mould observed in the basement of 422 Guelph line.

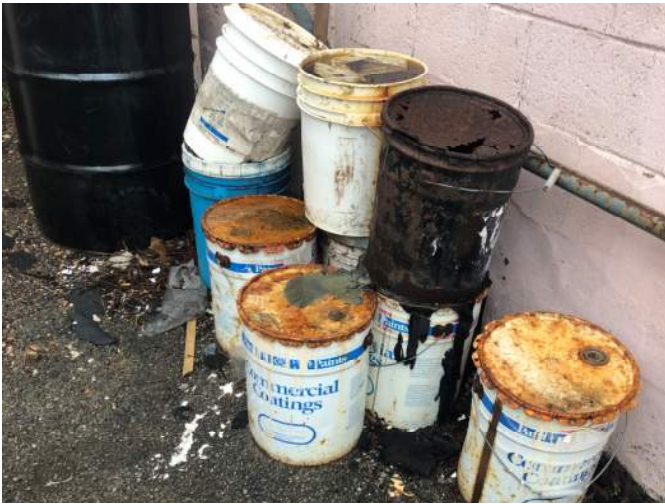
Photo 7: View of the storage pails observed on the southeast exterior portion of 422 Guelph Line.

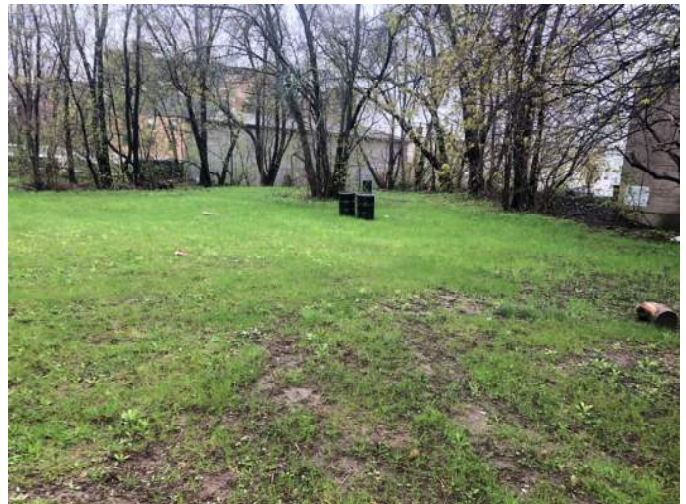
Photo 8: View of the south-western portion of the Site. Photograph taken behind the Site building at 418 Guelph Line, facing south.

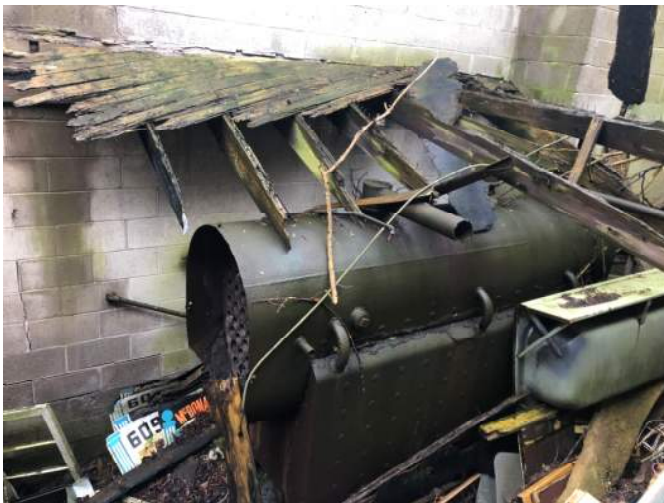
Photo 9: View of the large AST observed in the concrete structure west adjoining to the Site building at 418 Guelph Line.

- The property addressed as 3001 New Street was listed as gasoline service station from 1992 to 1998 (addressed as 457 Guelph Line).
- An AST used for furnace oil was observed on the Site addressed as 418 Guelph Line in a structure adjoined to the garage. According to the Site representative, furnace oil was formerly used to heat the residence.

In addition, a single-vehicle garage was observed north adjoining to the residential structure, as well as a concrete structure observed west adjoining to the garage. The structure appeared to be in a poor condition, with the roof and second floor collapsed. Through a window of the structure, debris was observed covering the entire floor. A large boiler was partially observed within the structure. According to the Site representative, the fuel source was formerly oil or diesel for heating the residential structure, and as such; an AST is likely to have been situated in the vicinity of the boiler. The former presence of an AST is associated with PCA#28- Gasoline and Associated Products Storage in Fixed Tanks.

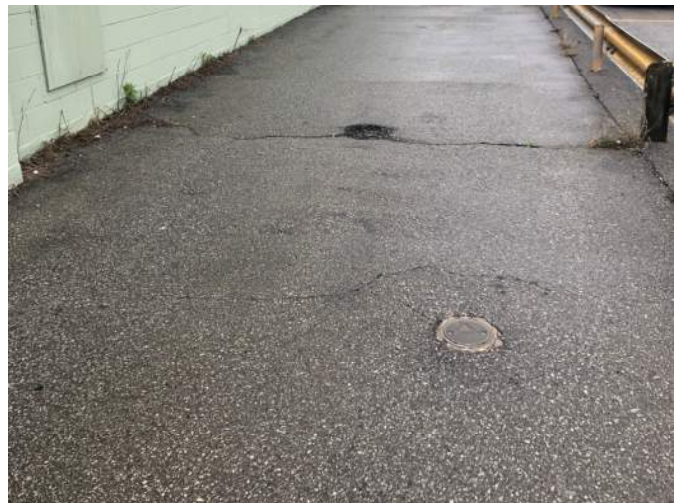
Photo 10: View of the one of the observation monitoring wells observed on the Site.

Several monitoring wells that had been installed during previous environmental investigations (see Section 3.1.5) were observed at the time of the Site visit (see Figure 3). The wells were observed to be in good condition.

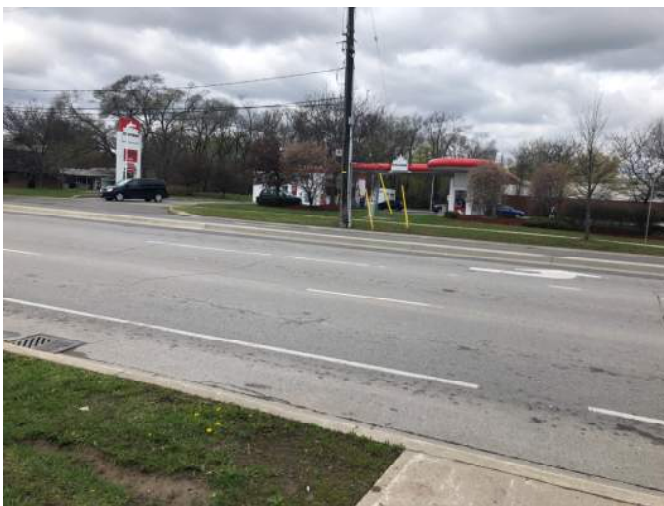
Photo 11: View of the gas service station located at 458 Guelph Line (60 m north of the Site).

- The property at 458 Guelph Line (formerly 2439 New Street) was occupied by Kirby BP Service Station, Petro Canada, and Suncore Energy Products and TSSA had records of three (3) active USTs. Gasoline was noted to have leaked from a UST and was identified in a borehole. At the time of the 2017 Site visit, this property remained occupied by Petro Canada. This property is associated with PCA#28 – Gasoline and Associated products in fixed tanks.
