**DRAFT  
REPORT ON  
PHASE ONE ENVIRONMENTAL SITE ASSESSMENT  
2477 QUEENSWAY DRIVE  
BURLINGTON, ONTARIO**

**REPORT NO.: 4328-16-E-SHA-A  
REPORT DATE: MAY 19, 2016**

**PREPARED FOR  
1937570 ONTARIO INC.  
250 CONSUMER ROAD  
NORTH YORK, ONTARIO  
M5J 4V6**

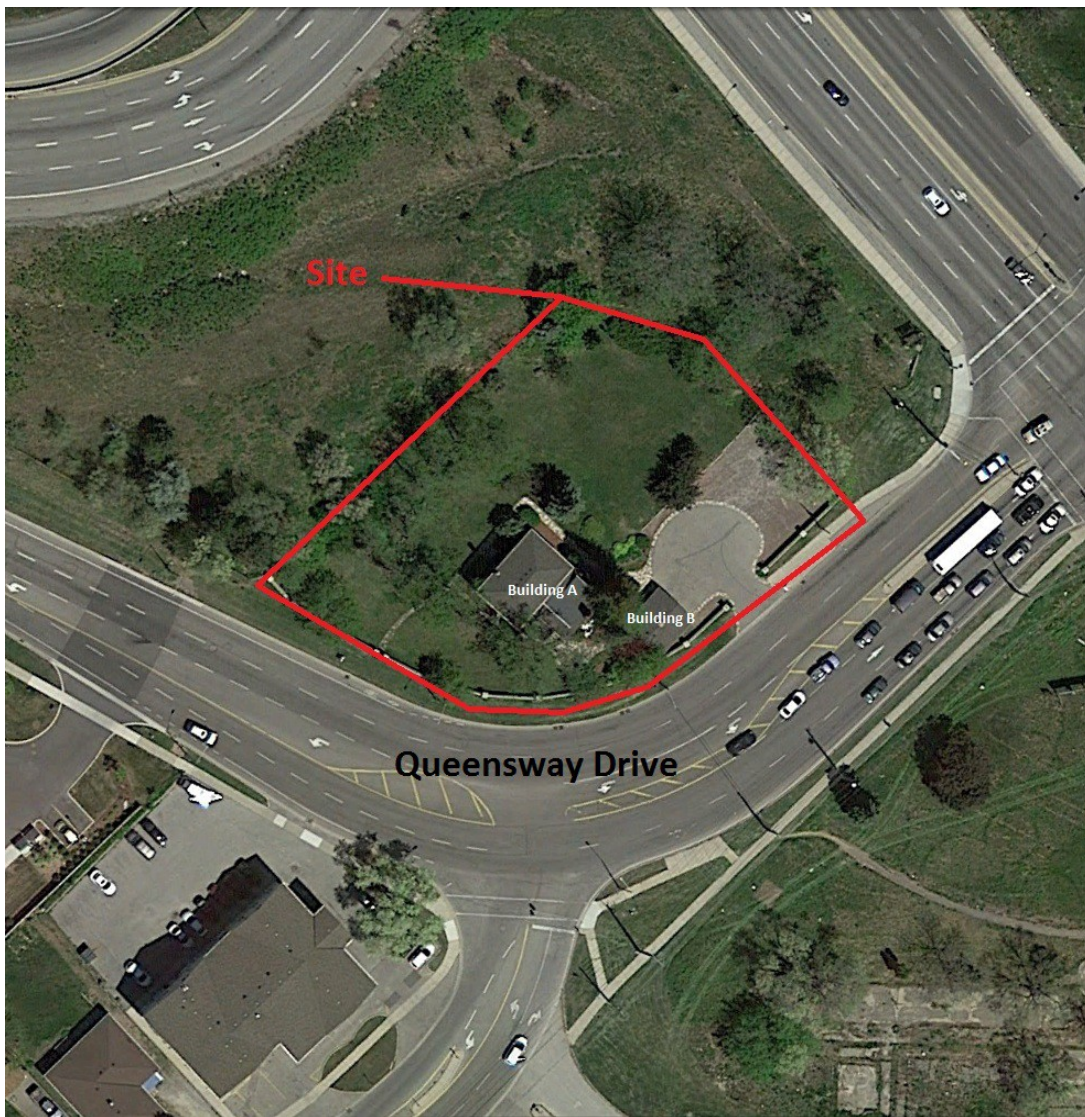
Image No. 1 : Aerial image from Google Earth

The Site is developed with a two-storey commercial building with a basement (Building A) and a single-storey commercial building (Building B). A parking area which is partially covered with asphalt and gravel is provided at the southern portion of the Site. Landscape areas are provided to the north, east, and west of the building. An aerial view of the Phase One property is presented in Image No. 1 below.
