Phase One Environmental Site Assessment

441 Maple Avenue, Burlington, Ontario

Project No. 0025-001.01
January 9, 2019

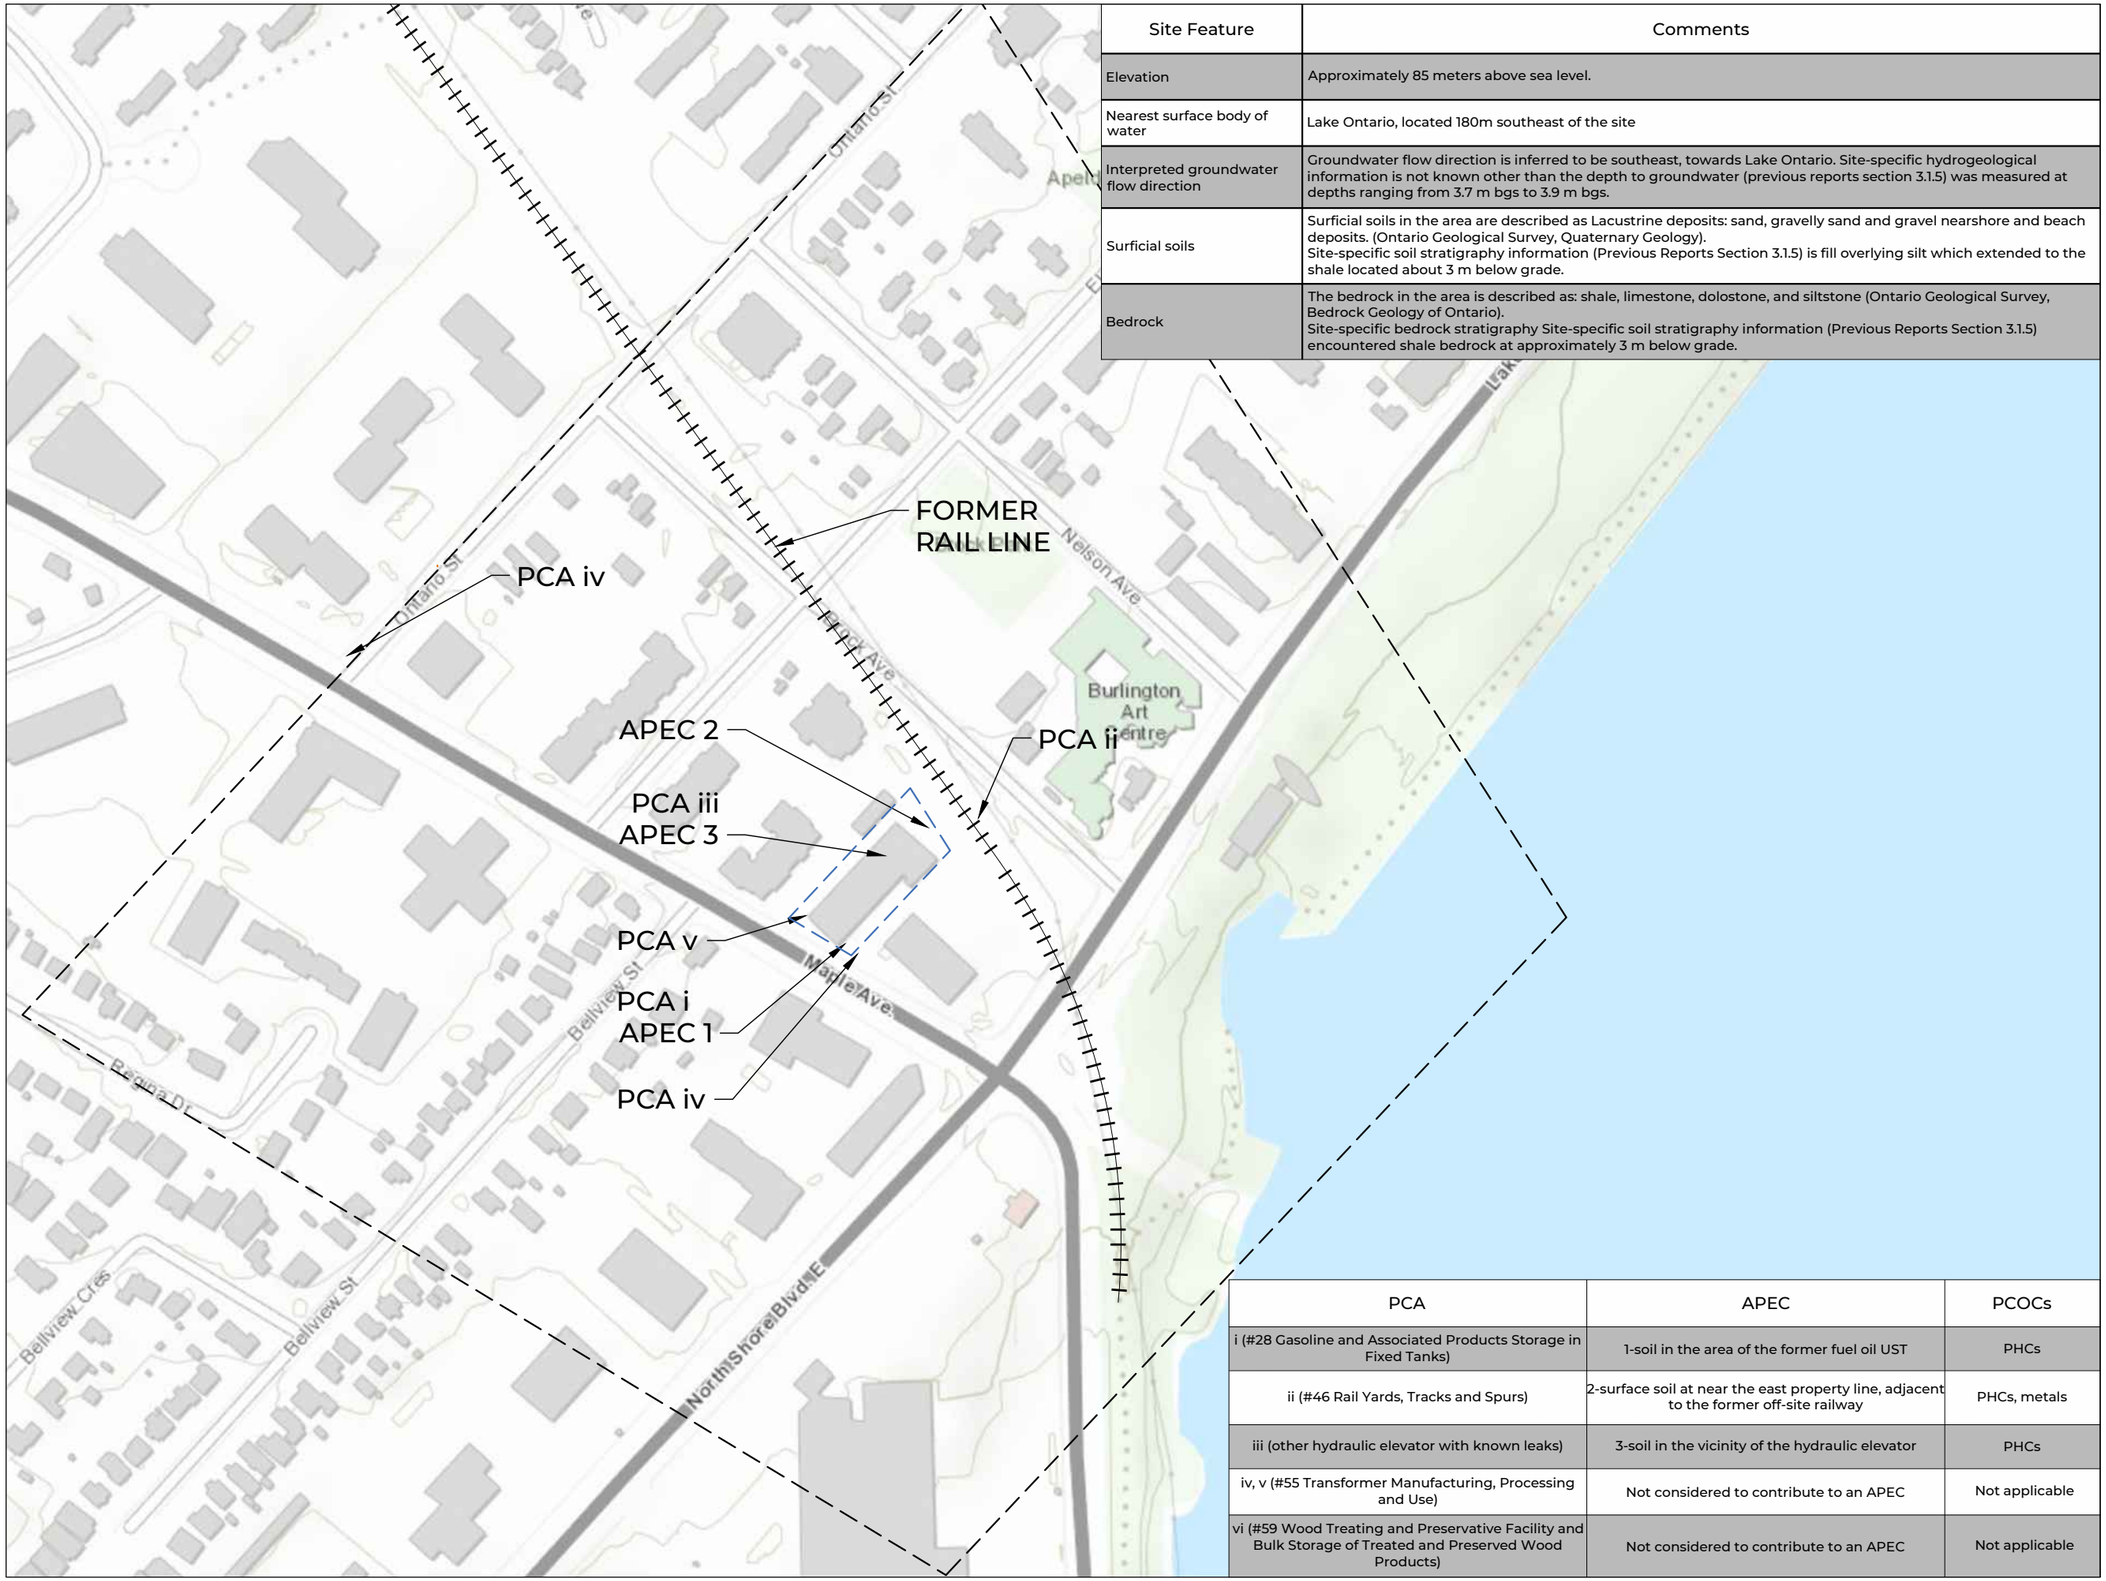
0025-001.01	January, 2019	Figure 2

Neighbouring properties were observed during the Site visit from publicly accessible locations. Current uses of properties adjacent to the Site are presented on **Figure 2**; Land uses were primarily residential.

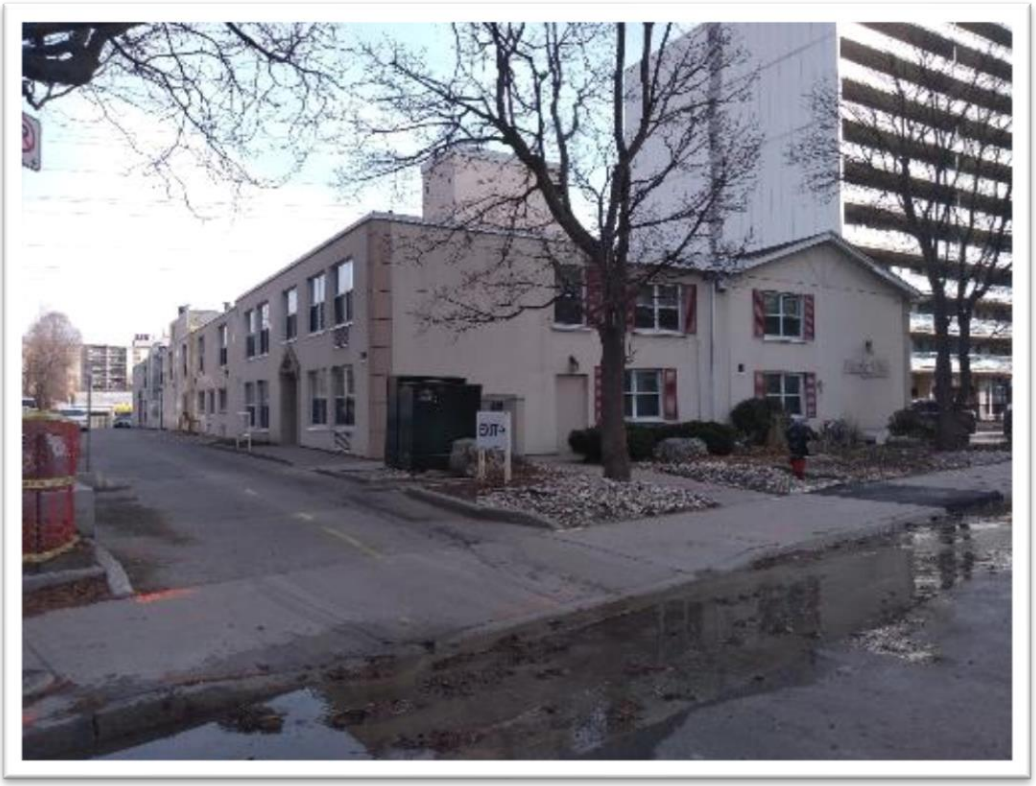
Photo 1: The Site (looking north).

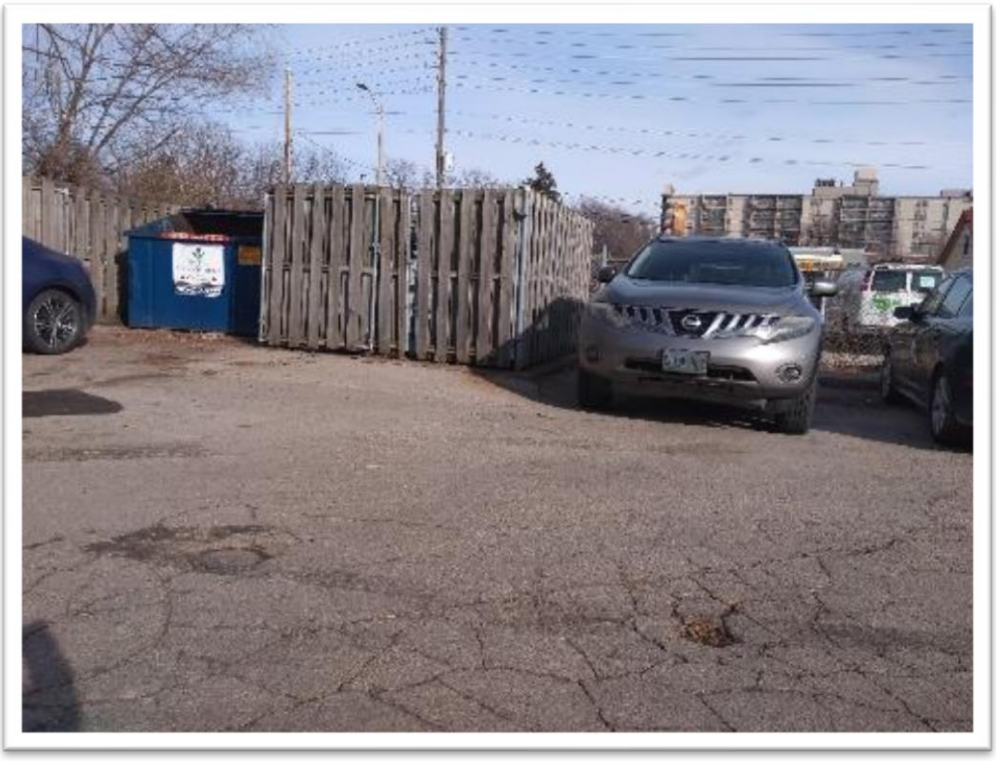
Photo 2: The Site (looking northeast).

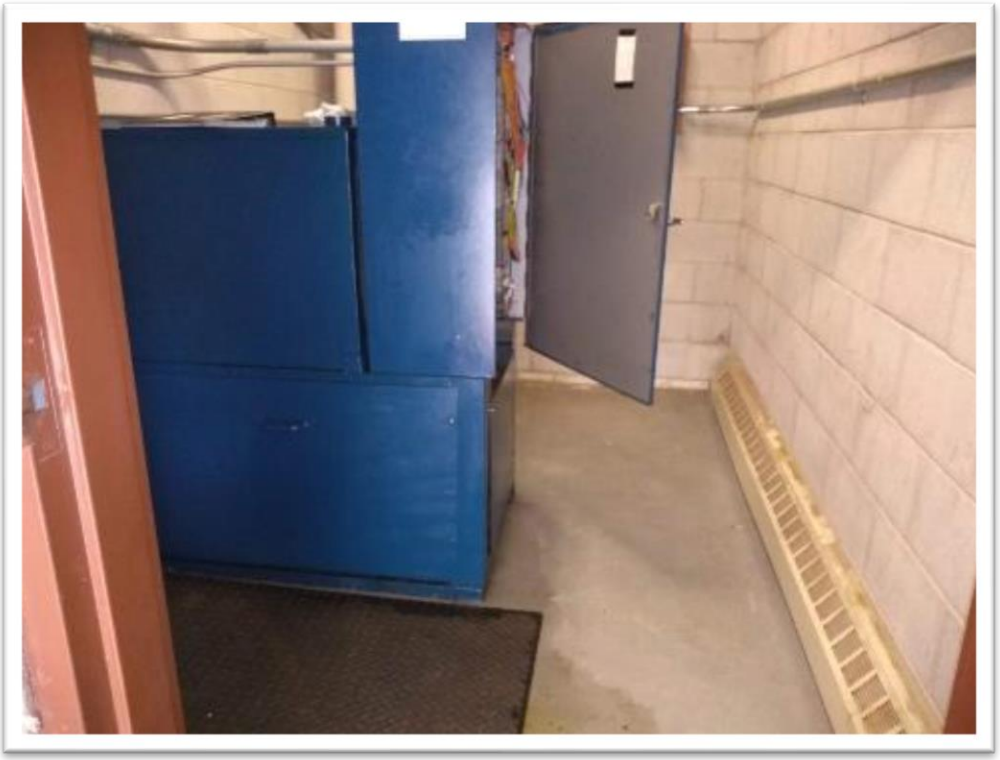
Stains or corrosions	A minor leak of hydraulic fluid in the rooftop elevator room was evident.
Drains, pits and Sumps	There were no drains or sumps other than for water; two stormwater sumps were observed in the basement.
Unidentified Substances	None observed.
Above and below ground storage tanks including evidence of fill/vent pipes	A pad mounted diesel generator was located in the rooftop utility room. A reservoir for diesel fuel was located beneath the generator and is filled by jerrycan. A vent pipe for the generator was located was located outside of the rooftop utility room.
Other	A hydraulic elevator was located at the eastern portion of the building. The hydraulic oil reservoir was located in the rooftop elevator room. The elevator was found to be leaking in 2014, and was repaired, during the Site visit, hydraulic fluid was observed adjacent to the elevator on the floor of the rooftop mechanical room.

Photo 10: Hydraulic elevator and oil spill/staining.
