PHASE ONE ENVIRONMENTAL SITE ASSESSMENT

VACANT PROPERTY 1450 KING ROAD BURLINGTON, ONTARIO

PROJECT NO.: OESAR2210
MAY 2023

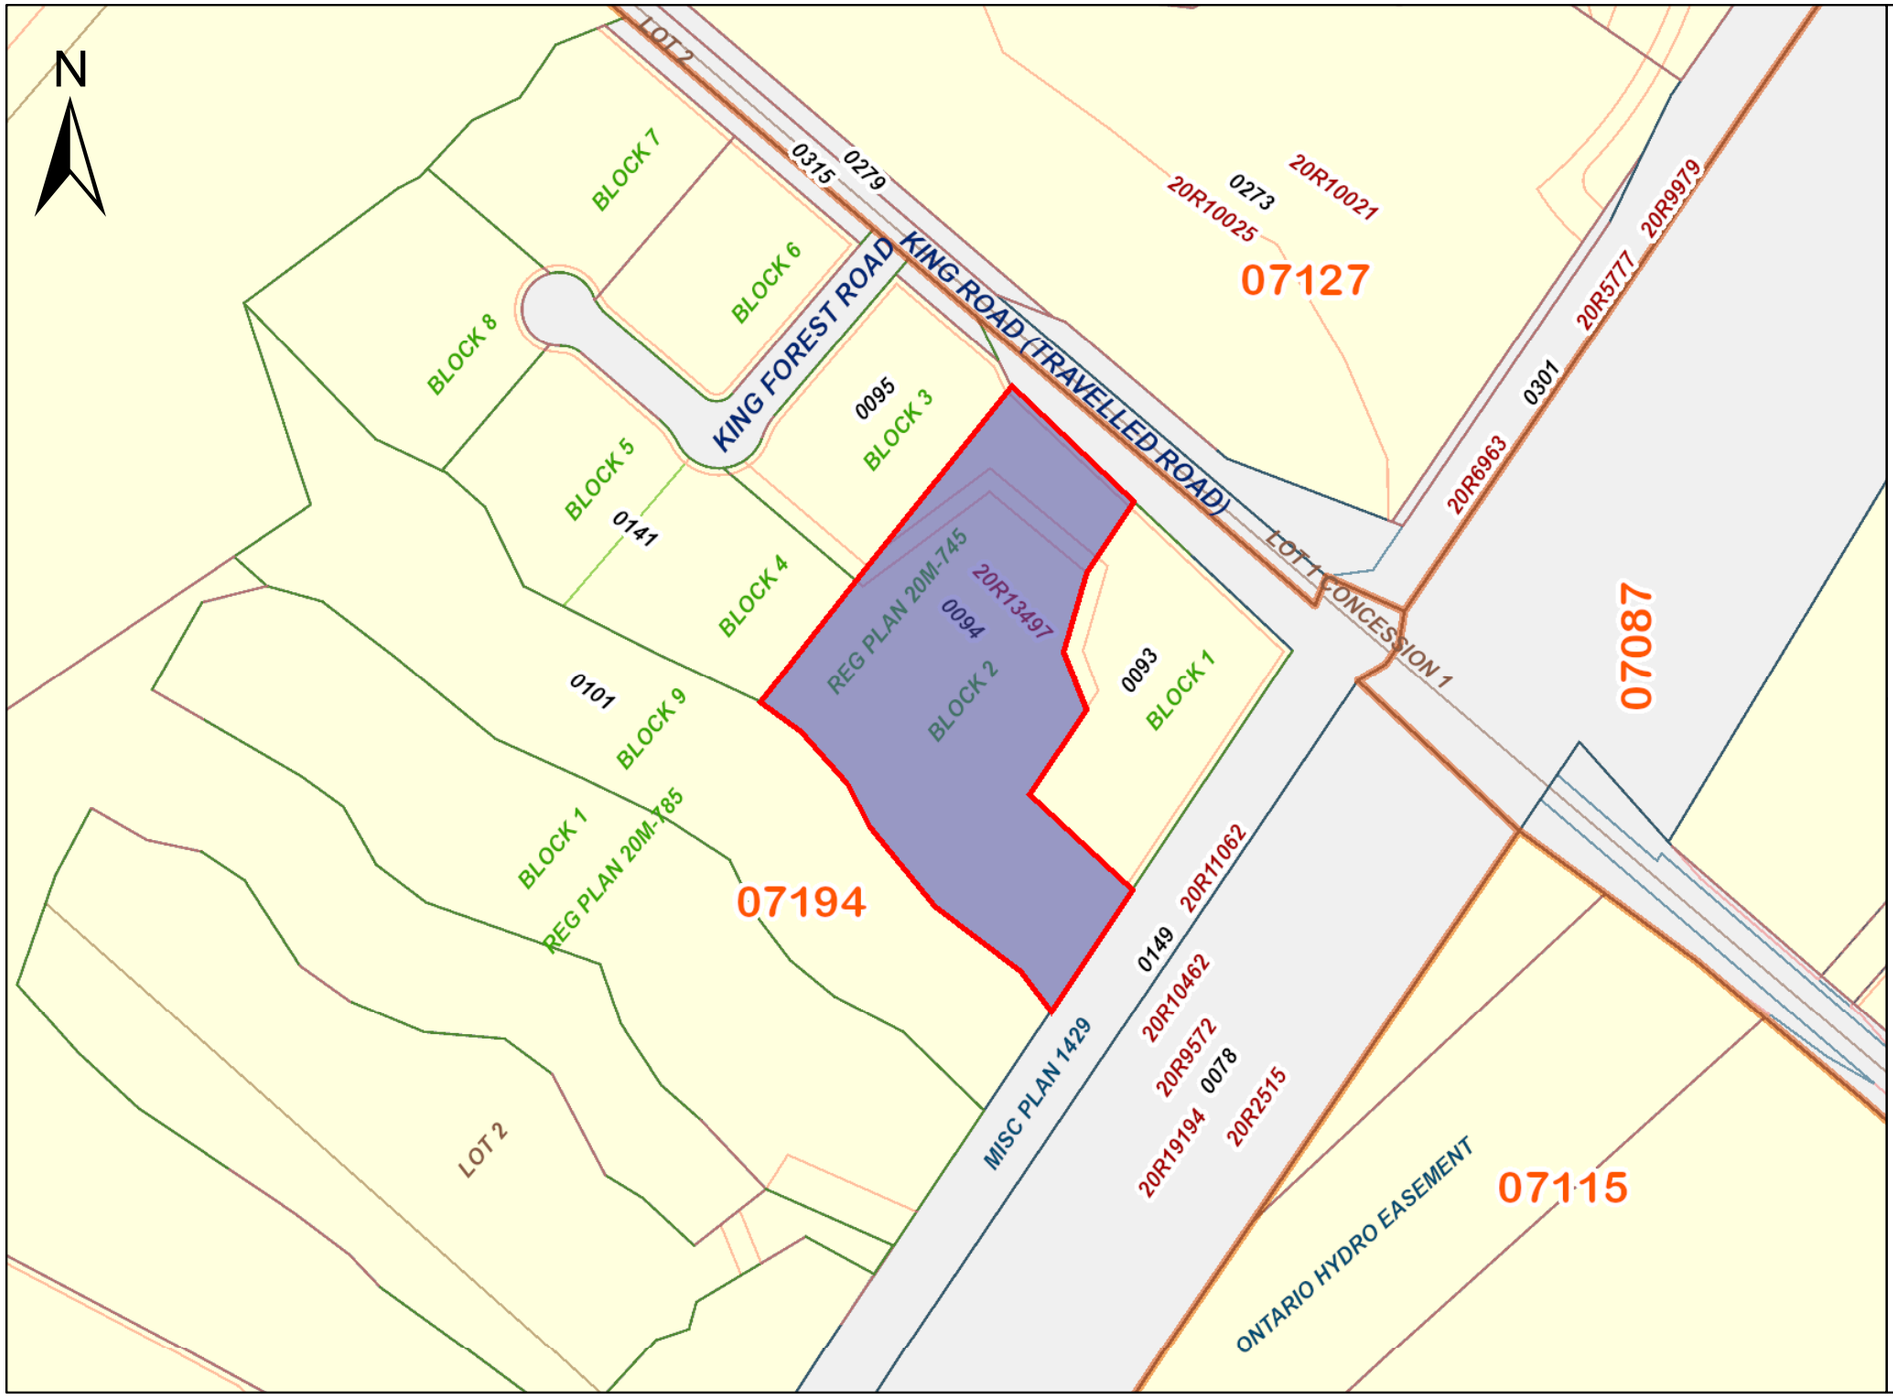
DATE: OCTOBER 2022
PROJECT NO: OESAR2210
REV. NO.: A
DRAWING No. 5

TITLE
AREAS OF POTENTIAL ENVIRONMENTAL CONCERN
