Phase One Environmental Site Assessment

Millcroft Golf Club (Block E)

Burlington, Ontario

DS Project No : 19-199-102
Date: 2020-01-30
Revised: 2020-07-02

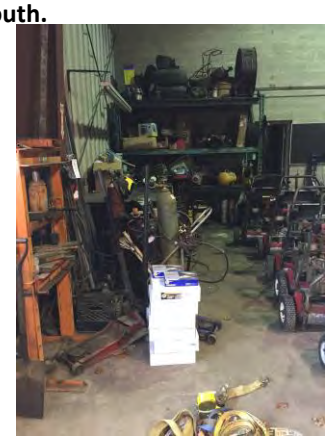
Picture 14: One (1) hydraulic hoist was observed inside, to the south end of the maintenance building, facing west.
