Phase One Environmental Site Assessment

1393 Grahams Lane

Burlington, Ontario

File No: 02211083.001

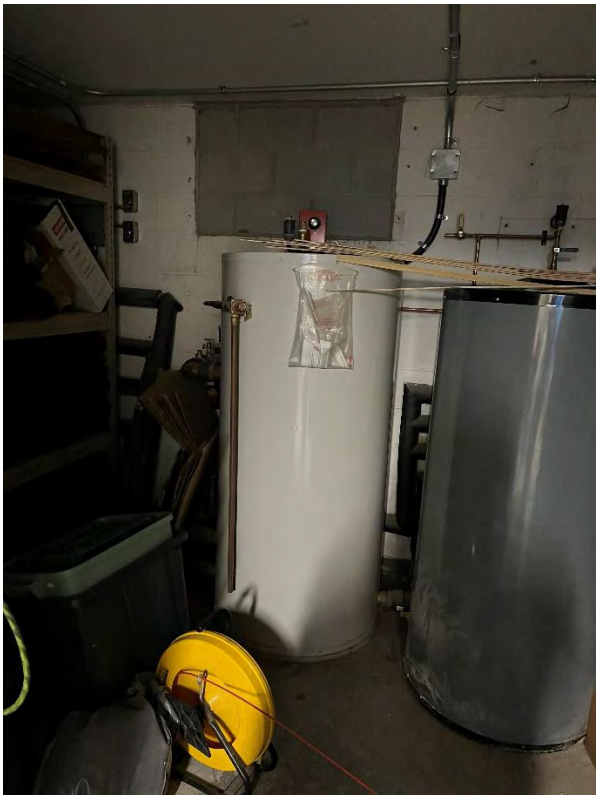
Photograph 4

Description: Storage area
