Phase One Environmental Site Assessment
441 Maple Avenue, Burlington, Ontario

Project No. 0025-001.01
October 21, 2020

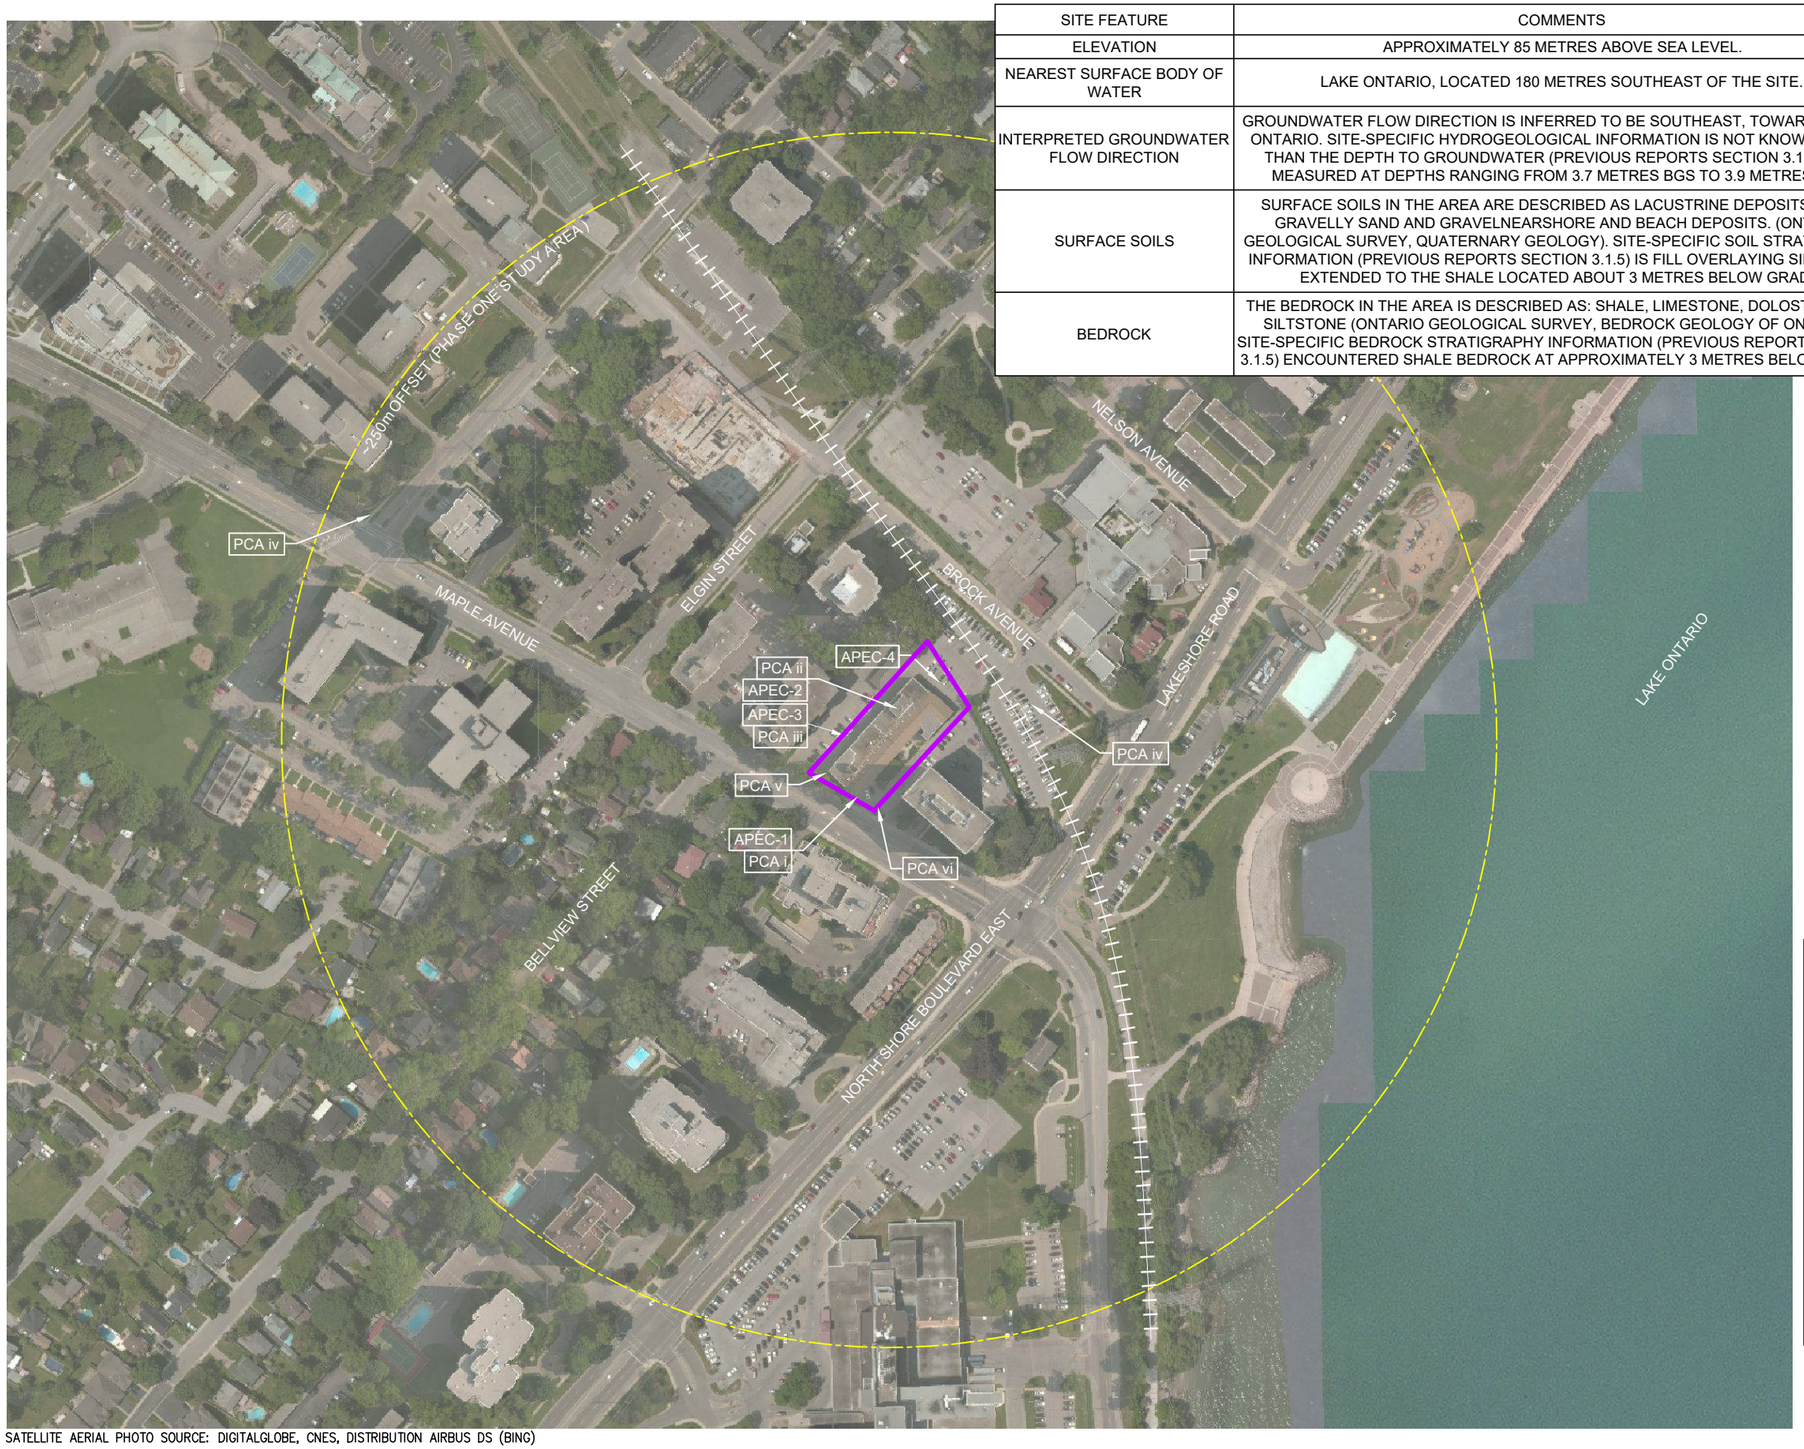
0025-001.01	OCTOBER 2020	FIGURE 2

Neighbouring properties were observed during the Site visit from publicly accessible locations. Current uses of properties adjacent to the Site are presented on **Figure 2**; Land uses were primarily residential.

SITE FEATURE	COMMENTS
ELEVATION	APPROXIMATELY 85 METRES ABOVE SEA LEVEL.
NEAREST SURFACE BODY OF WATER	LAKE ONTARIO, LOCATED 180 METRES SOUTHEAST OF THE SITE.
INTERPRETED GROUNDWATER FLOW DIRECTION	GROUNDWATER FLOW DIRECTION IS INFERRED TO BE SOUTHEAST, TOWARDS LAKE ONTARIO. SITE-SPECIFIC HYDROGEOLOGICAL INFORMATION IS NOT KNOWN OTHER THAN THE DEPTH TO GROUNDWATER (PREVIOUS REPORTS SECTION 3.1.5) WAS MEASURED AT DEPTHS RANGING FROM 3.7 METRES BGS TO 3.9 METRES BGS.
SURFACE SOILS	SURFACE SOILS IN THE AREA ARE DESCRIBED AS LACUSTRINE DEPOSITS: SAND, GRAVELLY SAND AND GRAVELNEARSHORE AND BEACH DEPOSITS. (ONTARIO GEOLOGICAL SURVEY, QUATERNARY GEOLOGY). SITE-SPECIFIC SOIL STRATIGRAPHY INFORMATION (PREVIOUS REPORTS SECTION 3.1.5) IS FILL OVERLAYING SILT WHICH EXTENDED TO THE SHALE LOCATED ABOUT 3 METRES BELOW GRADE.
BEDROCK	THE BEDROCK IN THE AREA IS DESCRIBED AS: SHALE, LIMESTONE, DOLOSTONE AND SILTSTONE (ONTARIO GEOLOGICAL SURVEY, BEDROCK GEOLOGY OF ONTARIO). SITE-SPECIFIC BEDROCK STRATIGRAPHY INFORMATION (PREVIOUS REPORTS SECTION 3.1.5) ENCOUNTERED SHALE BEDROCK AT APPROXIMATELY 3 METRES BELOW GRADE.

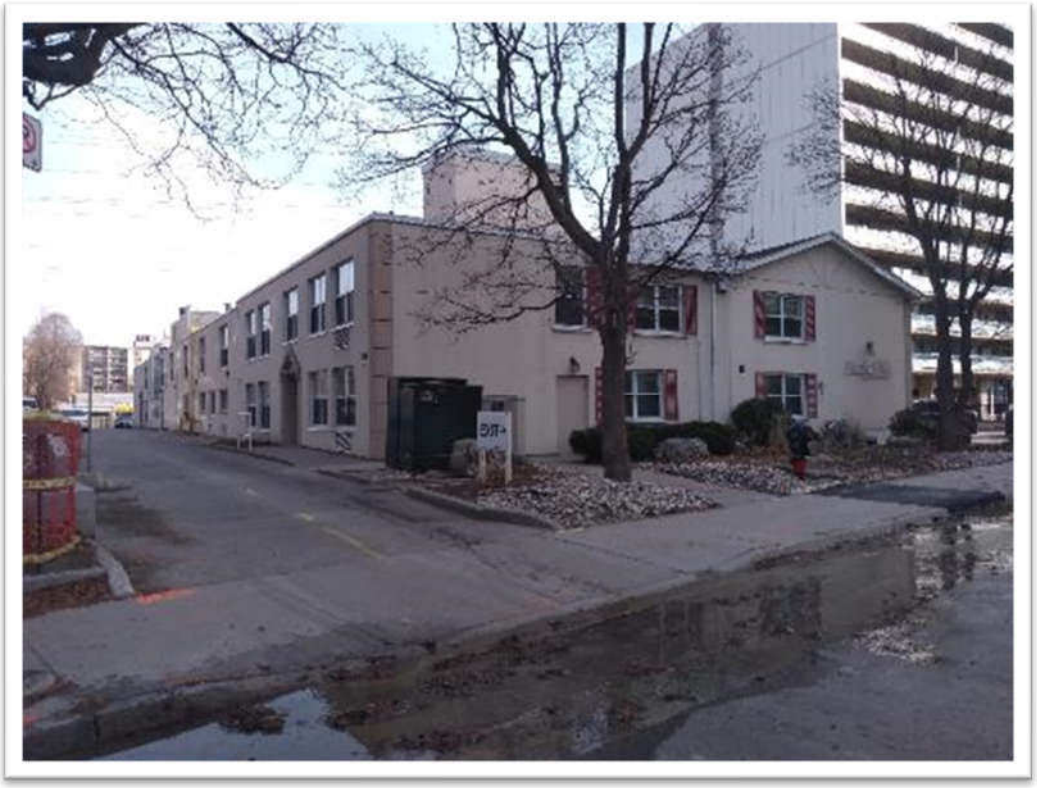
Photo 1: The Site (looking north).

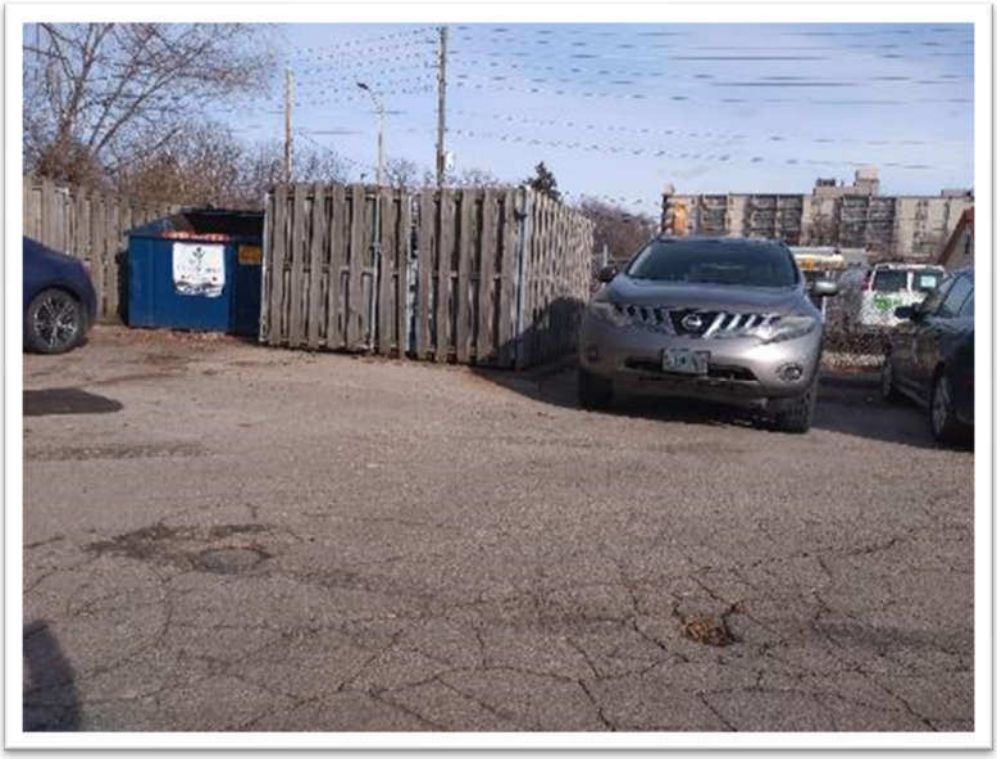
Photo 2: The Site (looking northeast).
