SOIL-MAT ENGINEERS & CONSULTANTS LTD.

PROJECT NO.: SM 177692-G September 27, 2017

SLOPE STABILITY ASSESSMENT
PROPOSED MULTI-STOREY APARTMENT BUILDING
4063 UPPER MIDDLE ROAD
BURLINGTON, ONTARIO

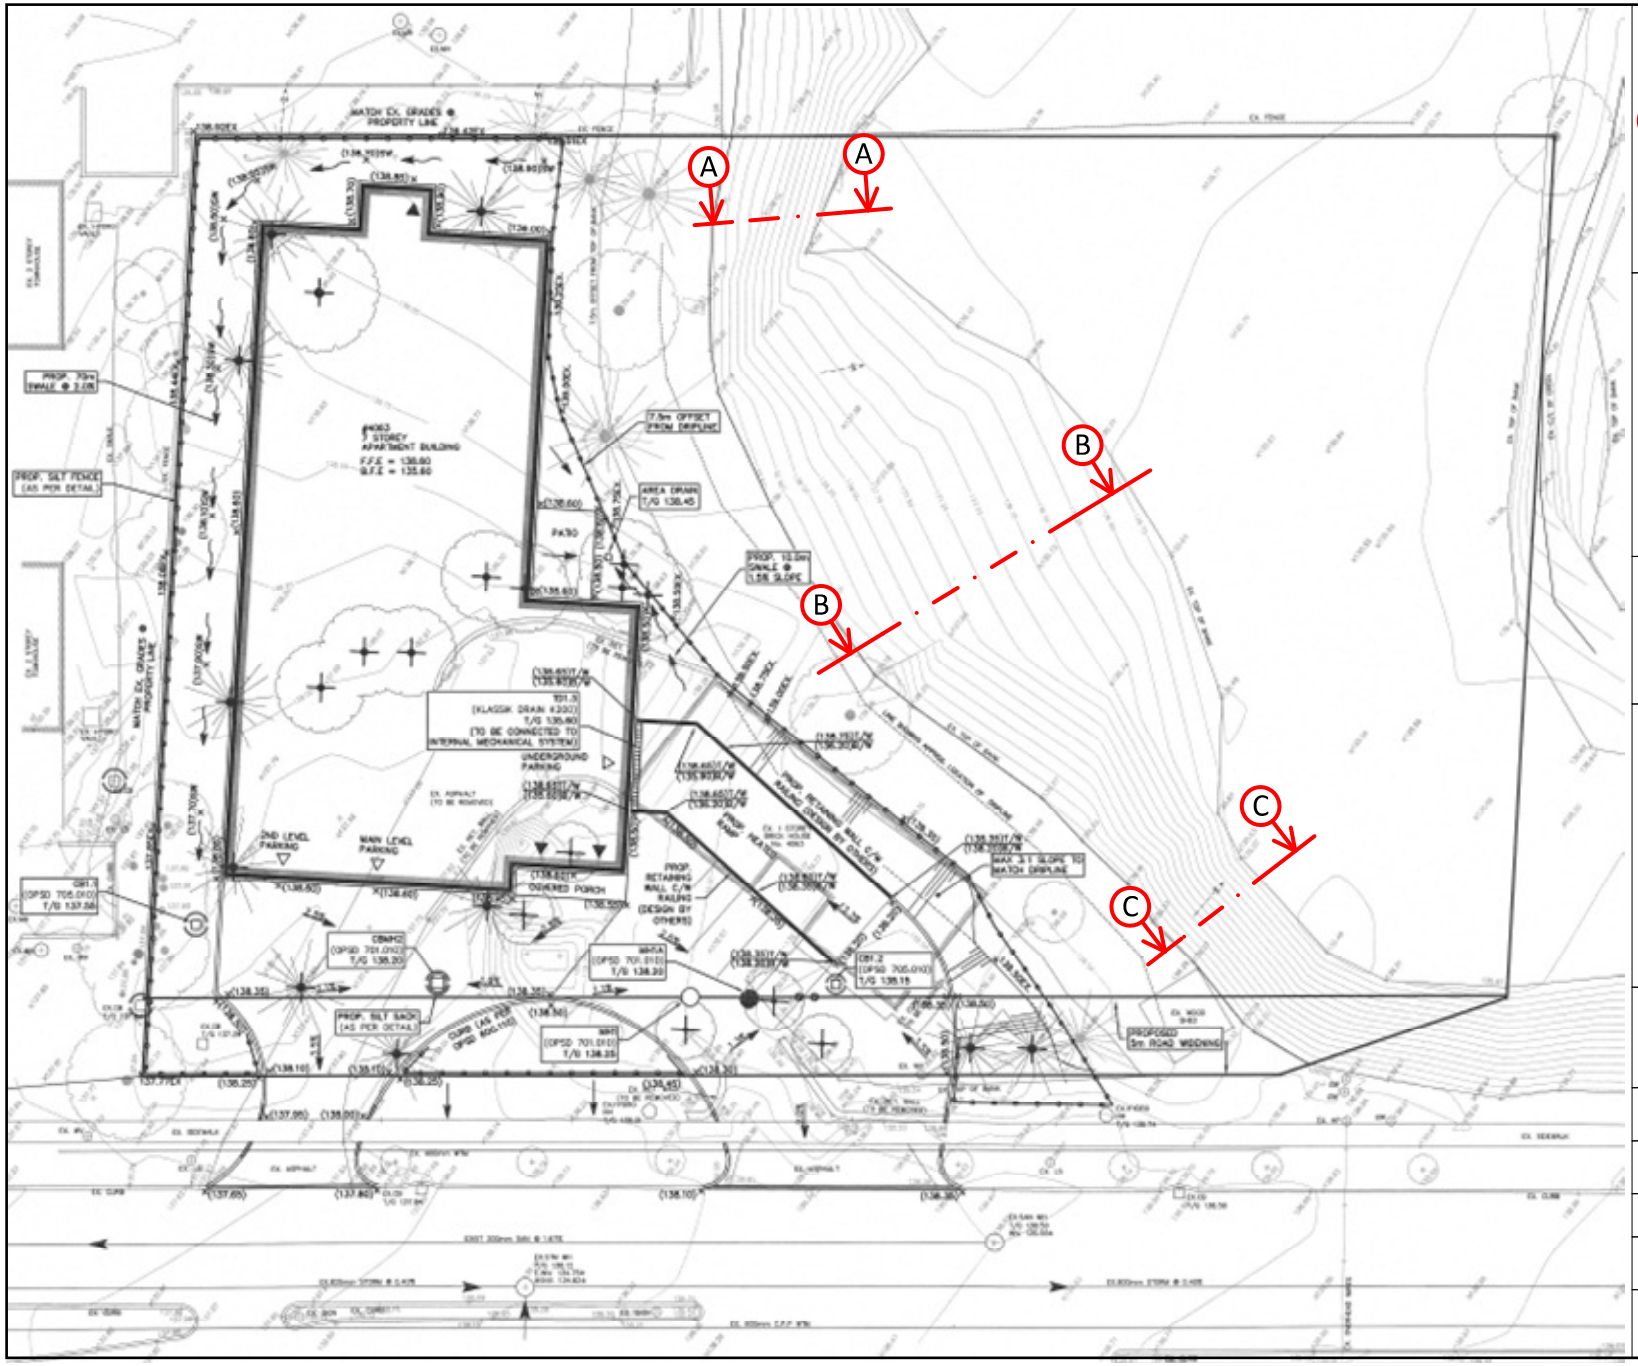
Drawing No. 1

SM 177692-G Slope Profile Location Plan

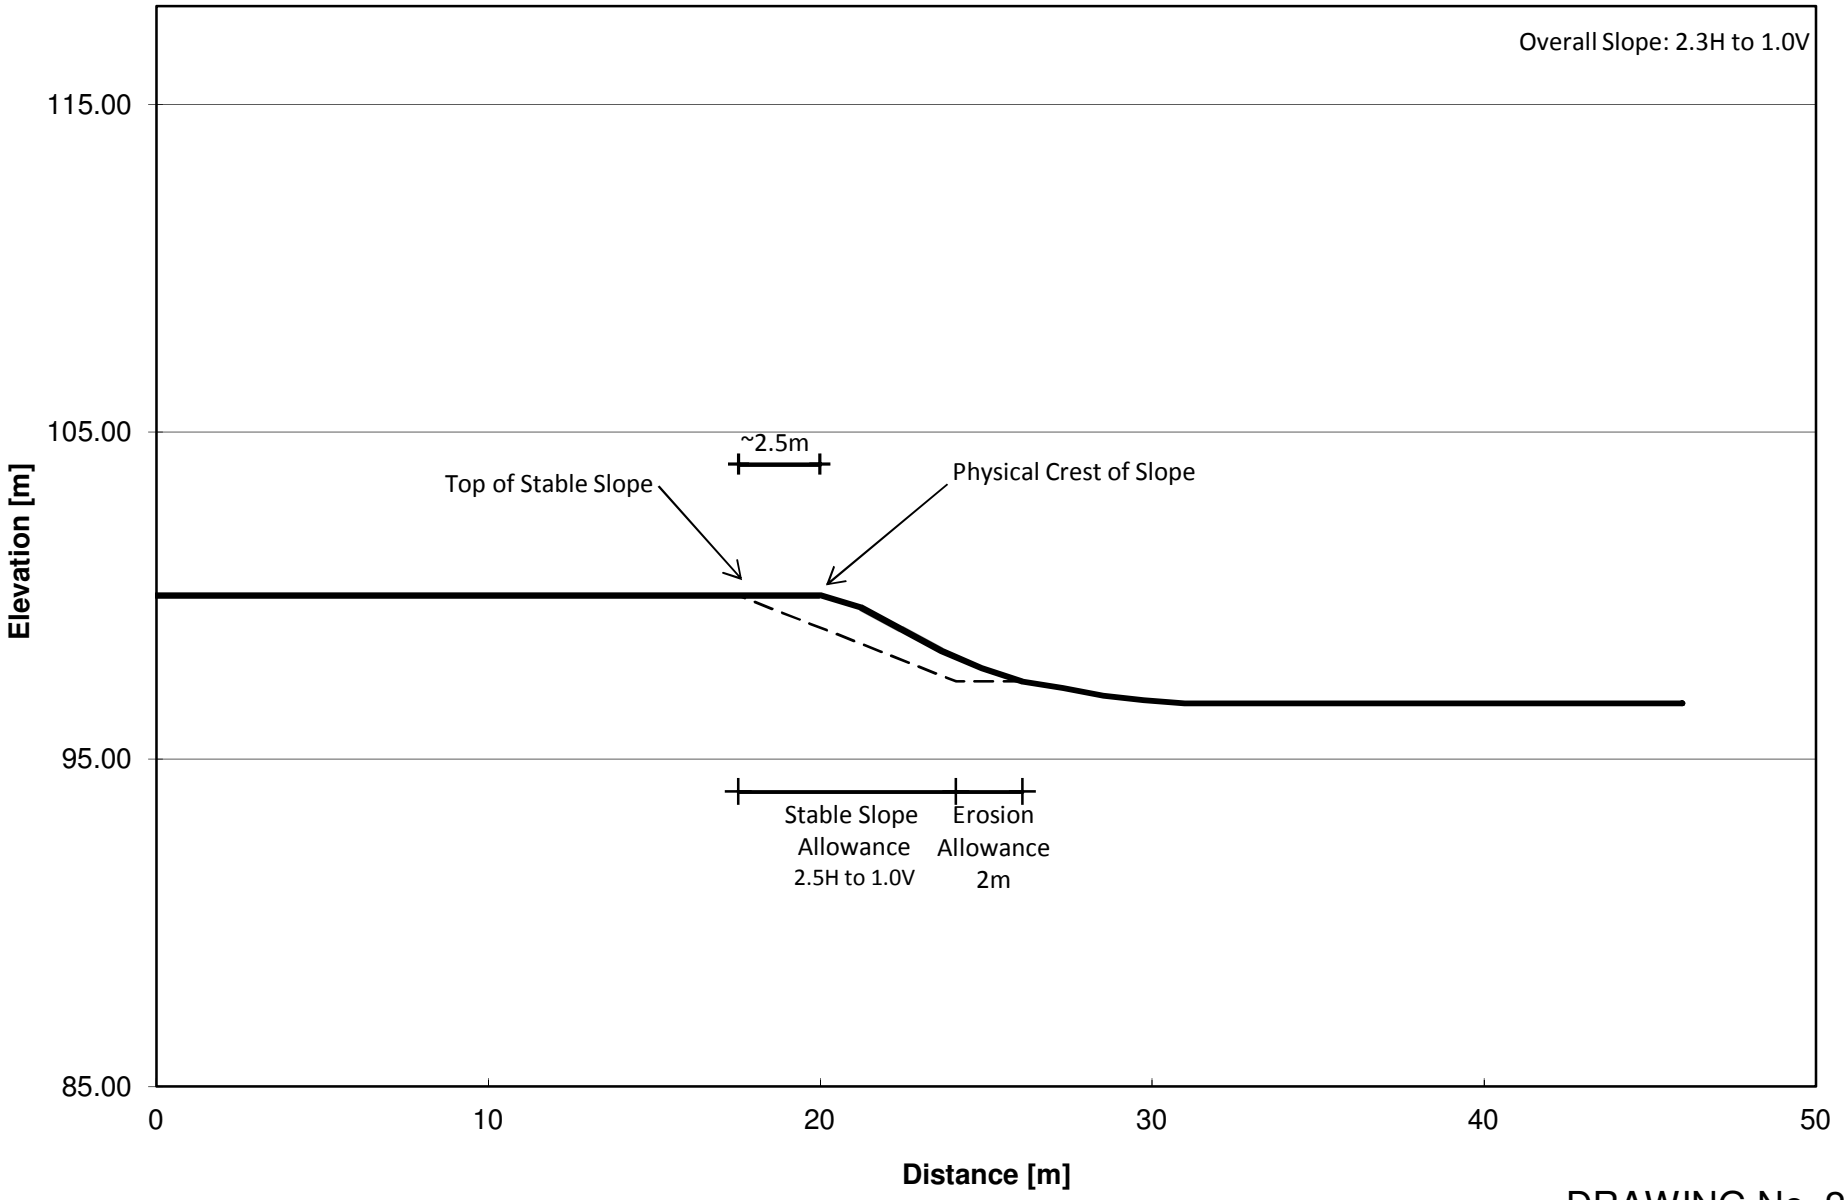
DRAWING No. 2

Based on our analyses, the subject slope was found to have minimum factors of safety for Profiles A-A, B-B, and C-C on the order of 3.36, 6.23, and 2.70, respectively, for normal conditions, and on the order of 2.82, 5.94, and 2.38 for elevated groundwater conditions. Sample results of these analyses are attached to the end of this report.

The Ministry of Natural Resources "Geotechnical Principles for Stable Slopes" publication, Table 7.2 lists a minimum Factor of Safety of 1.3 to 1.5 for Active Land Use application [habitable or occupied structures]. As the calculated factors of safety were found to far exceed this range, the subject slope is considered stable in its present condition in the short and long-term.
