**SUBJECT: Arborist Report and Tree Protection Plan
1350 Waterdown Road, Burlington – Fellowship Church**

Arborist Report and Tree Protection Plan

1350 Waterdown Road, Burlington

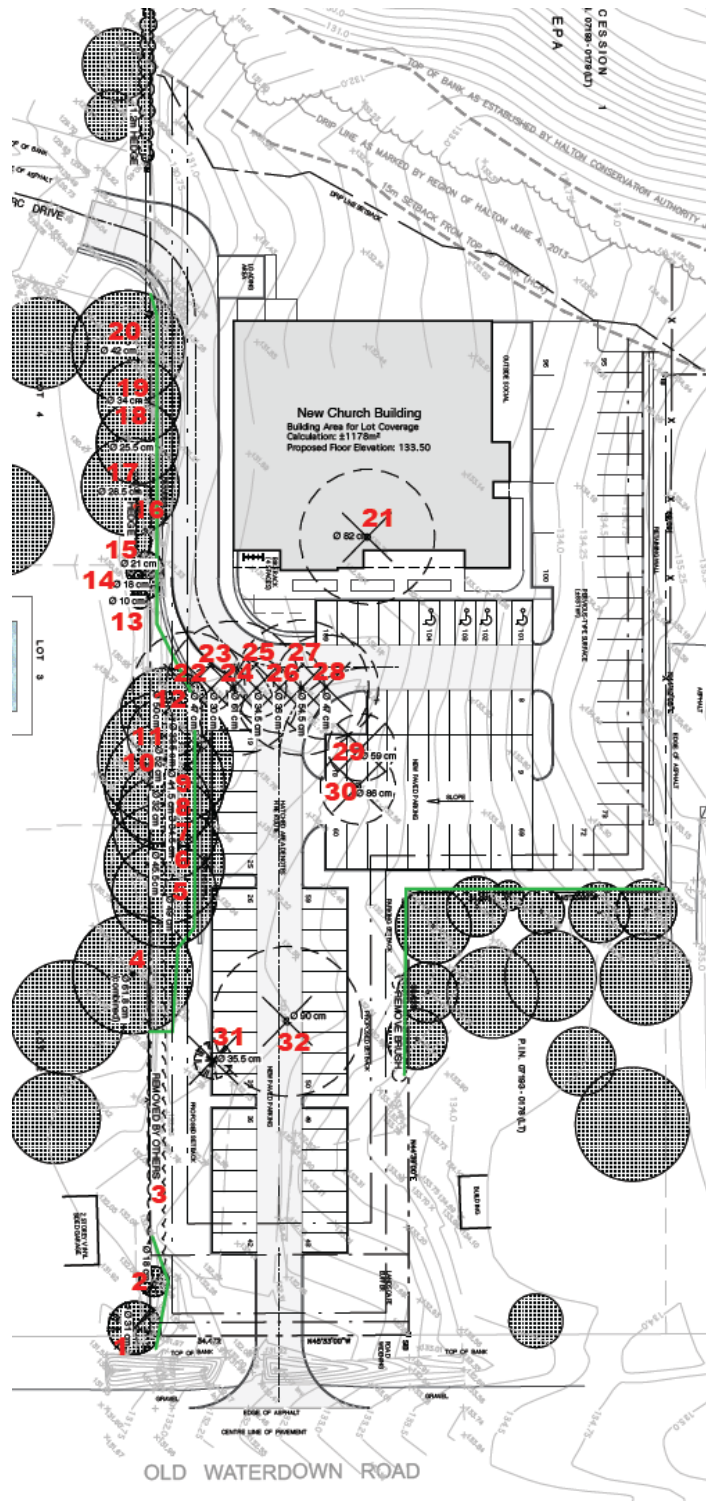
Appendix A: Proposed Site Plan

Note: The proposed Tree Protection Zone (TPZ) hoarding is shown as green lines and is not to scale on this drawing.
